PROJECT MEMORANDUM SYCAMORE-PEÑASQUITOS 230-KV TRANSMISSION LINE PROJECT

Date: February 26, 2018
To: Billie Blanchard, CPUC Project Manager
From: Sheila Hoyer, CPUC Monitoring Supervisor
Subject: Weekly Report #59 – February 12 to February 17, 2018

2018-02-15 AM Inspection Report

2018-02-17 AM Inspection Report

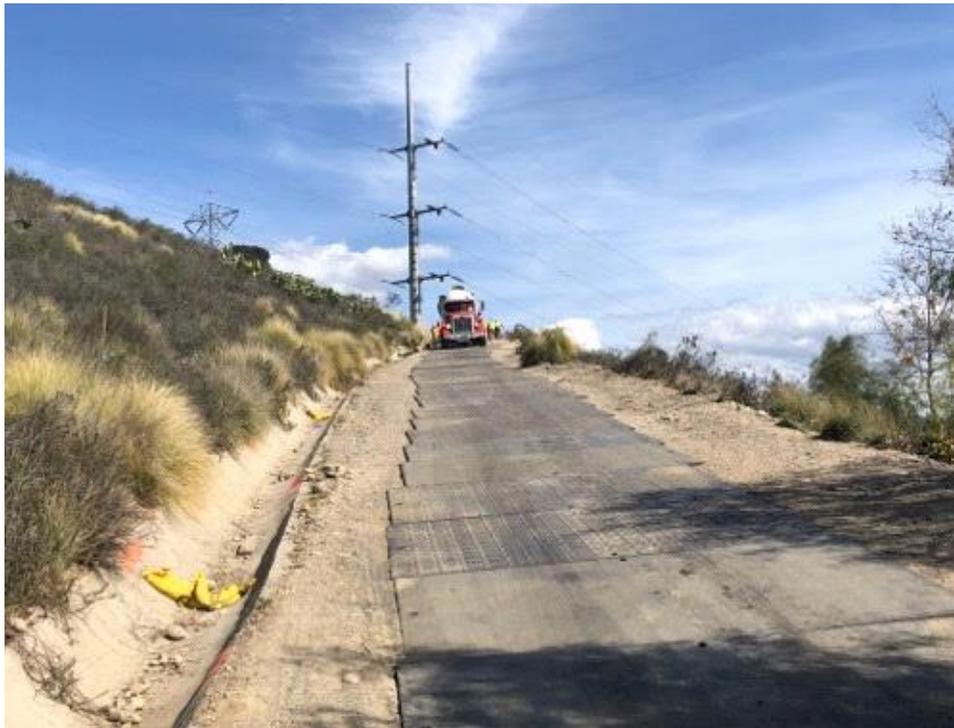
Caption Concrete work on dirt road to P05.

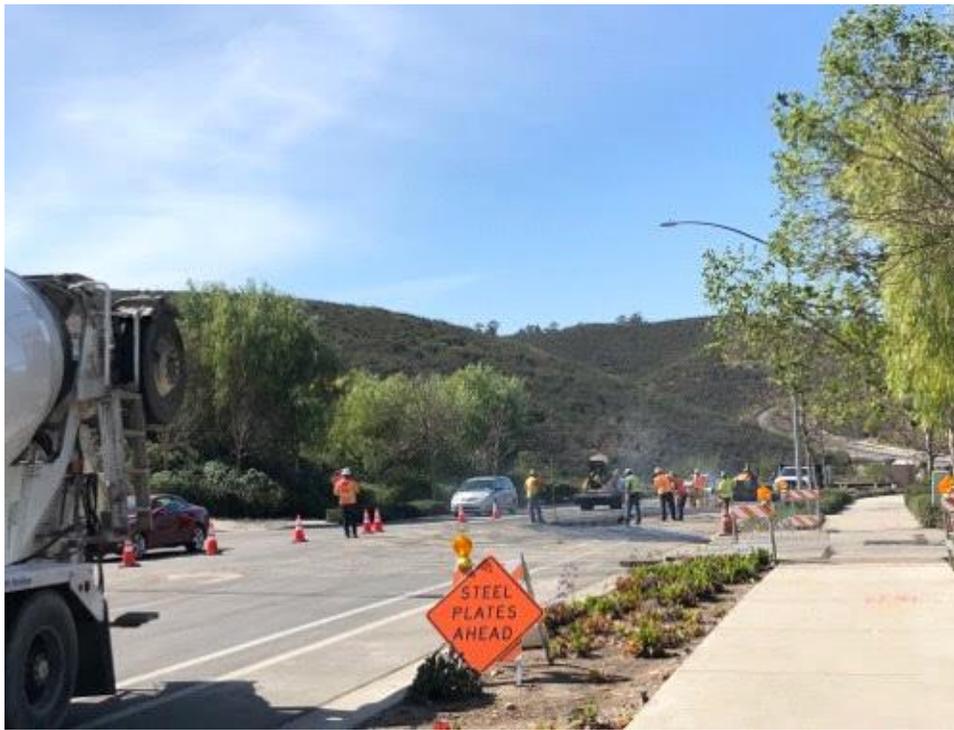
Caption Repaving Stonebridge Parkway.

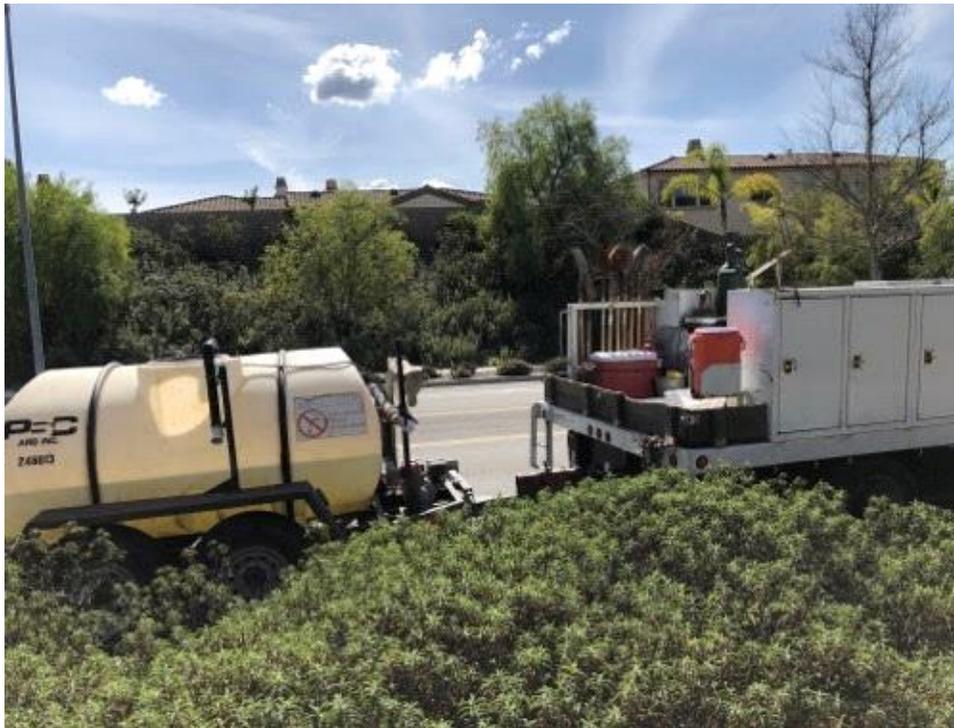
Caption Fire tools on vehicles on Stonebridge Parkway.

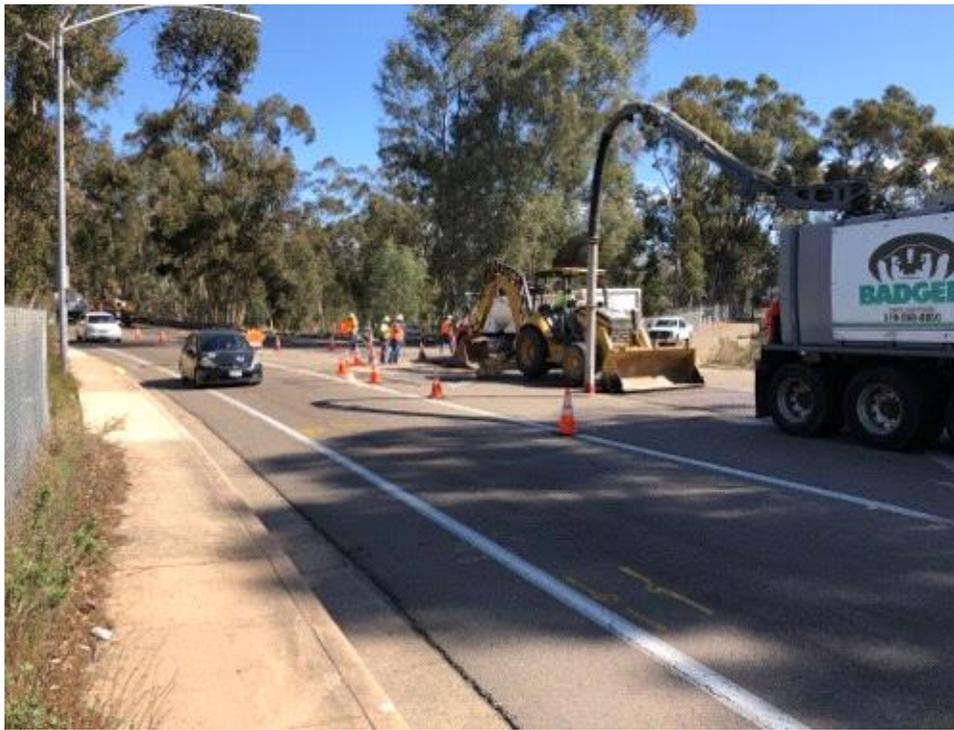
Caption Trenching and potholing work on Pomerado Road.

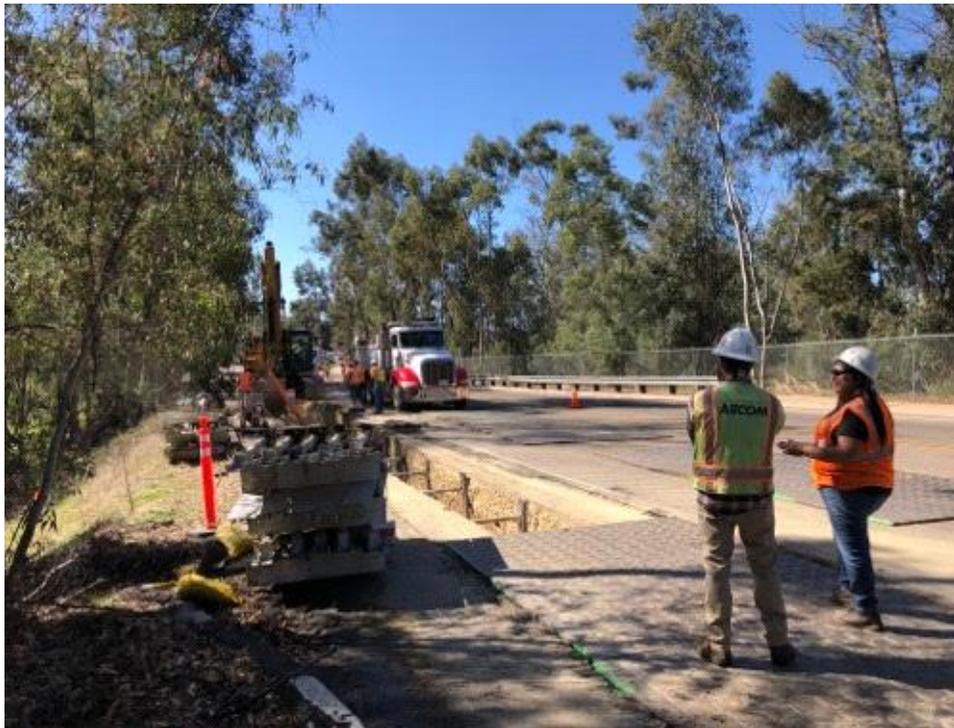
Caption Trenching on Pomerado Road east of I-15 and west of Avenue of Nations.

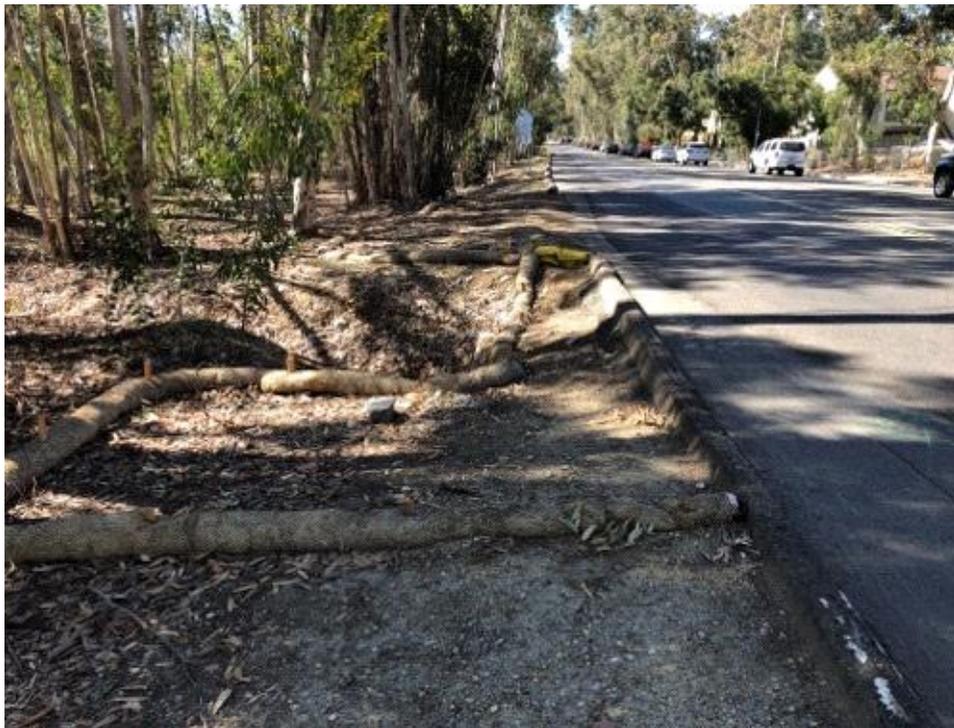
Caption BMPs on Pomerado west of Avenue of Nations on south side of road.

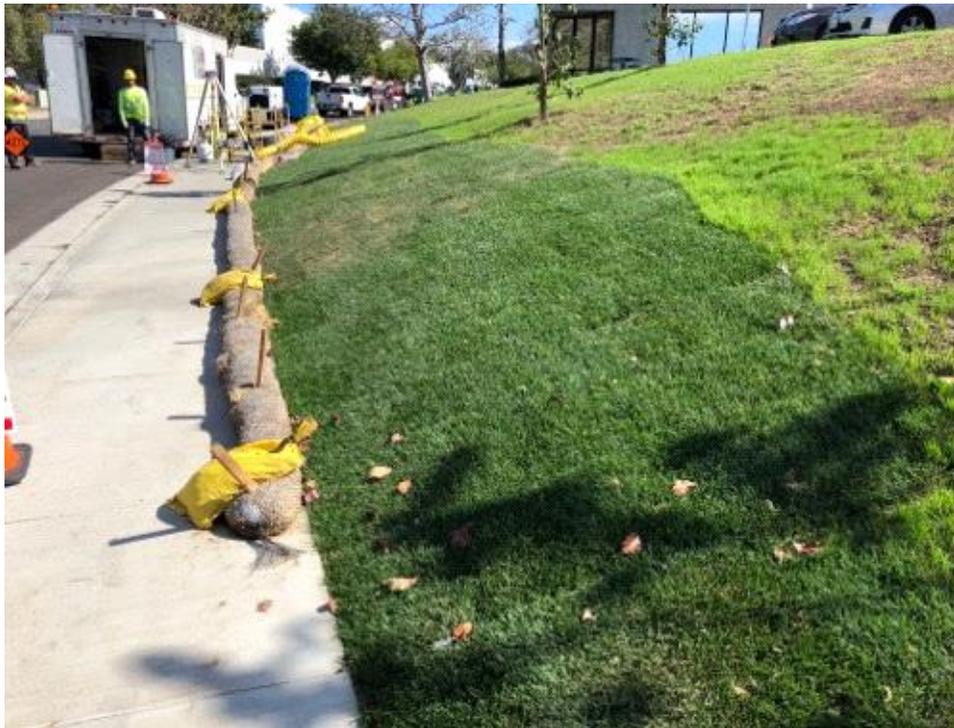
Caption Turf and BMPs controlling erosion on Activity Road.

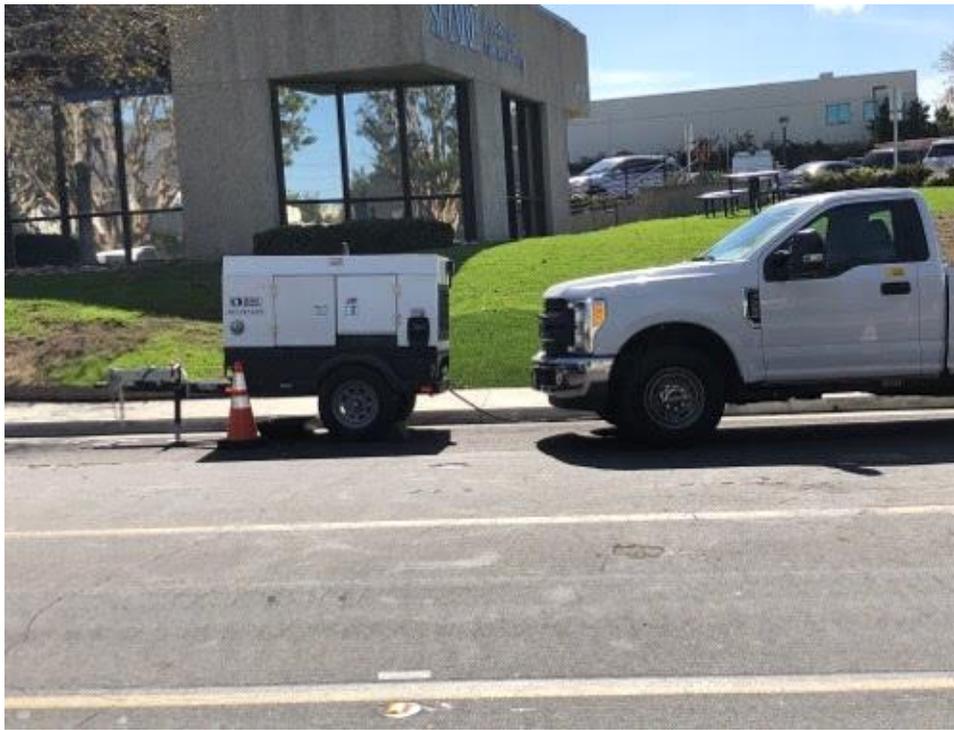
Caption Drip pan in place on generator on Activity Road.

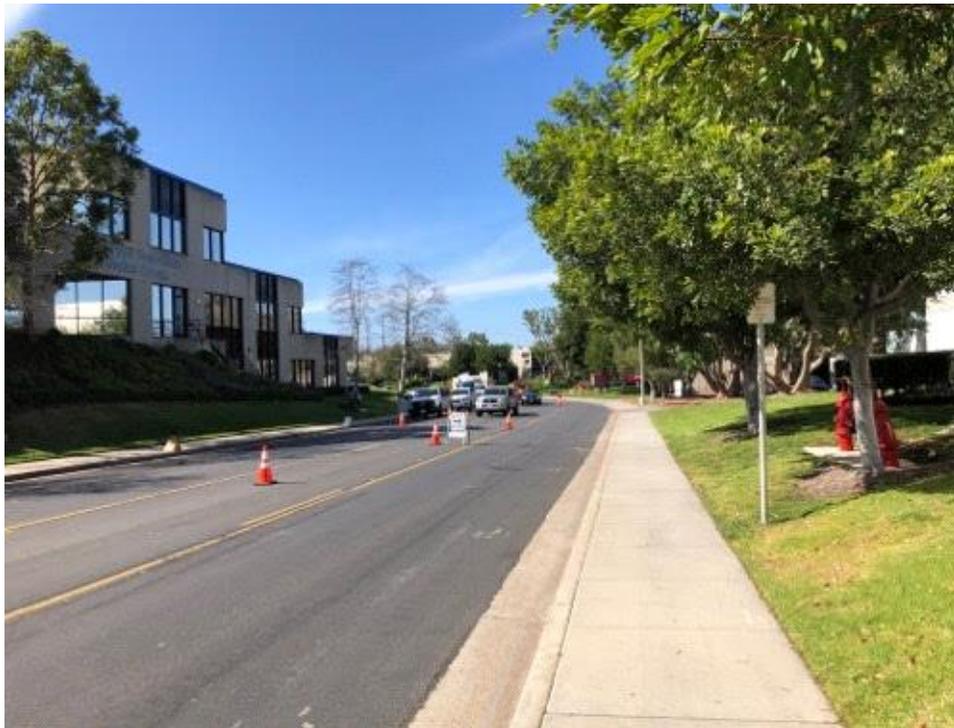
Caption Traffic control and vault work on Activity Road.

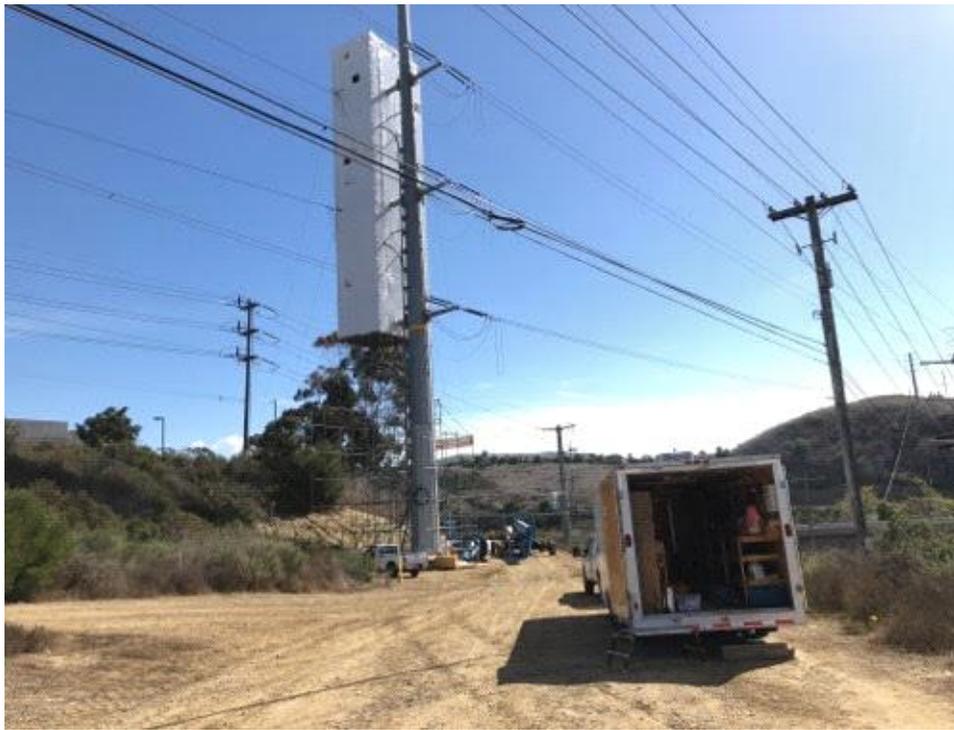
Caption CC MM CP work site- note fire tools in trailer.

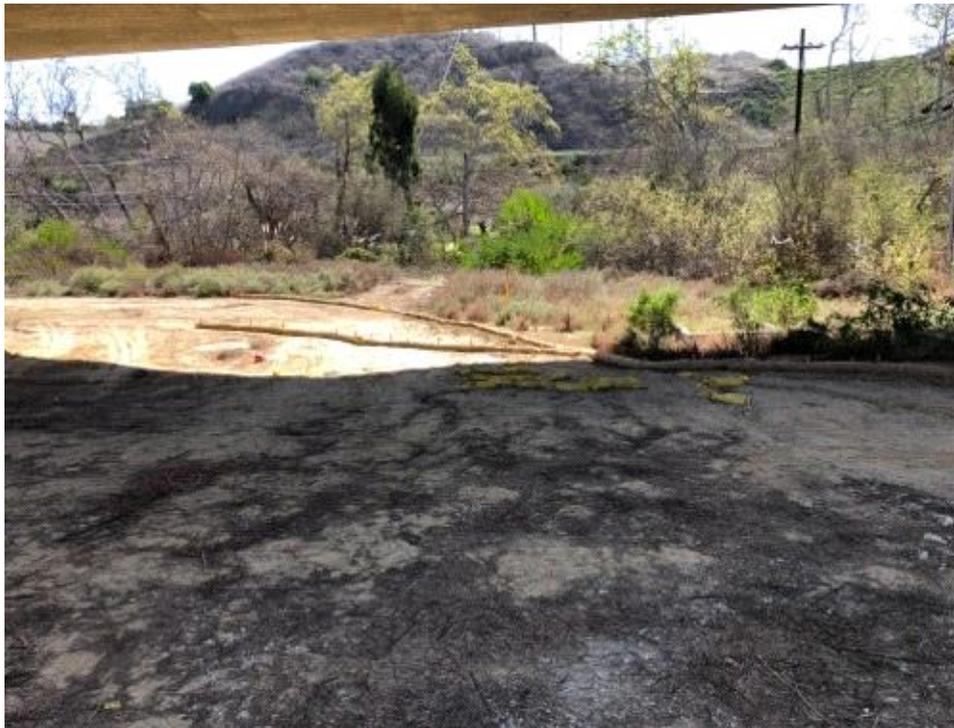
Caption Post storm event BMPs beneath Carroll Canyon Road bridge.

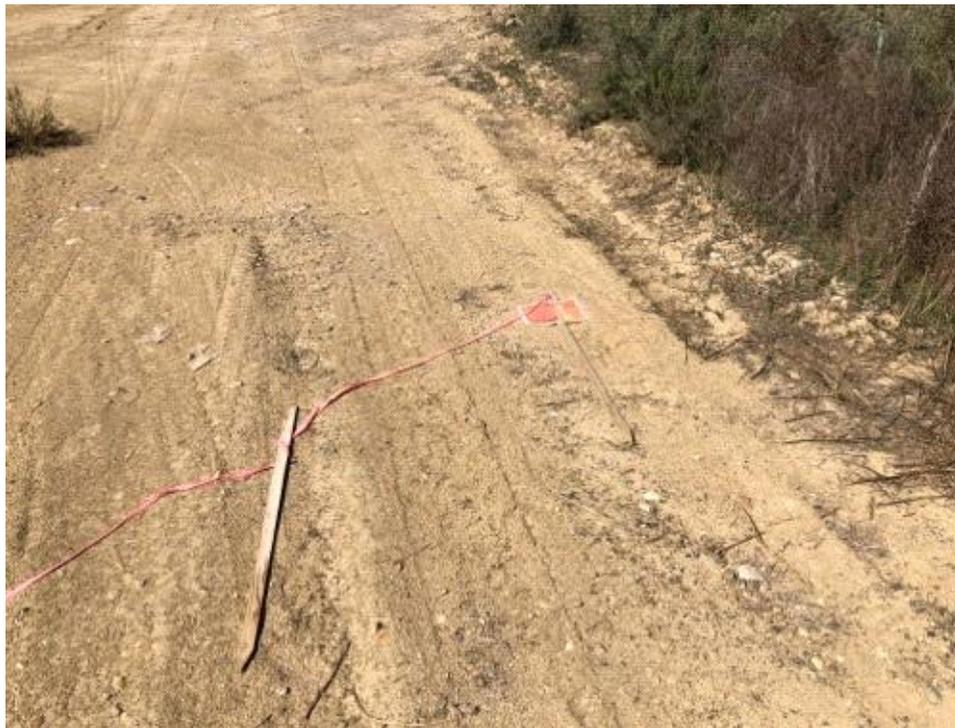
Caption Access signs not maintained adjacent to access road.

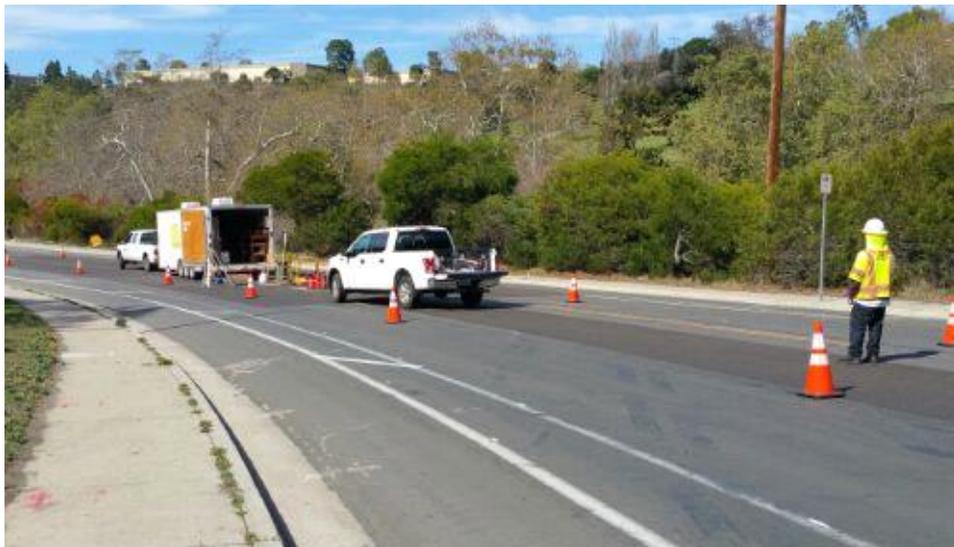
Caption Splicing on Carroll Canyon Road.

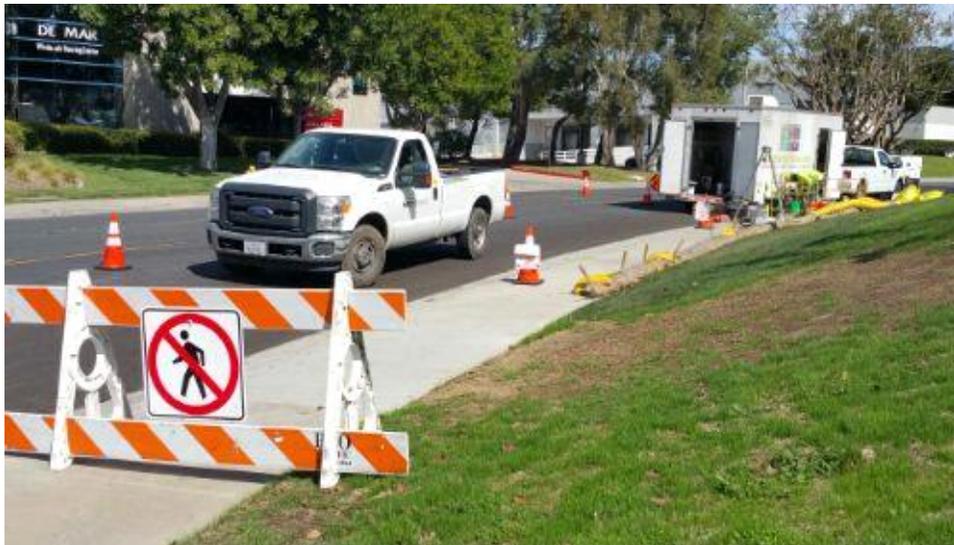
Caption Splicing on Activity Road.

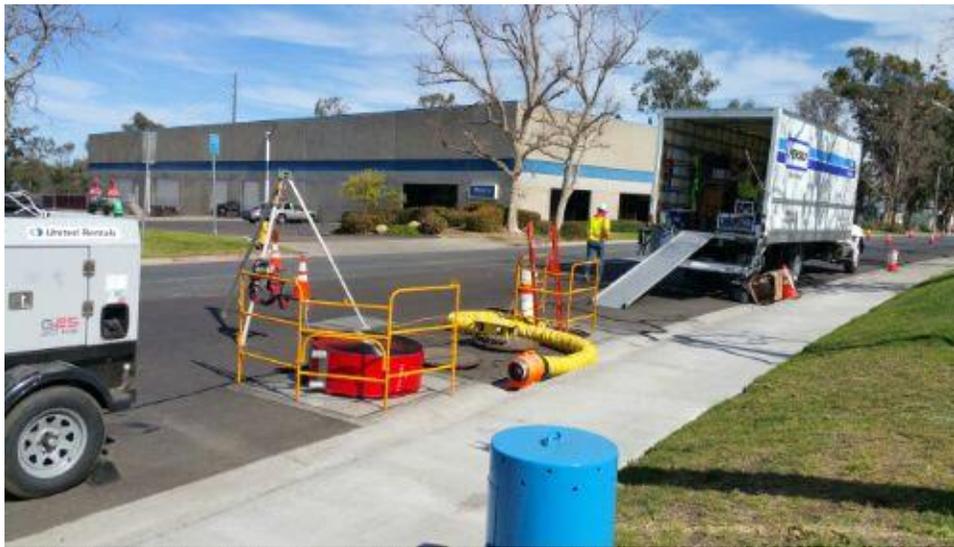
Cable splicing site on Activity Road.

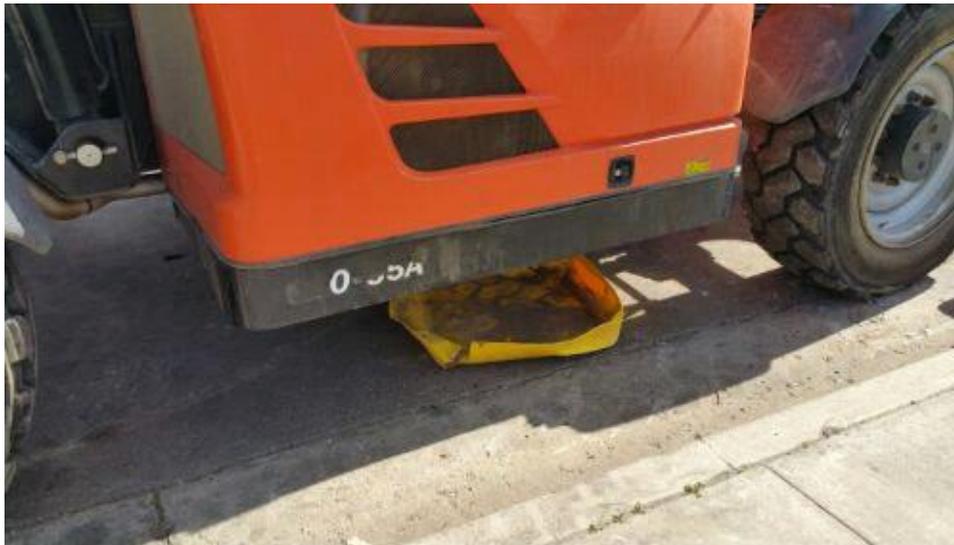
Damaged drip pan would not be effective at Padgett Road staging area.

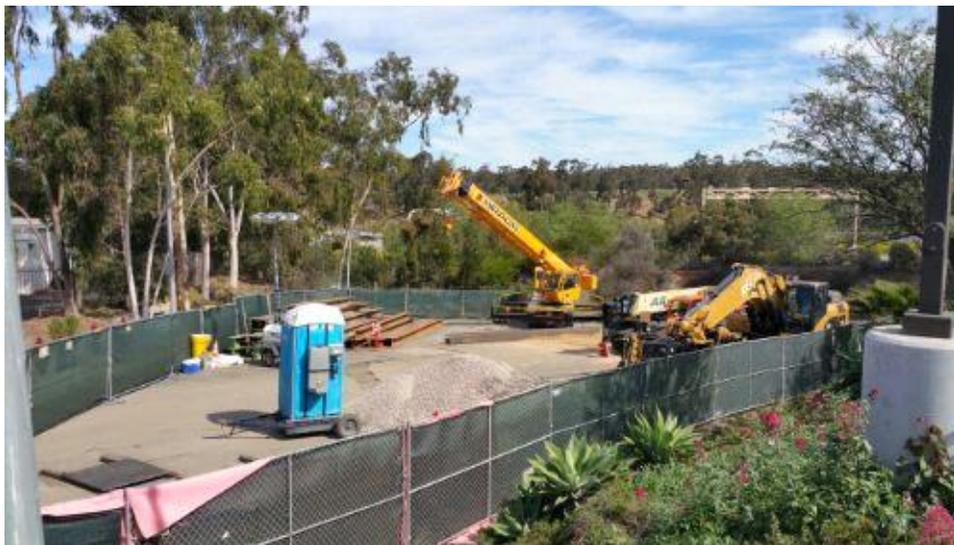
Staging area at Kearney Mesa Road.

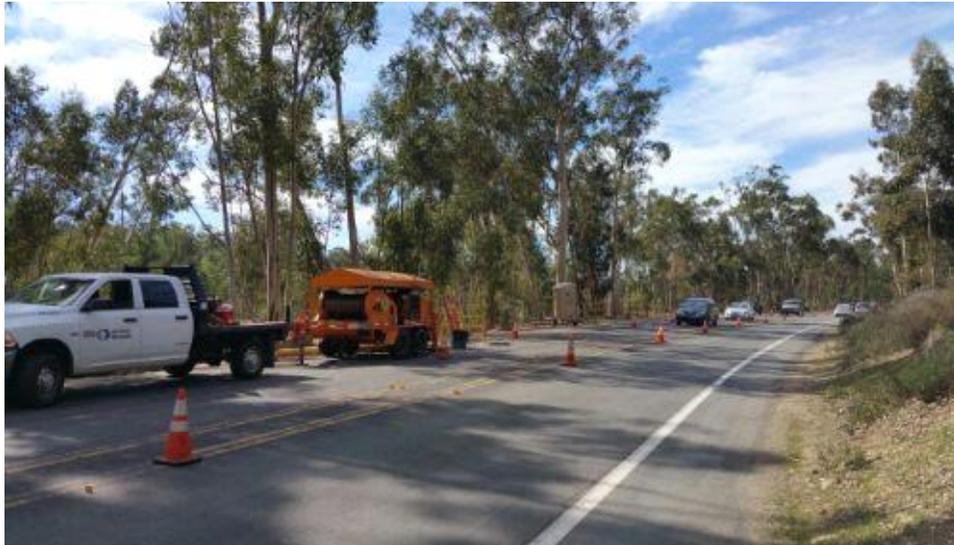
Caption Mandreling at Pomerado Road.

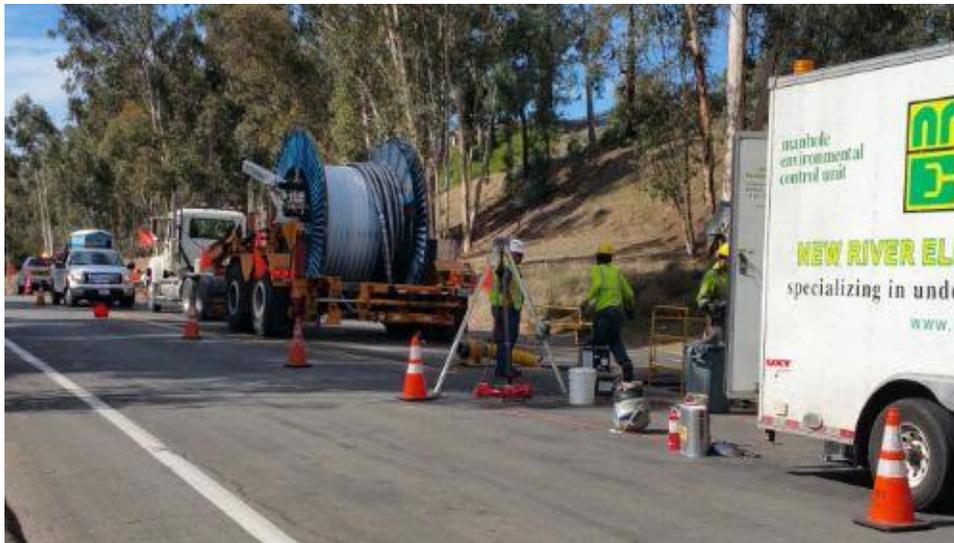
Caption Stringing cable at Pomerado Road.

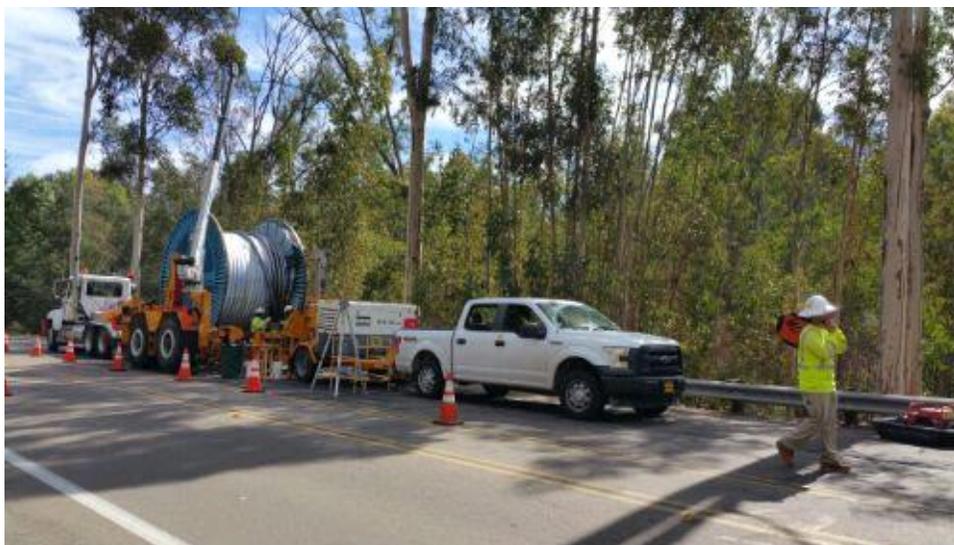
Caption Spooling cable at Pomerado Road.
Photo Attributes Capture Date/Time: Sat Feb 17 2018 11:02:15 GMT-0800 (PST)
Coordinates: 32.906028, -117.080748
View Direction: Southeast

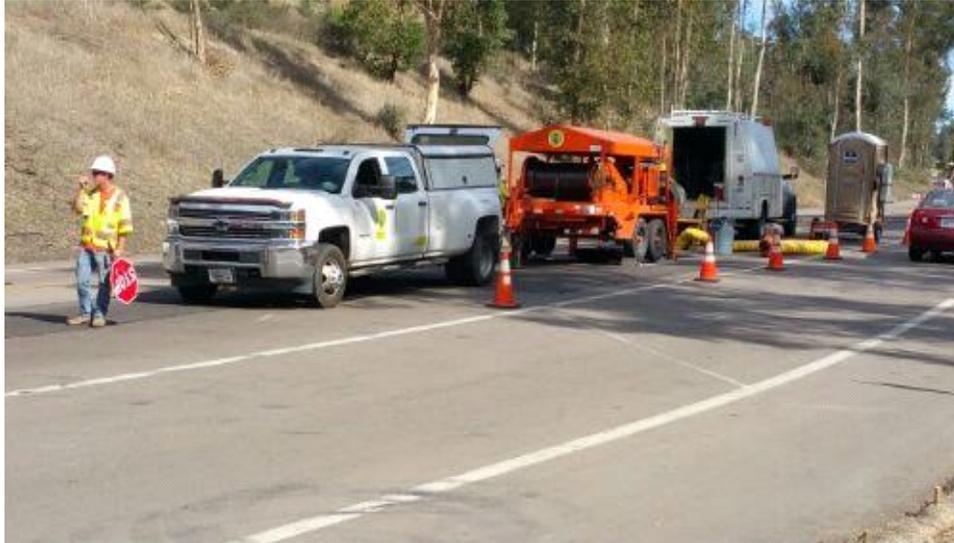
Caption Pulling cable at Pomerado Road.
Photo Attributes Capture Date/Time: Sat Feb 17 2018 10:46:01 GMT-0800 (PST)
Coordinates: 32.90798, -117.076107
View Direction: Northeast

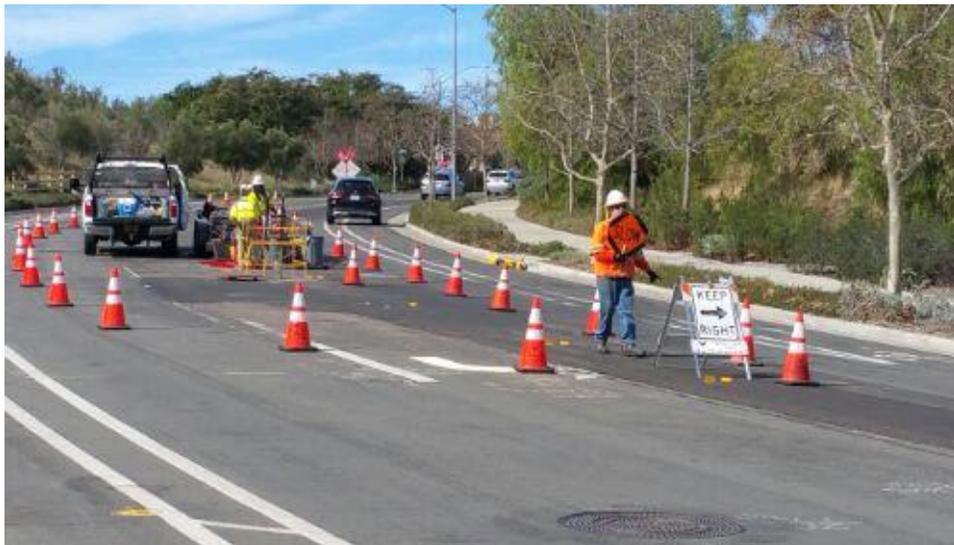
Caption Mandreling along with traffic control on Stonebridge Parkway.
Photo Attributes Capture Date/Time: Sat Feb 17 2018 10:25:25 GMT-0800 (PST)
Coordinates: 32.92116, -117.055316
View Direction: West

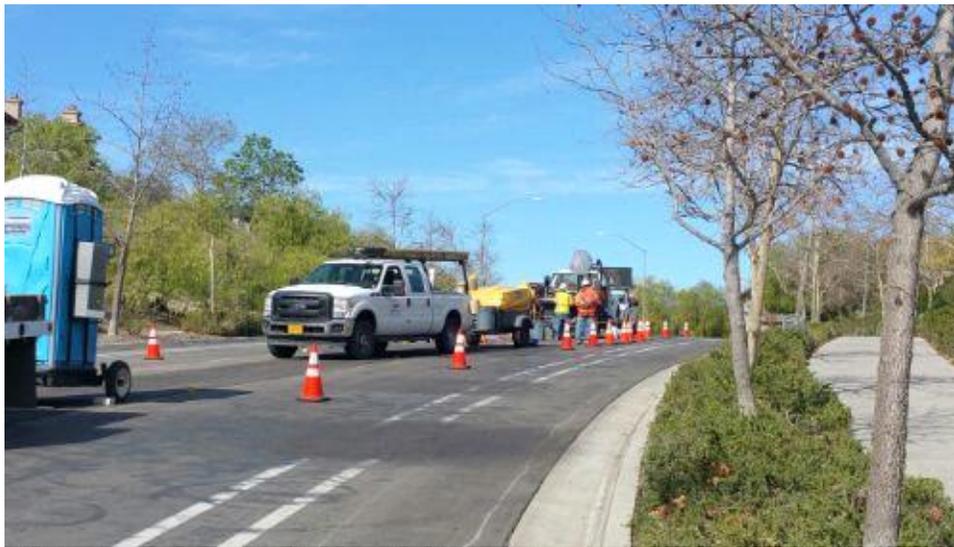
Caption Mandreling along with traffic control on Stonebridge Parkway.

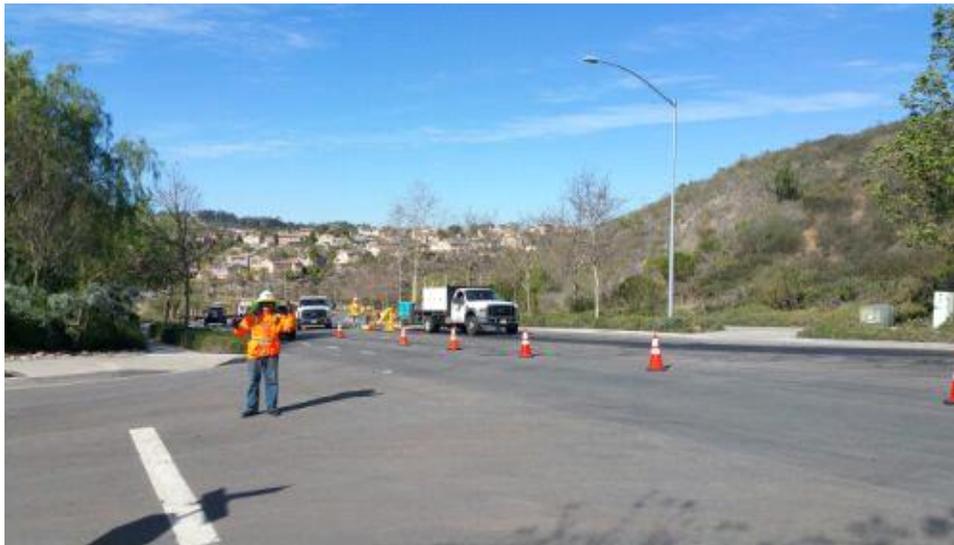
Caption Mandreling and traffic control on Stonebridge Parkway.
