## PROJECT MEMORANDUM SYCAMORE-PEÑASQUITOS 230-KV TRANSMISSION LINE PROJECT

Date: July 6, 2018  
To: Billie Blanchard, CPUC Project Manager  
From: Jessica Hing, CPUC Monitoring Supervisor (back-up)  
**Subject:** Weekly Report #78 – June 25-June 30

## SDG&E Sycamore-Peñasquitos 230-kV Transmission Line Project: Daily Inspection Report

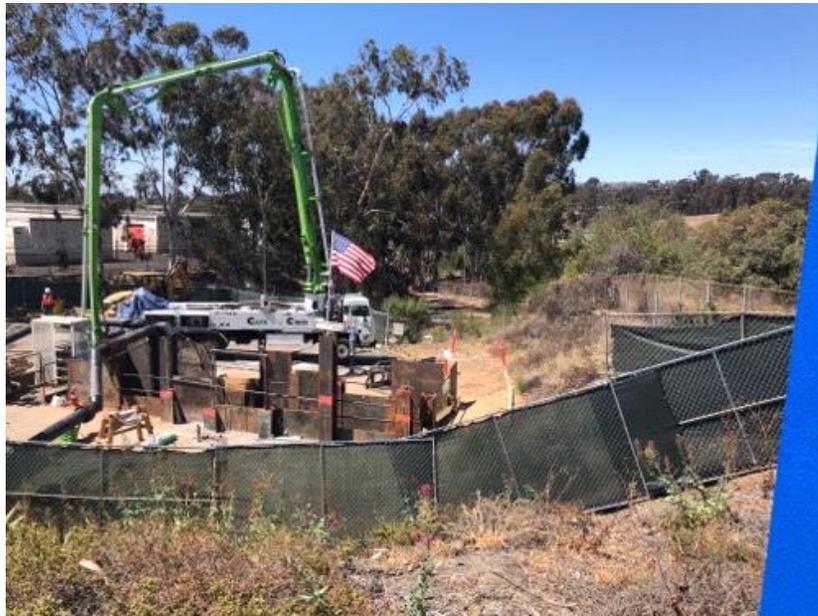
Caption According to LEI there was a discharge of water at the western bore pit today. Water was discharged north of the pit, filter with gravel bags.

Q7 Notes	Water from grouting at bore pit was discharged outside of work area. The discharges didn't impact any jurisdictional water ways.
Q8 – Invasive Weed Control: Were procedures to prevent the spread of invasive weeds implemented adequately?	Met Requirements
Q9 – Hazardous Materials and Waste Management: (a) Were hazardous materials stored and labeled properly? (b) Was hazardous material waste disposed of appropriately? (c) Were any spills or leaks addressed adequately? (d) Was solid waste collected and disposed of adequately?	Met Requirements
Q9 Notes	Discharge sediment will be tested for PH to determine if mediation is required
Q10 – Fire Management: (a) Were fire prevention procedures in place? (b) Was firefighting equipment available on site?	Met Requirements
Q11 – Cultural, Paleontological, and Tribal Resources: (a) Were cultural, paleontological, and tribal resources monitoring and impact avoidance occurring as required? (b) If potential resources or human remains were inadvertently discovered, were response procedures and protocols implemented as required?	Met Requirements

As a corrective action, SDG&E has informed the contractor that a vacuum truck must be available on-site while the cooling system continues to operate (approximately 3 more days) to prevent any further discharges resulting from pipe failure.

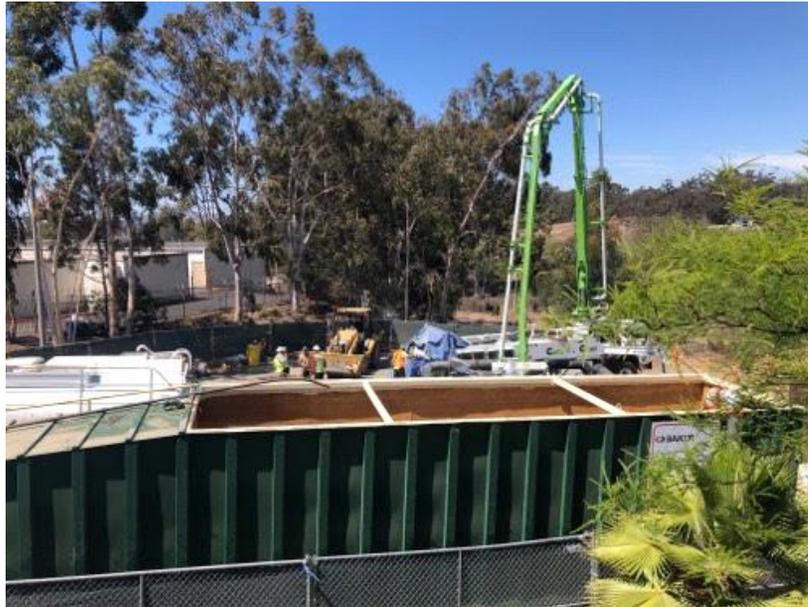
Caption Western bore pit grouting under way.

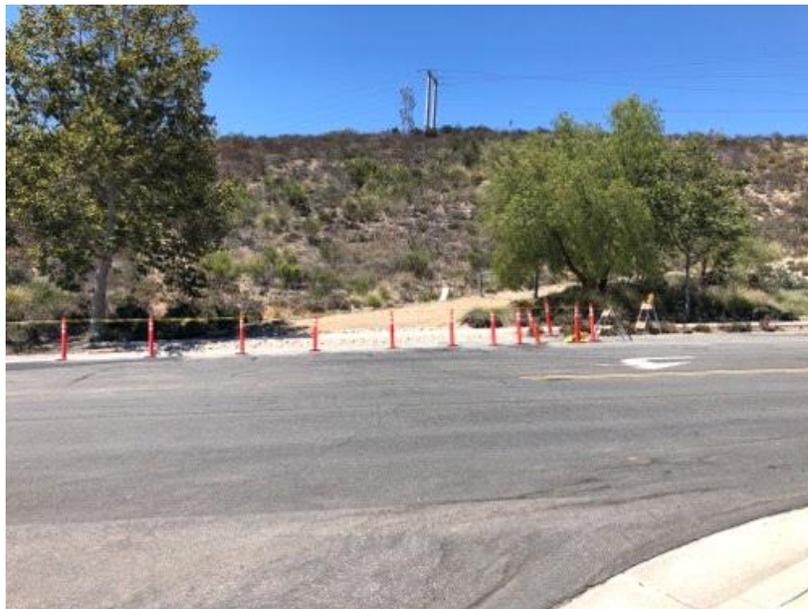
Caption No active work along Stonebridge.
