Re: Monthly Report Summary #4 for the Manning 500/230 kV Substation Project

MANNING 500/230 KV SUBSTATION PROJECT

CPUC SITE INSPECTION FORM

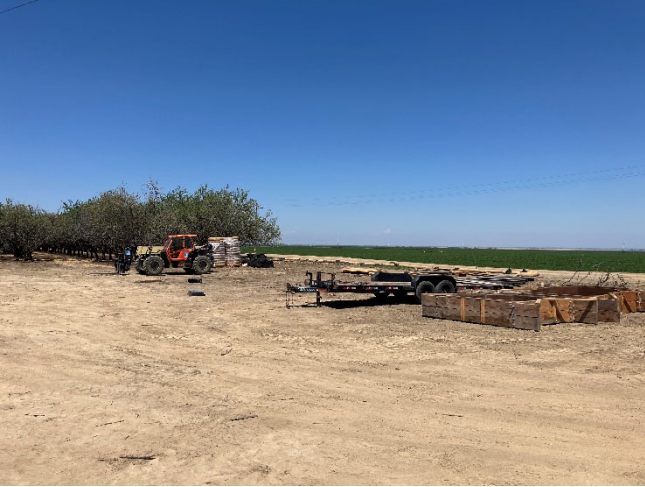
A photograph showing a temporary staging area at an interconnection site. The ground is dry and dusty. In the background, there are trees and a clear blue sky. A yellow tractor and a trailer are visible in the middle ground.	Temporary staging area at interconnection site
5/7/26	Interconnection site (orchard)

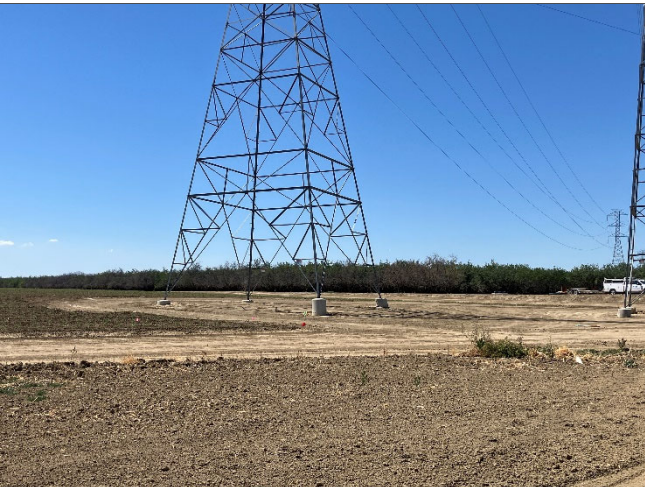
A photograph of a transmission tower under construction. The tower is a lattice structure. Power lines are visible in the background. The ground is dry and dusty.	ESA under active crows nest on transmission line – some stakes are down and may be re-erected, but current project activities are not encroaching into this area.
5/7/26	Interconnection site (orchard)

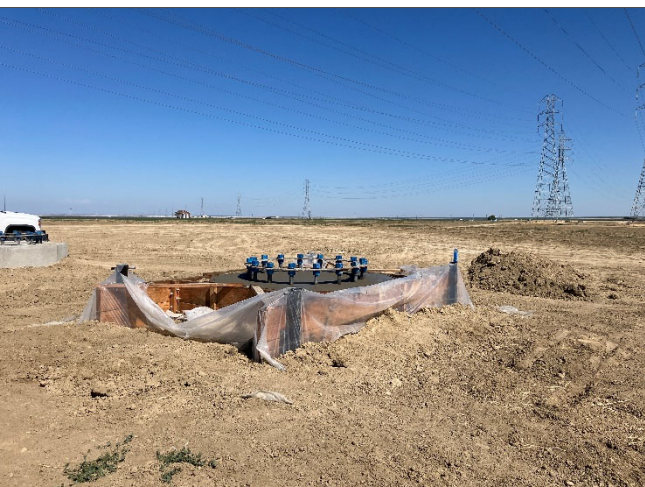
A photograph of a construction site. A large area of ground is covered with concrete, which has been filled and leveled. The concrete is surrounded by a plastic barrier. In the background, there are power lines and a clear blue sky.	Concrete filled and leveled by the end of the day, and left open for drying overnight

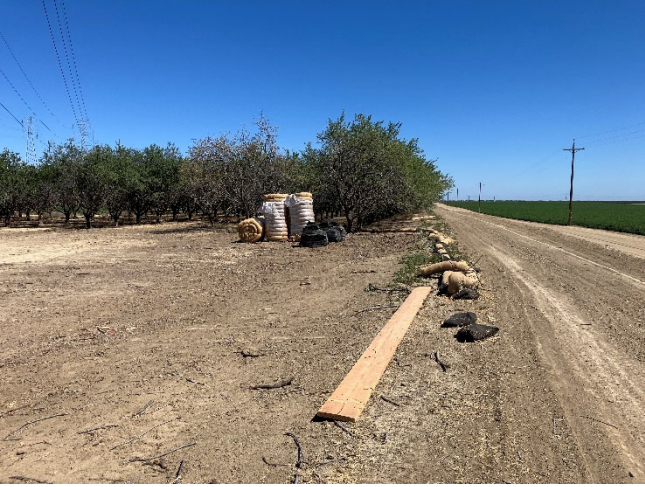
Temporary staging area at interconnection site still has some materials on it, no activity.
5/14/26	Interconnection site (orchard)

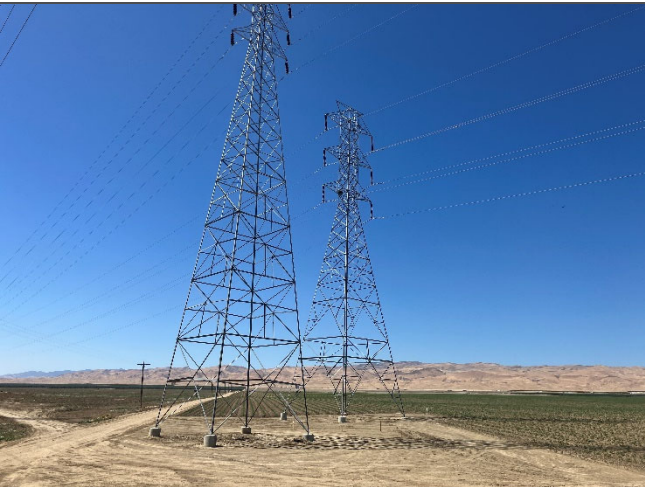
ESA under active crows nest on transmission line
5/14/26	Interconnection site (orchard)

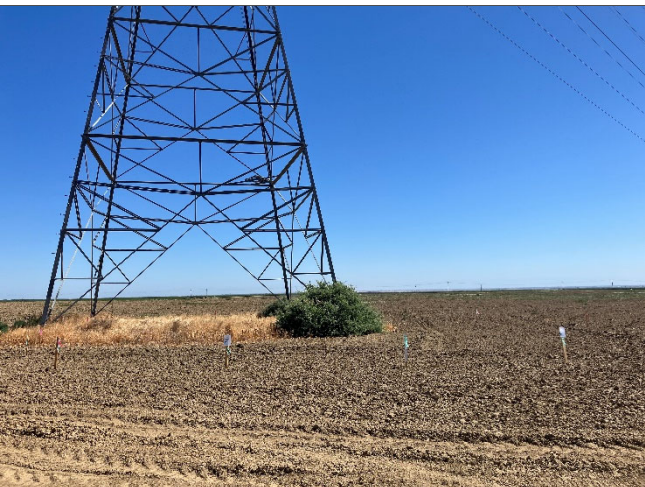
Other ESA still erected on interconnection site

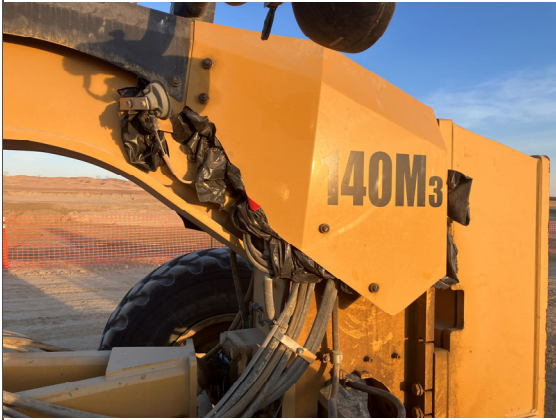
Date	Location	Photo	Description
5/21/26	Manning Substation

Plastic to prevent nesting birds on equipment.
5/21/26	Manning Substation

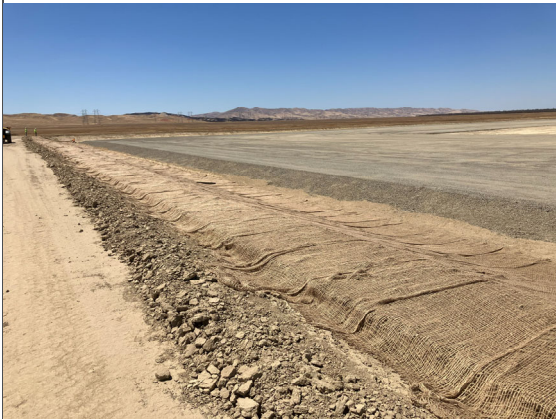
Jute netting at substation site.
5/21/26	PG&E staging area

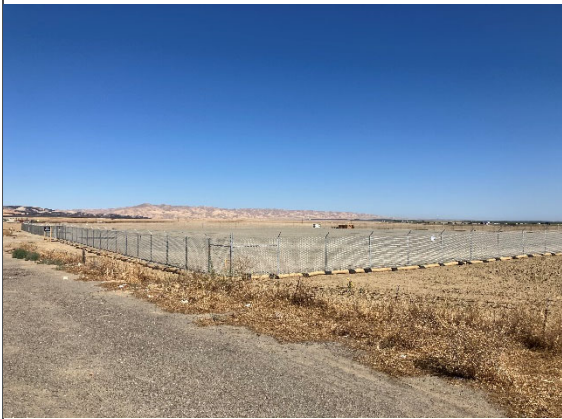
Staging area for PG&E

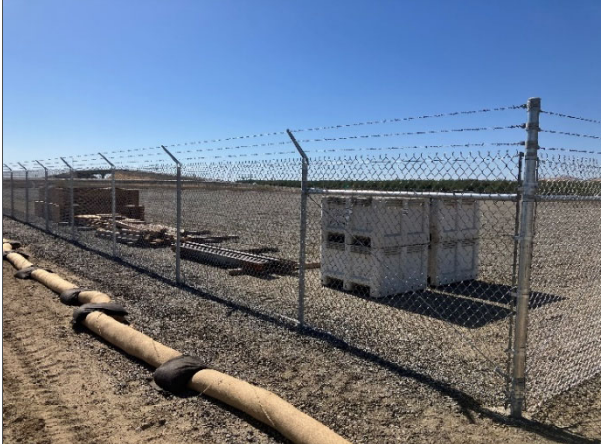
5/21/26	PG&E staging area

A photograph showing a fenced-in staging area. In the foreground, a large, thick, yellowish-brown pipe lies on the ground. Behind a chain-link fence, there are stacks of materials, including what appears to be a large white container or tank. The area is outdoors with a clear blue sky.	Materials at Staging Area
5/21/26	Junction site

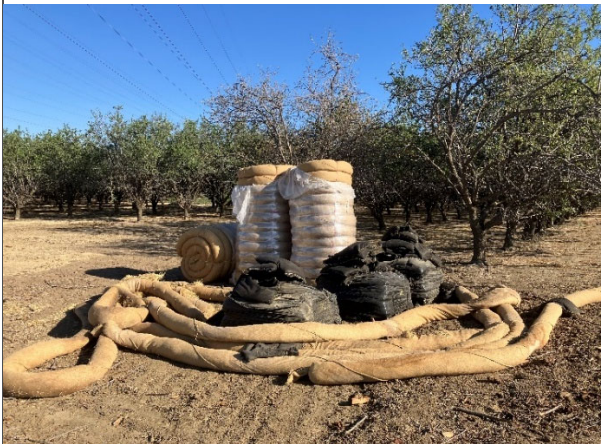
A photograph of a temporary staging area located near an orchard. The ground is dirt. There are several large rolls of white material, possibly plastic or fabric, and some other equipment or materials scattered around. Trees and power lines are visible in the background under a clear blue sky.	Materials at temporary staging area near orchard
5/21/26	Junction site

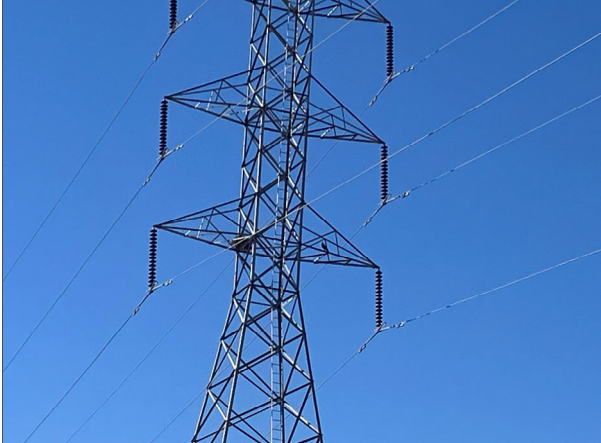
A photograph of a high-voltage power line tower, also known as a pylon. The tower is a lattice structure made of metal, and it supports several power lines. The background is a clear, bright blue sky.	Ravens attending nest

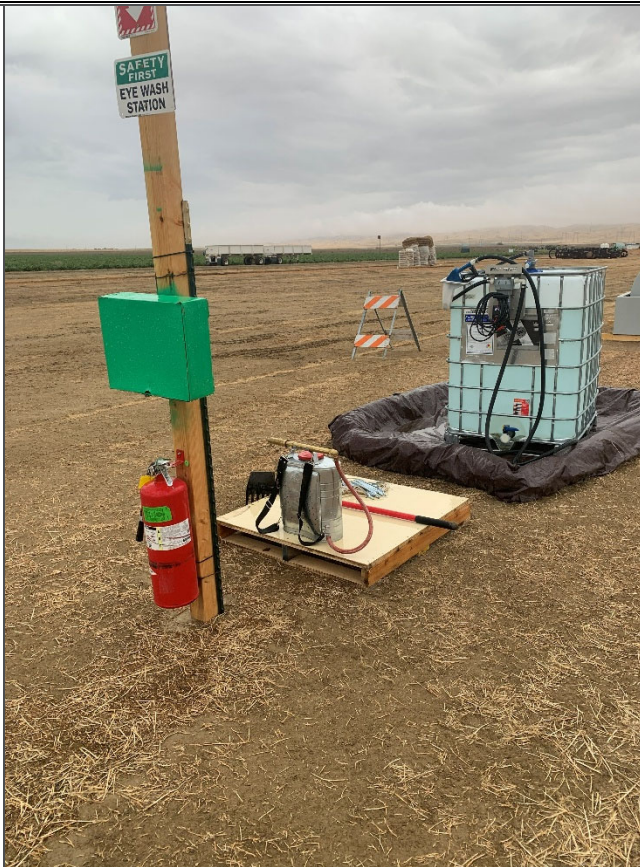
Manning
Substation

DEF pump with containment
and fire suppression gear

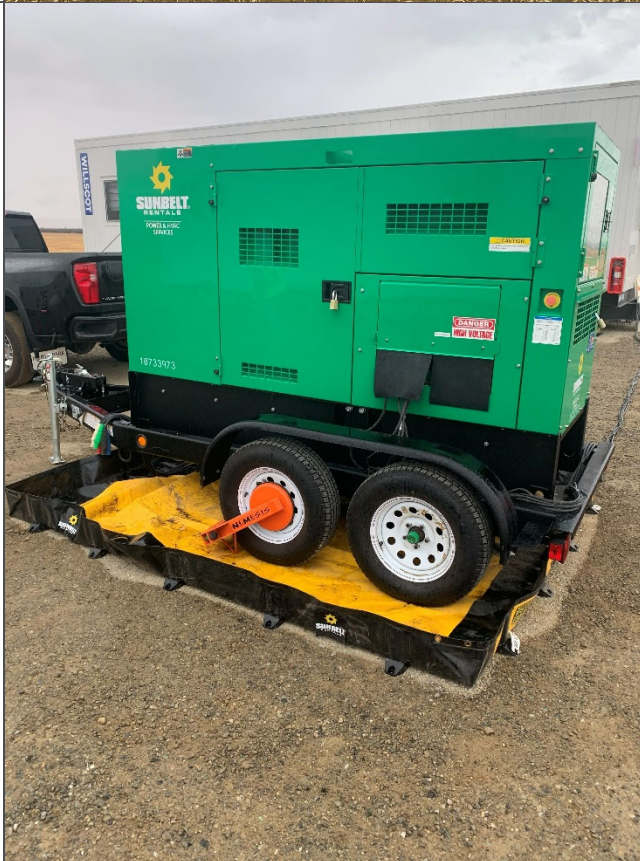
Manning
Substation

Generator in place with
containment

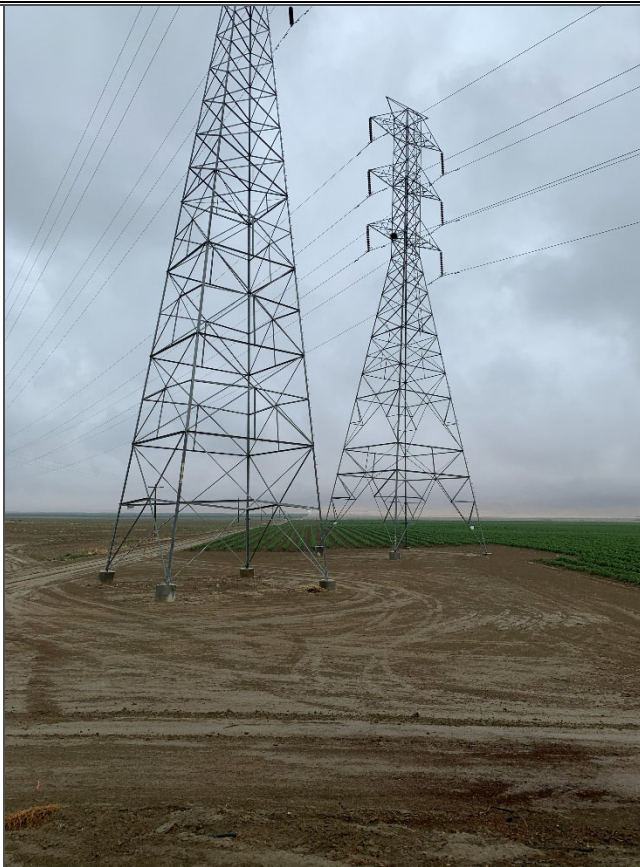
PG&E Orchard Site

Nest in tower, no activity observed at nest no ESA signs around tower

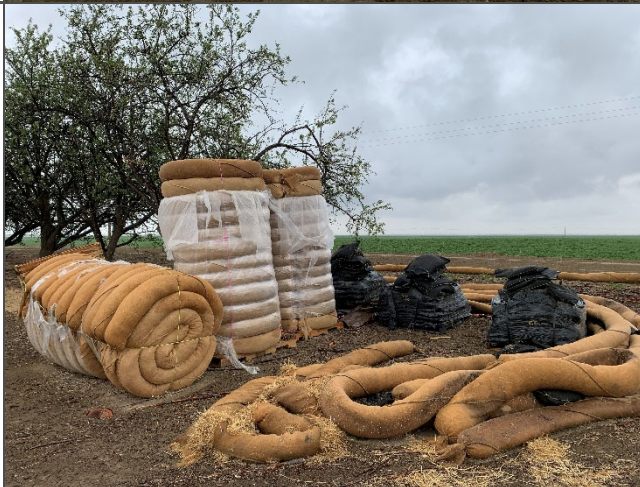
PG&E Orchard Site

BMP Materials on site. No activity.
