This report provides a summary of environmental monitoring and compliance activities conducted by Burns and McDonnell (BMcD) staff and BMcD subconsultants for the San Diego Gas & Electric (SDG&E) Sunrise Powerlink Project during the above weekly time period.

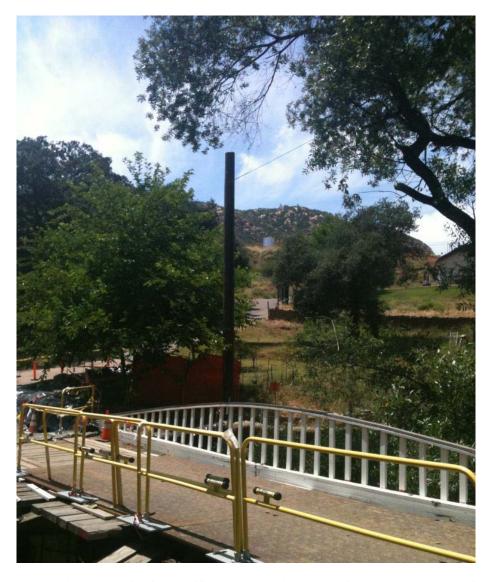
Bauer property bridge is secured for foot traffic only. Pole in center of photo was installed for the breeding bird acoustic blanket. Orange barriers placed behind the pole are a visual shield for the black-chinned hummingbird while the pole was installed.

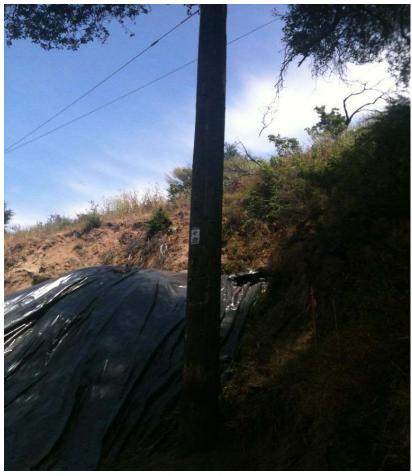
A pole that was placed for future installation of a breeding bird acoustic blanket on the Bauer property. Behind the pole is a covered stockpile of soil.
