This report provides a summary of environmental monitoring and compliance activities conducted by Burns and McDonnell (BMcD) staff and BMcD subconsultants for the San Diego Gas & Electric (SDG&E) Sunrise Powerlink Project during the above weekly time period.

# Sunrise Powerlink Project Weekly Report 38 – June 5, 2011 through June 11, 2011

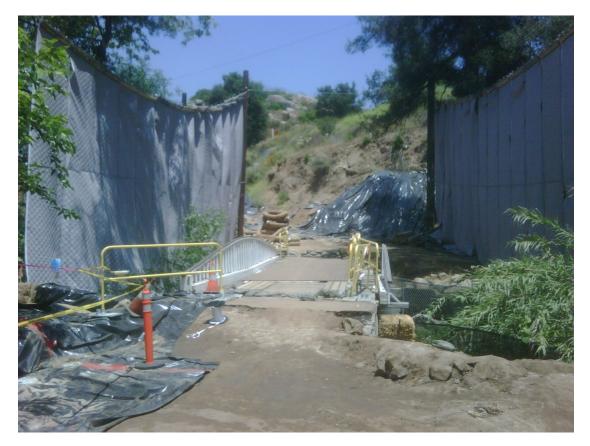
- Jointing (splicing) occurred at V17L.
  - Grading occurred at the Loritz Property and V19R.
  - Acoustic blankets were originally delivered and installed the week of 5/29/11 but because of problems were re-installed on 6/7/11.

Acoustic blankets at the Bauer Bridge looking to the northeast. Photo courtesy of Jeff Smith.
