SCE VALLEY SOUTH SUBTRANSMISSION PROJECT

Date: October 3, 2019
To: Eric Chiang, Project Manager, CPUC
From: Vida Strong, Aspen Project Manager
Subject: Monitoring Report #12: September 15, 2019 to September 28, 2019

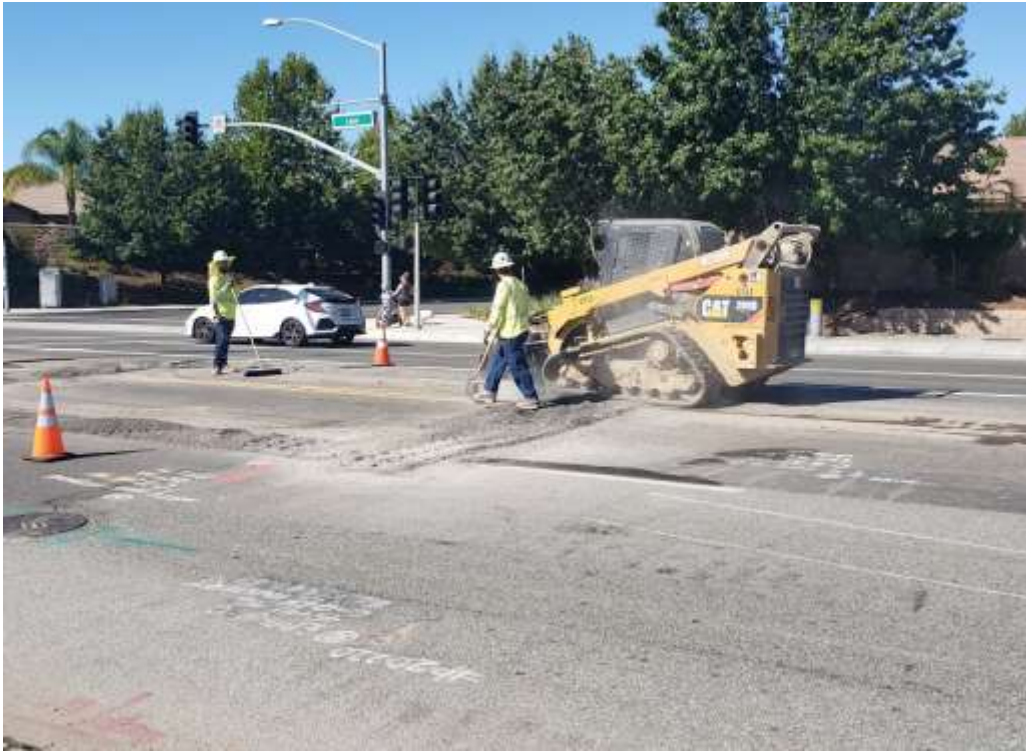
2. BMP inspections and maintenance occurred at TSP foundation locations in Segment 1.
3. Cattrac encased the duct bank trench and installed the conduit from UNK207 to Vault 1B and cut the excavation to Vault 3B (see Photo 1) for the southern underground section on Leon Road (Construction Areas UNK207 through UNK222).

Photo 1 – Construction activities on the southern underground (September 17, 2019).

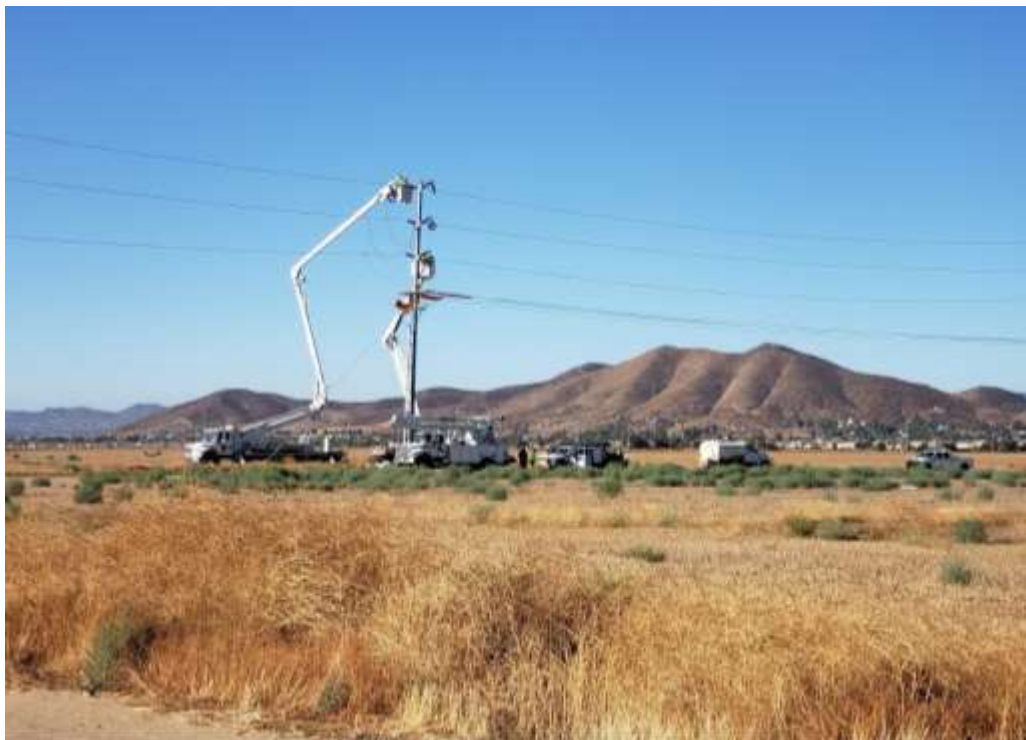
4. Construction activities on Segment 1 included: Overnight work including reframing insulators and reconductoring from Construction Area UNK250 to UNK01 (see Photo 2); repositioned pole at UNK169; hauled and framed poles from Construction Areas UNK140 to UNK247 (see Photo 3); conducted bonding on the 115 kV line from Construction Area UNK250 to Briggs Road; set poles from Construction Areas UNK237 and UNK241 through UNK243; and conducted tree trimming and vegetation clearing at Construction Areas UNK177 and UNK178 (see Photo 4).

Photo 2 – Reconducting activities from Construction Area UNK250 to UNK01 (September 17, 2019).

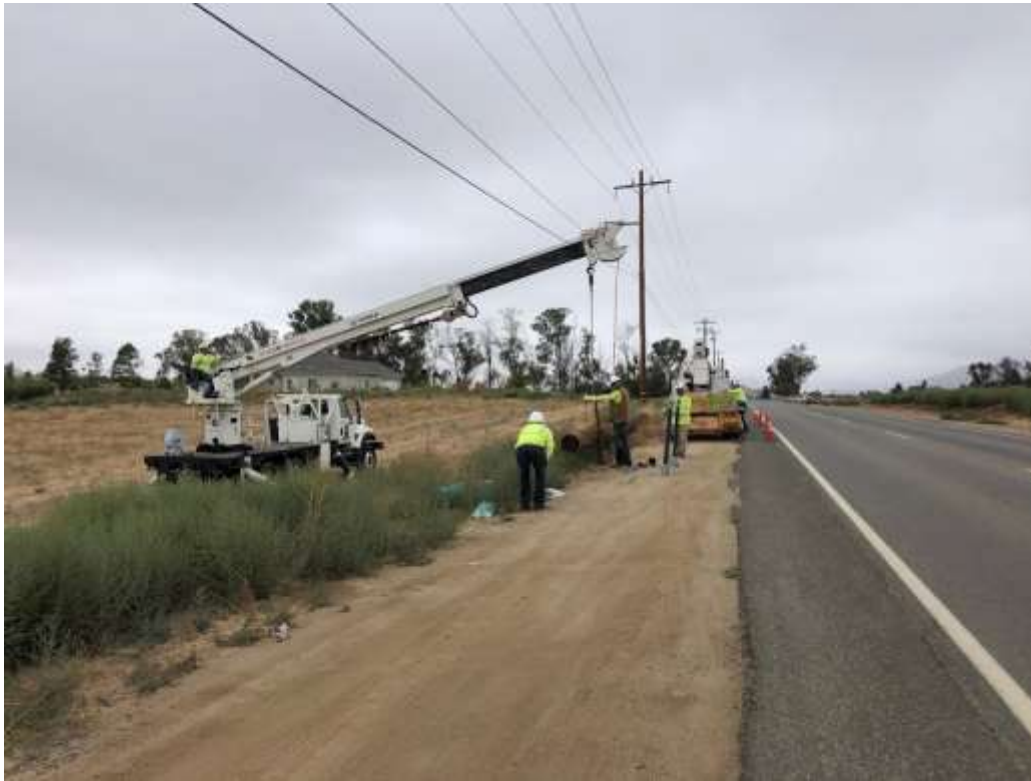
Photo 3 – Framing pole 2150098E at Construction Area UNK171 (September 5, 2019).

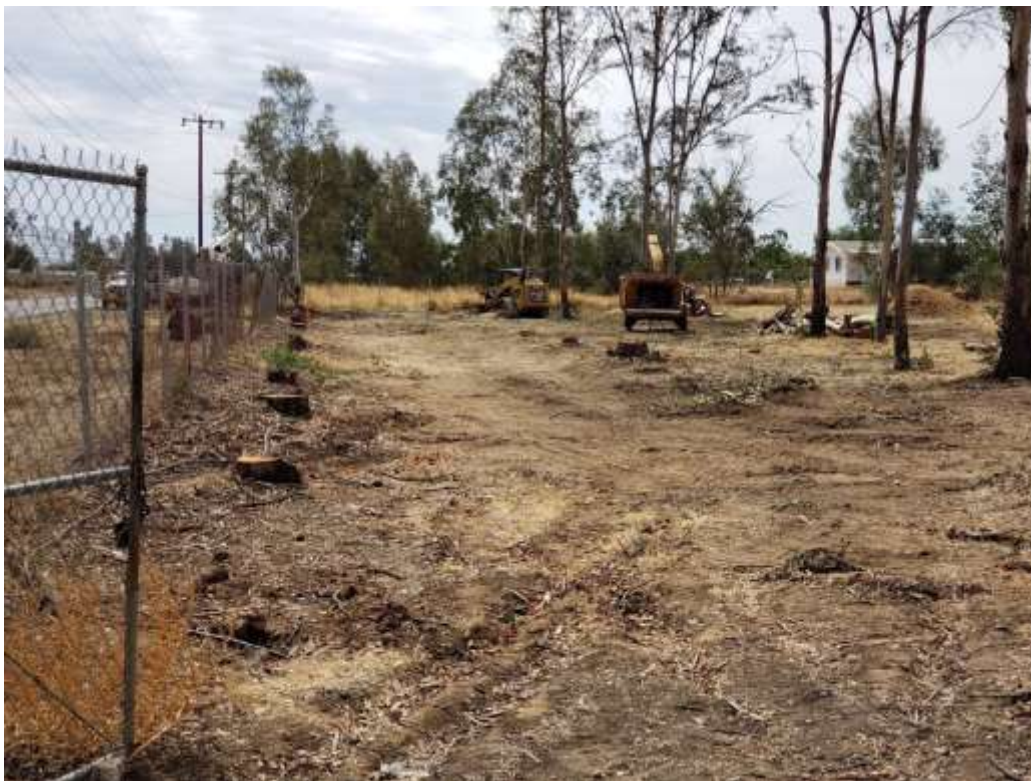
Photo 4 - Tree trimming and vegetation clearing at Construction Areas UNK177 and UNK178 (September 25, 2019).

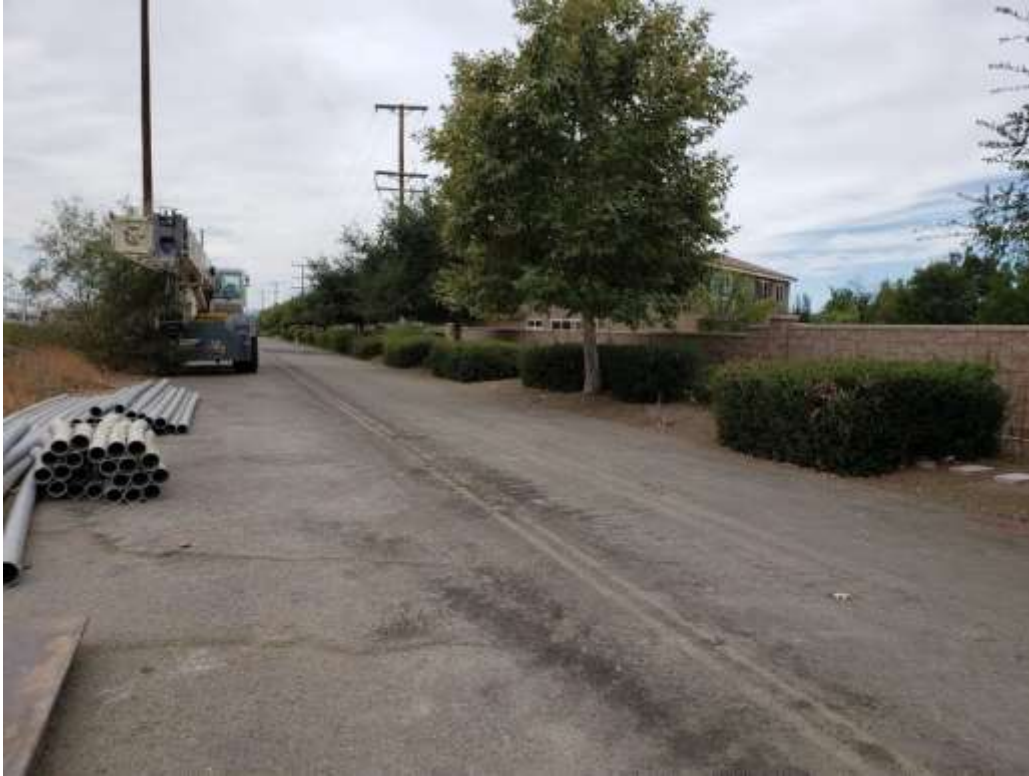
3. On September 25, the CPUC EM observed a temporary staging area at UNK222 with equipment for the southern underground that had several non-compliance issues with project mitigation measures and the project SWPPP. The temporary staging area was not screened (AES-1), pipes staged nearby were uncapped and trash was observed within the staging area (BIO-2) (see Photo 5), and six pieces of equipment were observed staged without proper secondary containment. The open excavation at the vault to UNK222 was also observed to have gaps in the covering where wildlife could enter and become entrapped (BIO-2). The contractor's Environmental Manager was immediately notified, and the excavation was covered properly while the CPUC EM was onsite. A Level 1 incident report was issued for all issues observed the same day. On October 1, SCE responded to the Level 1 incident stating all issues were resolved except the visual screening of the staging area which was scheduled to be completed by the end of day on October 2. The CPUC EM observed the screening was in place on October 2.

Photo 5 – Uncapped pipes and a piece of construction equipment staged without secondary containment near UNK222 (September 25, 2019).
