SCE VALLEY SOUTH SUBTRANSMISSION PROJECT

Date: November 1, 2019
To: Eric Chiang, Project Manager, CPUC
From: Vida Strong, Aspen Project Manager
Subject: Monitoring Report #14: October 13, 2019 to October 26, 2019

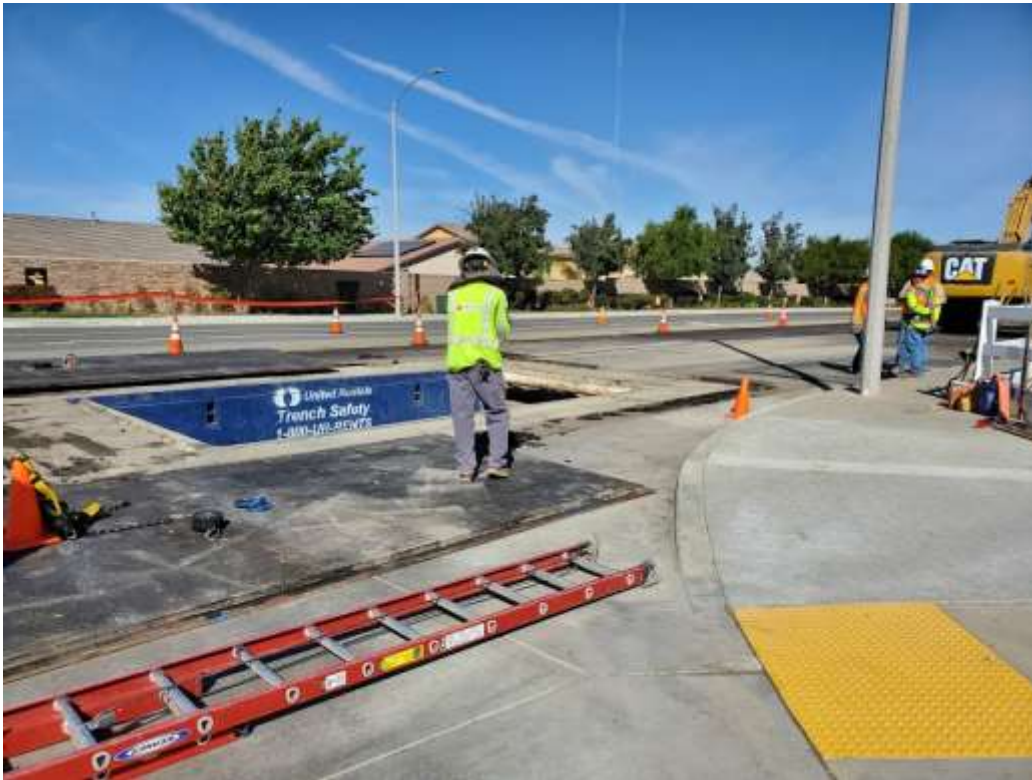
2. BMP inspections and maintenance occurred at TSP foundation locations in Segment 1.
3. Cattract continued cutting asphalt, trenching, and installing conduit in the duct bank trench between Vault 2B and Vault 3B (see Photo 1) for the southern underground section on Leon Road (Construction Areas UNK207 through UNK222).

Photo 1 – Construction activities at Vault 3B on the southern underground (October 16, 2019).

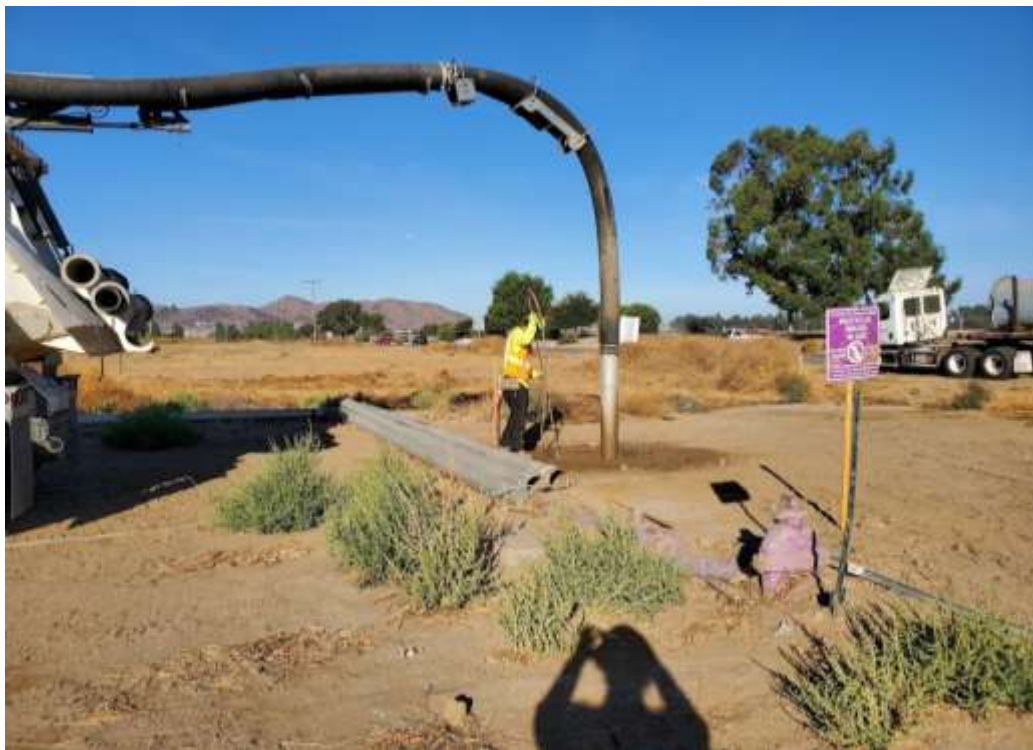
4. Wilson construction activities on Segment 1 included: Hauling and spotting poles at pole 4170857E; setting wood poles at Construction Areas UNK11 through UNK13, UNK151 through UNK153, UNK161, UNK162, UNK173, UNK177, UNK179, UNK185, and UNK189 through UNK203; assembling TSPs at Construction Area UNK207; hanging distribution arms from Construction Area UNK156 to UNK234; hydrovac drilling at Construction Areas UNK20 and UNK161 (see Photo 2); and vegetation removal at Construction Areas UNK161 and UNK179.

Photo 2 – Hydrovac drilling activities at Construction Area UNK20 (October 16, 2019).

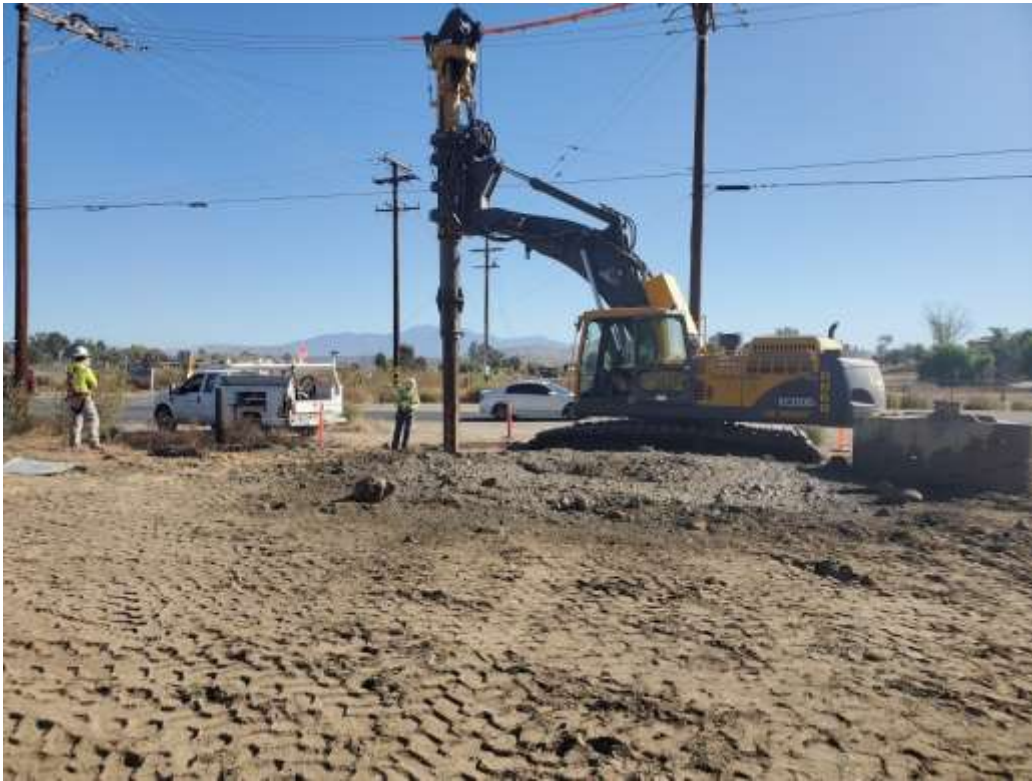
5. KV Structures remobilized to the project on October 21. Construction activities included foundation activities at UNK155 (see Photo 3) and UNK115 on Segment 1.

Photo 3 – Drilling at Construction Area UNK155 (October 23, 2019).

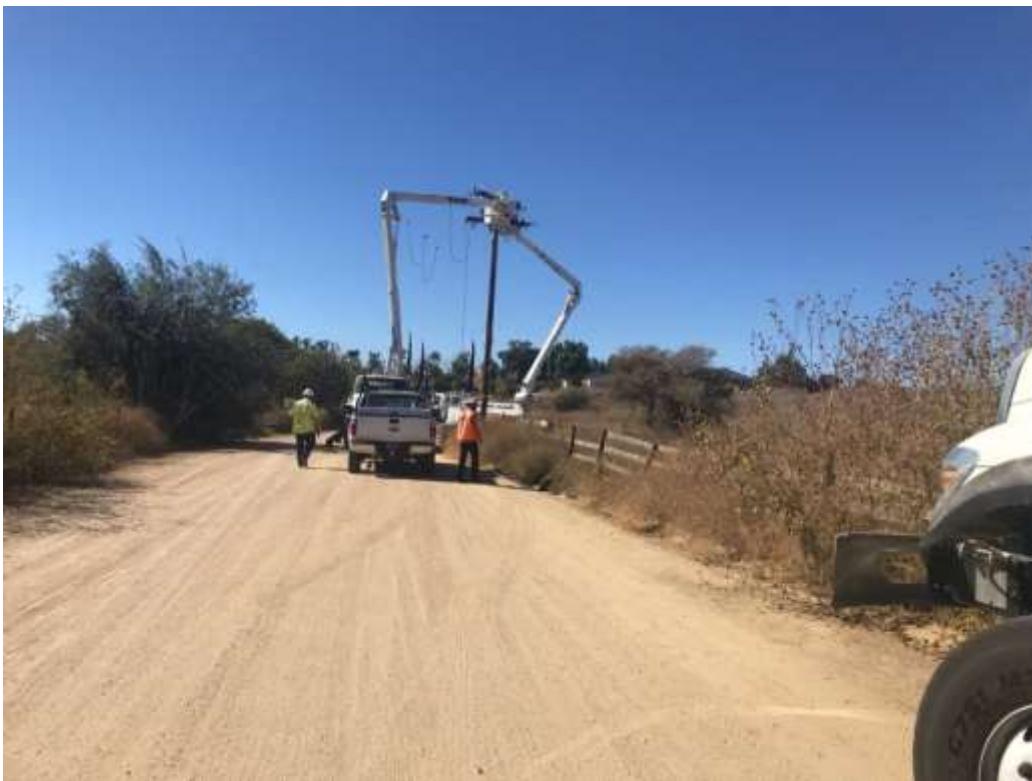
4. There was one SCE self-reported incident and five observations documented throughout the monitoring period. On October 21, the onsite biologist observed project-related ground disturbance and impacted vegetation from a Wilson utility truck approximately 25-30 feet west of Pole 4704757E on Segment 2, resulting in a Level 1 incident (see Photo 4). The biologist discussed with the crew that construction activities were to be confined to the approved road and the crew immediately moved the truck back onto the approved road once the wire pull was completed and it was safe to do so. Wilson had an extended tailboard with crews to review compliance, work area boundaries, and communication with the biologist. Observations included rock accumulated on shaker plates off of Menifee Road as discussed above and four non-project related ground disturbance and trash observations.

Photo 4 – Wilson truck outside approved work areas at pole 4704757E during reconductoring activities on Segment 2 (October 21, 2019) (Photo courtesy of SCE).
