PROJECT MEMORANDUM
SCE BANDUCCI SUBSTATION PROJECT

To: Jensen Uchida, Project Manager, CPUC
From: Vida Strong, Aspen Project Manager
Date: August 11, 2017
Subject: Monitoring Report #1: July 24 to August 5, 2017

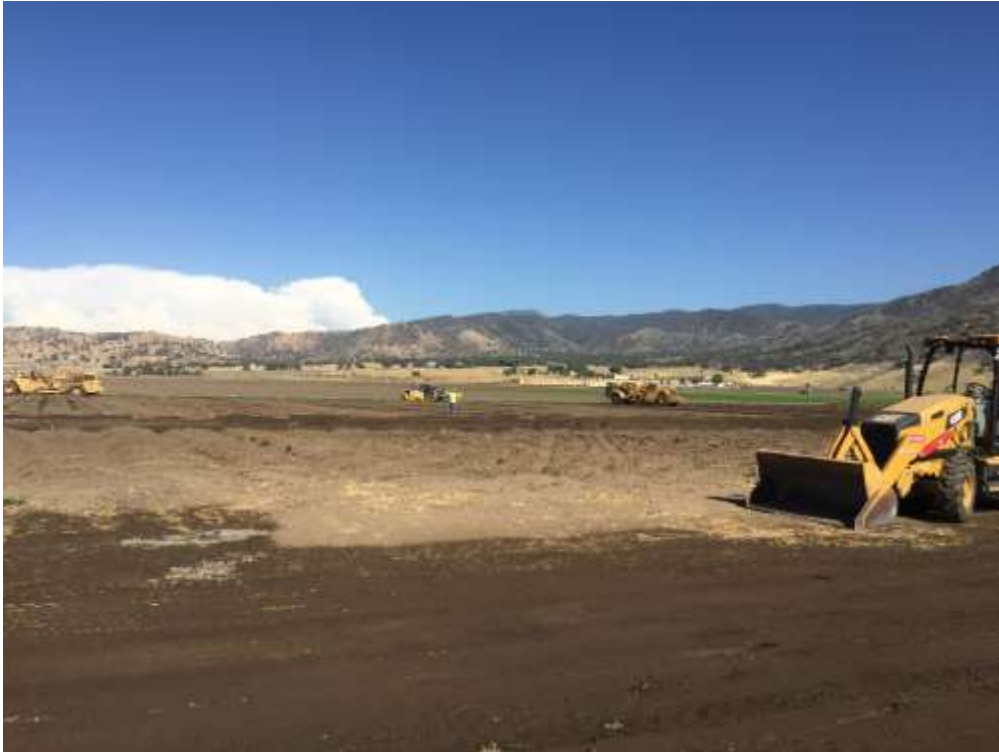
3. Construction equipment and materials were delivered to the site.
4. Grading and compaction of the substation site was conducted (see Figure 1).
5. Crews installed a permanent construction entrance along Pelliser Road and added rock and shaker plates to reduce track-out onto the adjacent paved road.
6. Construction crews are trucking in non-potable water for dust control and compaction from an approved hydrant located near Highline Road.
7. Trace amounts of rain were reported at the substation site on Thursday, August 3, 2017.

Figure 1 – Construction crews began grading activities at the Banducci Substation, July 26, 2017.

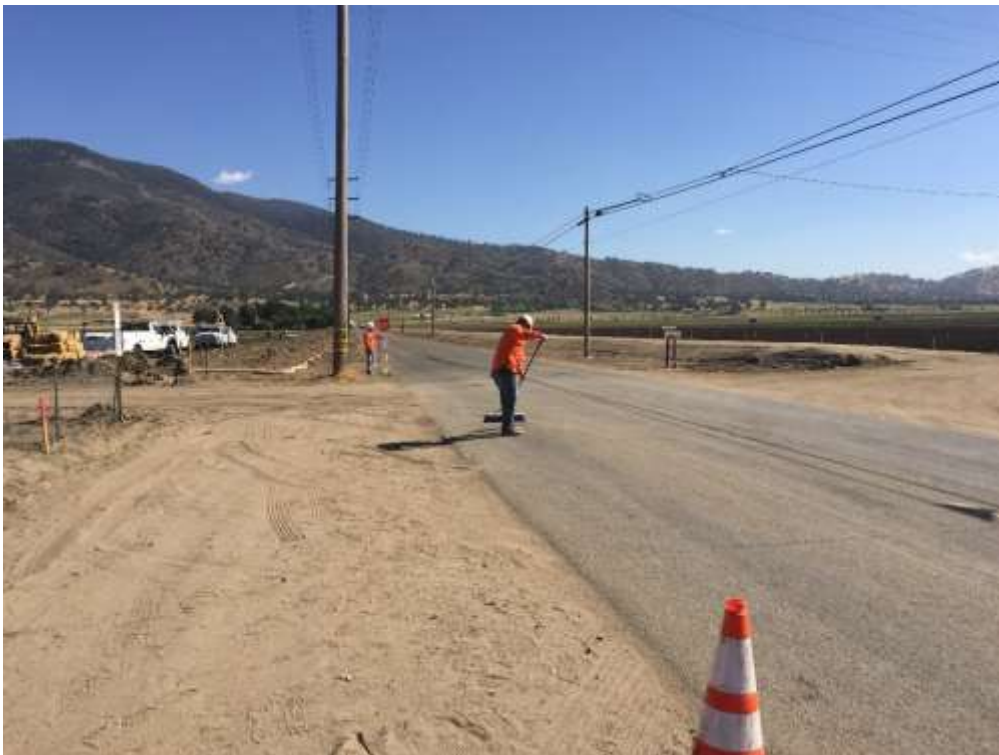
Figure 2 – Manual street sweeping was conducted along Pelliser Road while the stabilized construction entrance was being constructed, July 26, 2017.

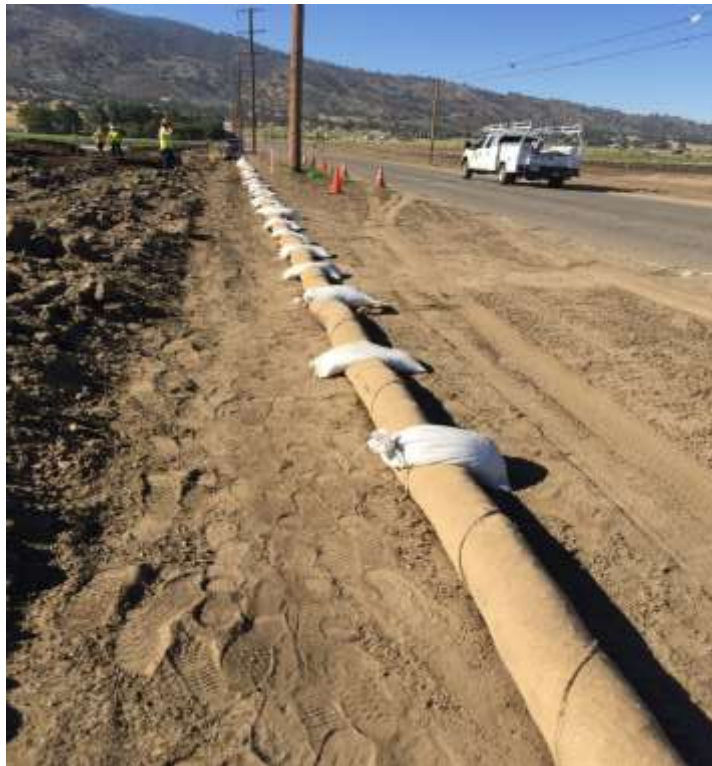
3. SCE submitted a TEWS request for the use of a nearby hydrant to supply non-potable water to the construction site for dust control and compaction (see Table 2).
4. Manual street sweeping for dust and track-out control was conducted on a daily basis (see Figure 2)
5. During a SWPPP inspection by the Project QSP, deficiencies were noted with BMP installation along Pelliser Road. The straw wattles were not installed correctly. When the contractor was notified of the issue, the necessary repairs were made (see Figures 3 and 4).
6. A stabilized construction entrance was constructed as required by the project SWPPP to prevent track-out (see Figure 5).

Figure 3 – Erosion control BMPs were observed to be incorrectly installed along Pelliser Road July 26, 2017.

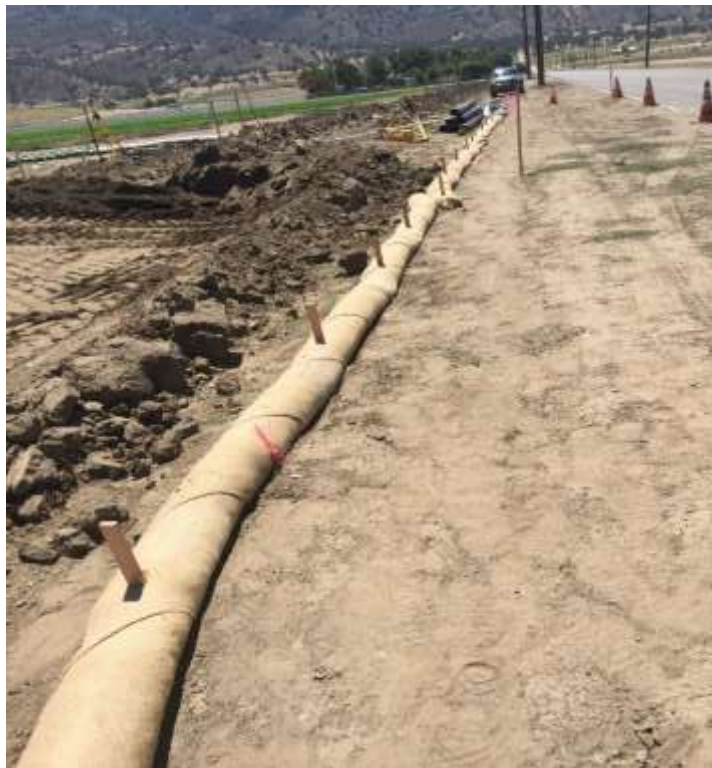
Figure 4 – Construction crews were alerted to the incorrect BMP installation and repairs were immediately made, July 27, 2017.

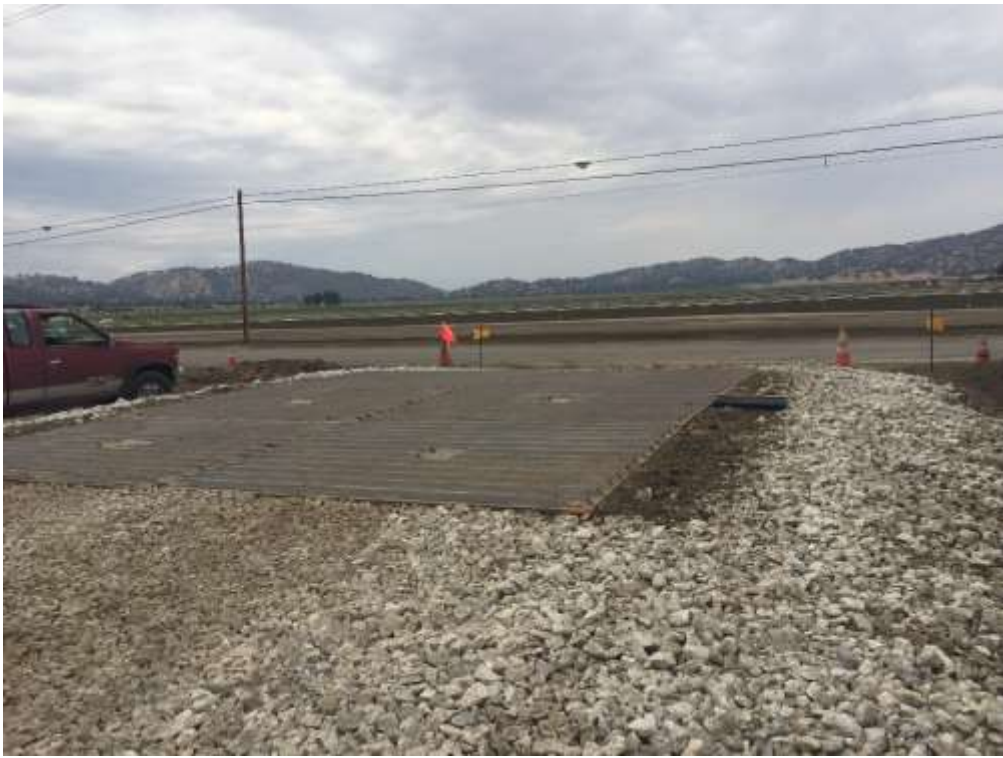
Figure 5 – Stabilized construction entrance was constructed at the substation site.
