PROJECT MEMORANDUM
SCE BANDUCCI SUBSTATION PROJECT

To: Jensen Uchida, Project Manager, CPUC
From: Vida Strong, Aspen Project Manager
Date: February 6, 2018
Subject: Monitoring Report #8: January 7 to January 27, 2018

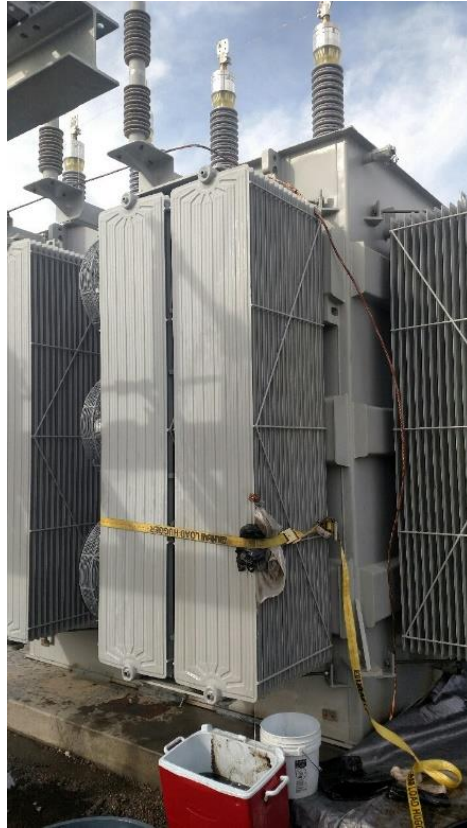
1. A major spill occurred on January 16 when a man-lift bumped into Transformer #1 at the Banducci Substation site. Approximately 125 gallons of mineral oil spilled out of the damaged transformer onto the ground. A professional environmental clean-up company was deployed to perform cleanup. The area contaminated was estimated to be 20-ft by 30-ft and impacted soil was removed (see Figures 1 through 3).

Figure 1 – Henkels and McCoy crew inadvertently damaged Transformer #1 causing a mineral oil spill at the substation site. Photo courtesy of SCE.

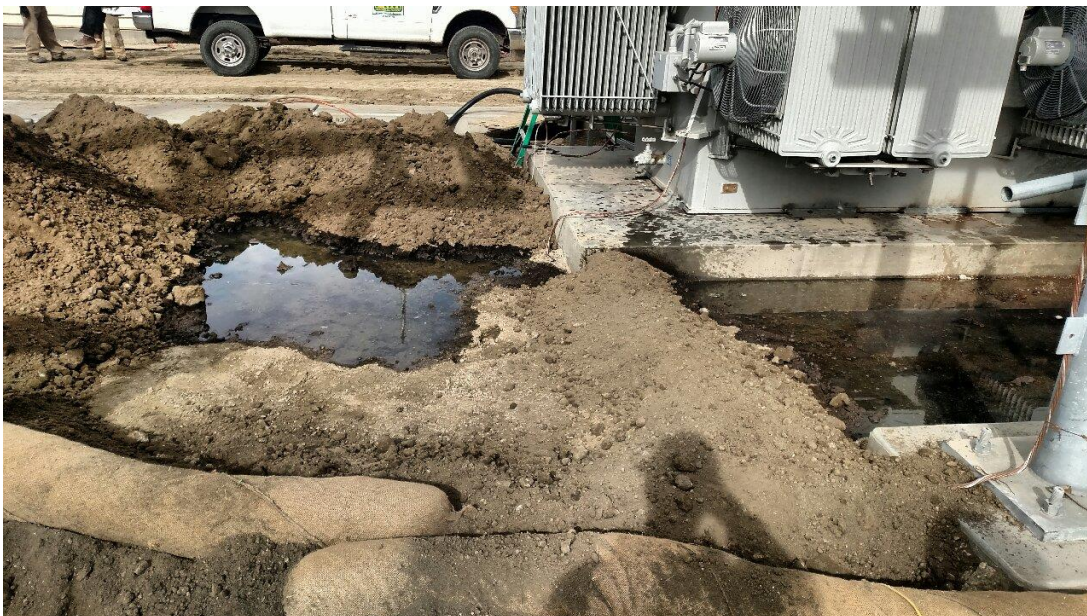
Figure 2 – Approximately 125-gallons of mineral oil spilled onto the ground under the damaged transformer. Photo courtesy of SCE.

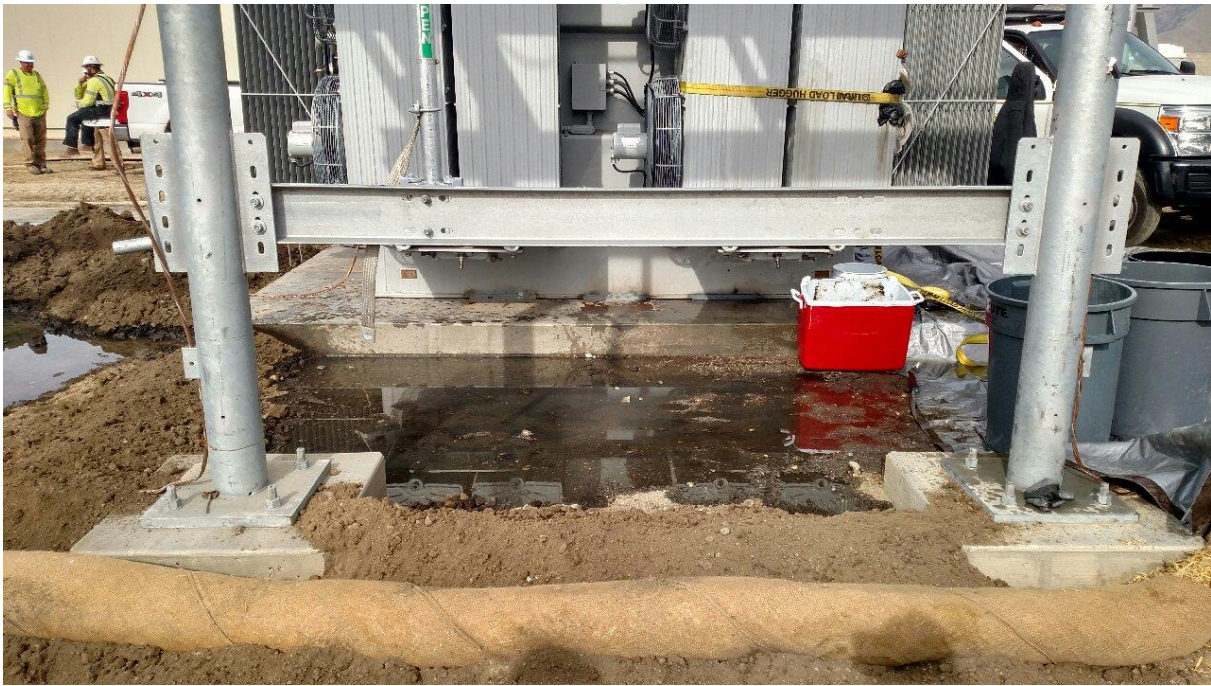
Figure 3 – Containment around the damaged transformer to prevent the spill from spreading. Photo courtesy of SCE.

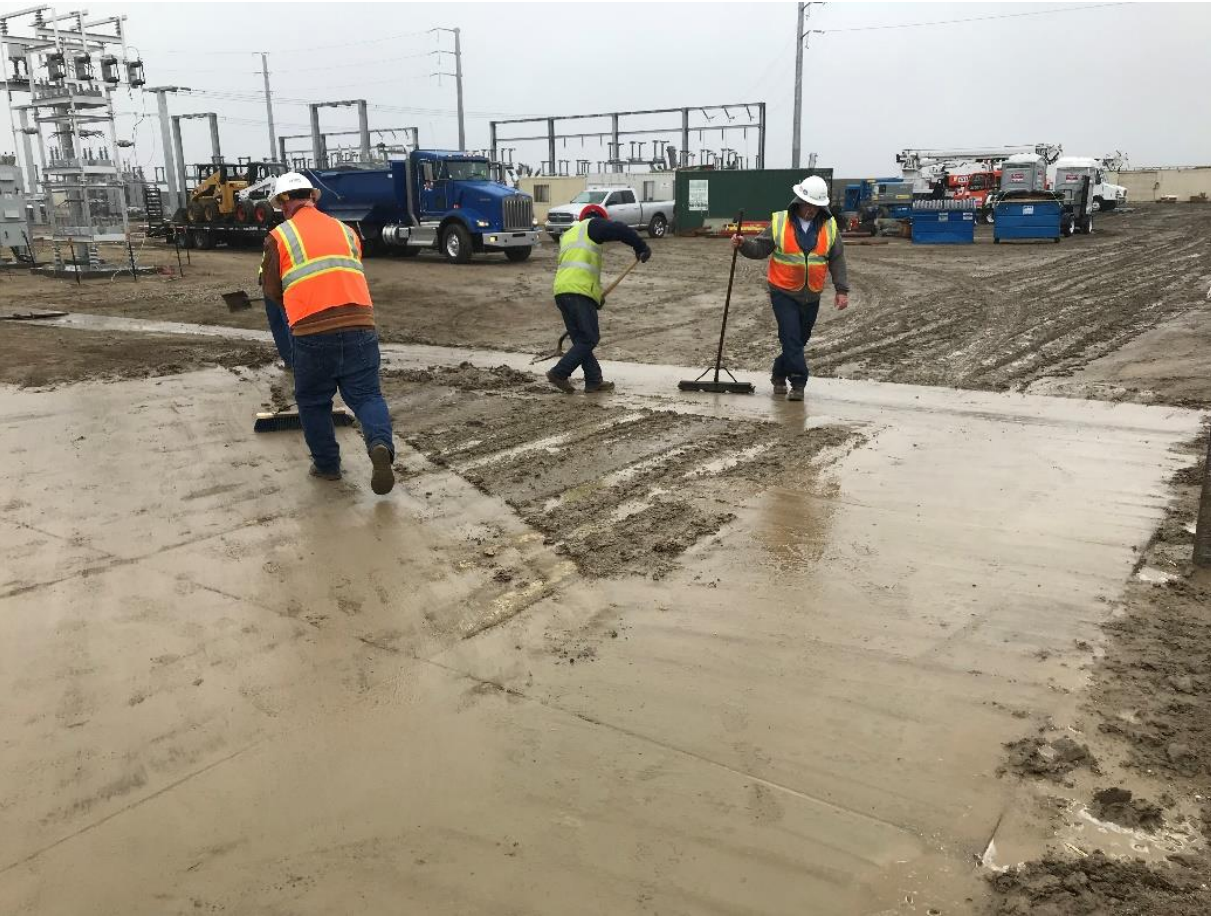
2. No paleontological monitoring took place during the monitoring period. To date, no paleontological resources have been identified.
3. Manual street sweeping is taking place as needed along Pellisier Road at the Substation entrance (see Figure 4).

Figure 4 – Crews using brooms to clean off mud from the substation entrance. Work was called off later due to rain.
