PROJECT MEMORANDUM

DOWNS SUBSTATION EXPANSION PROJECT

To: Eric Chang, Project Manager, CPUC
From: Vida Strong, Aspen Project Manager
Date: December 9, 2014
Subject: Monitoring Report #3 – December 1 to December 7, 2014

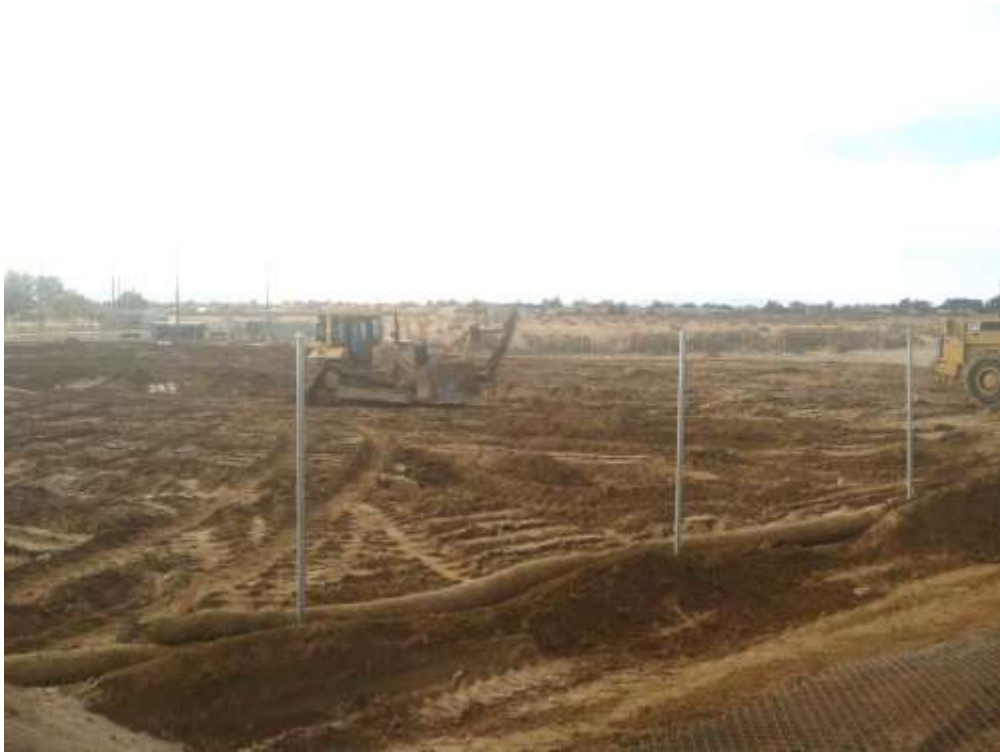
Figure 1 – Grading continued. View southwest, December 4, 2014.

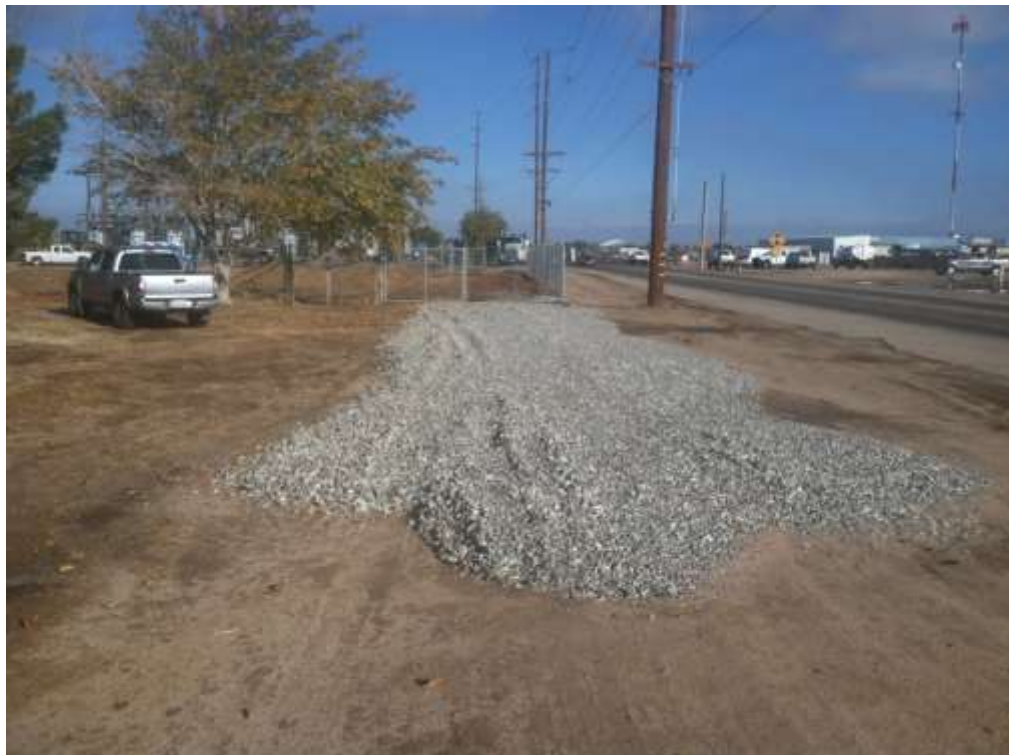
Figure 2 – Gravel apron and additional entrance was installed to accommodate longer vehicles delivering soil to the site. View north, December 4, 2014.

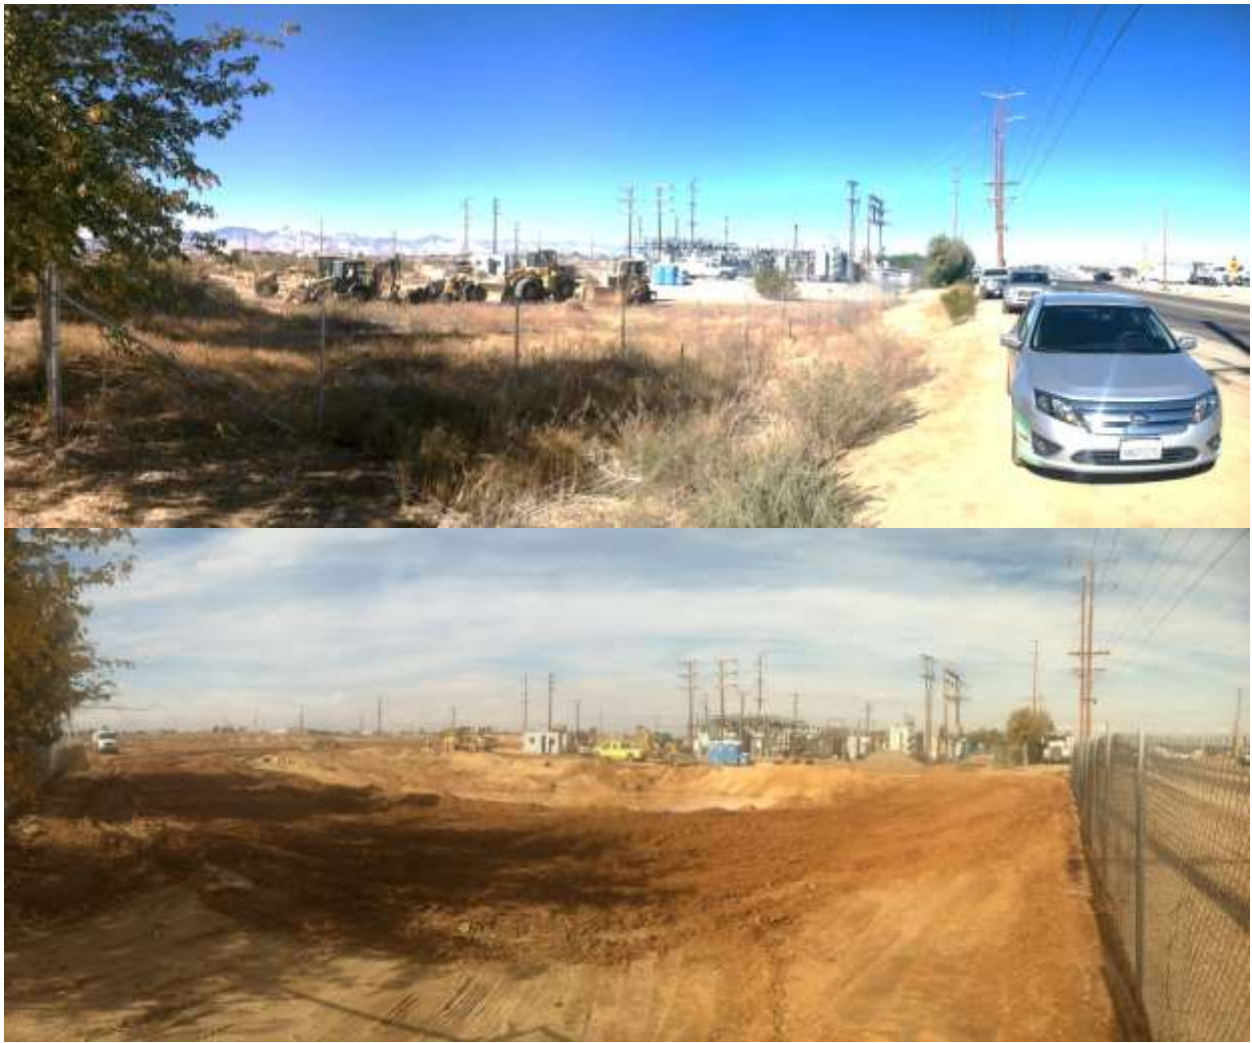
Figure 3 – Panoramic view of grading from southeast corner of site. Fence-line has moved outward along eastern boundary to accommodate necessary grading. View northeast, December 4, 2014.

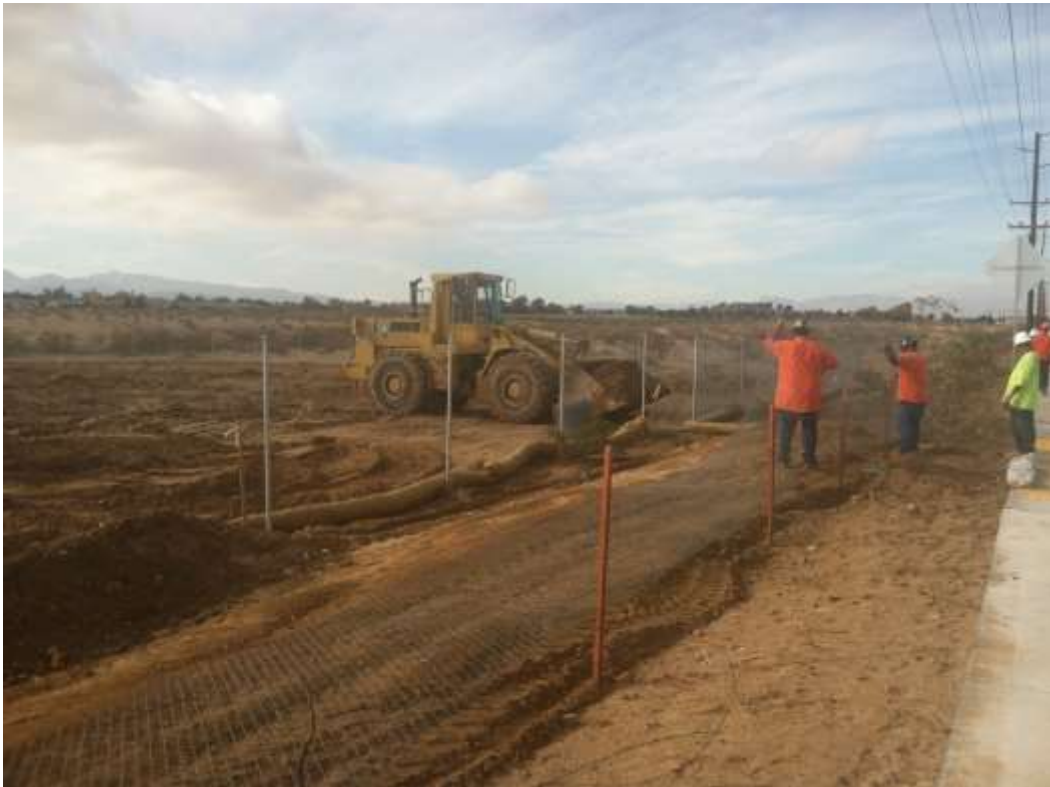
Figure 4 – Existing fencing, along northern work limits, was moved outward so that necessary grading could occur. View west, December 4, 2014.

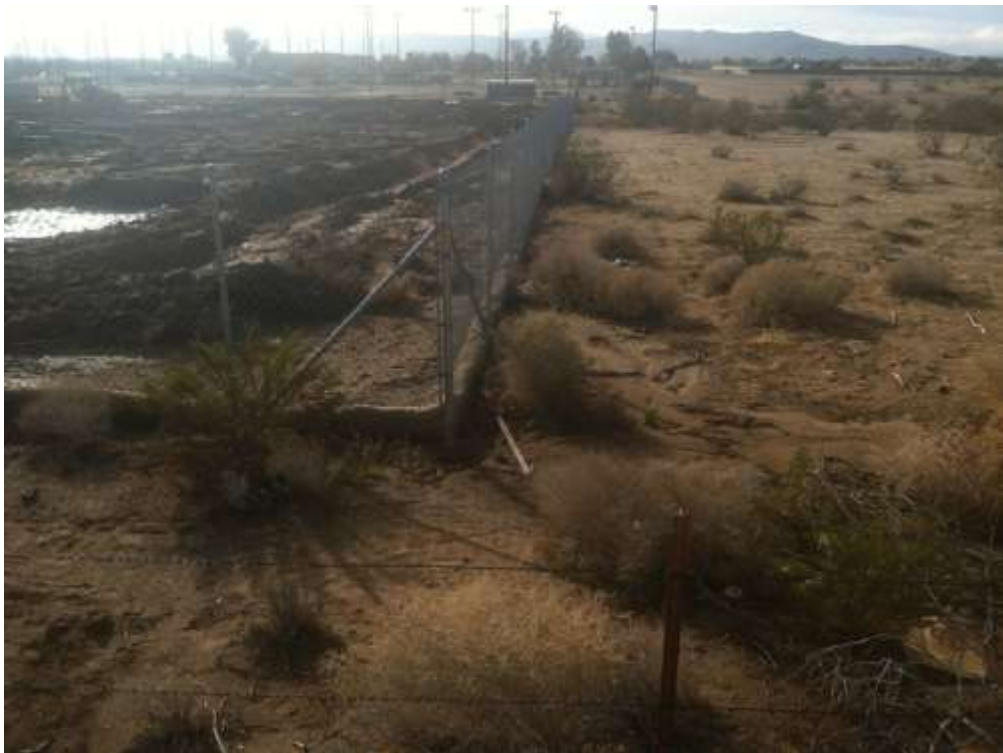
Figure 5 –Evidence of flow entering into the work area from offsite during the week's rain. No onsite sediment was transported offsite. View south, December 4, 2014.

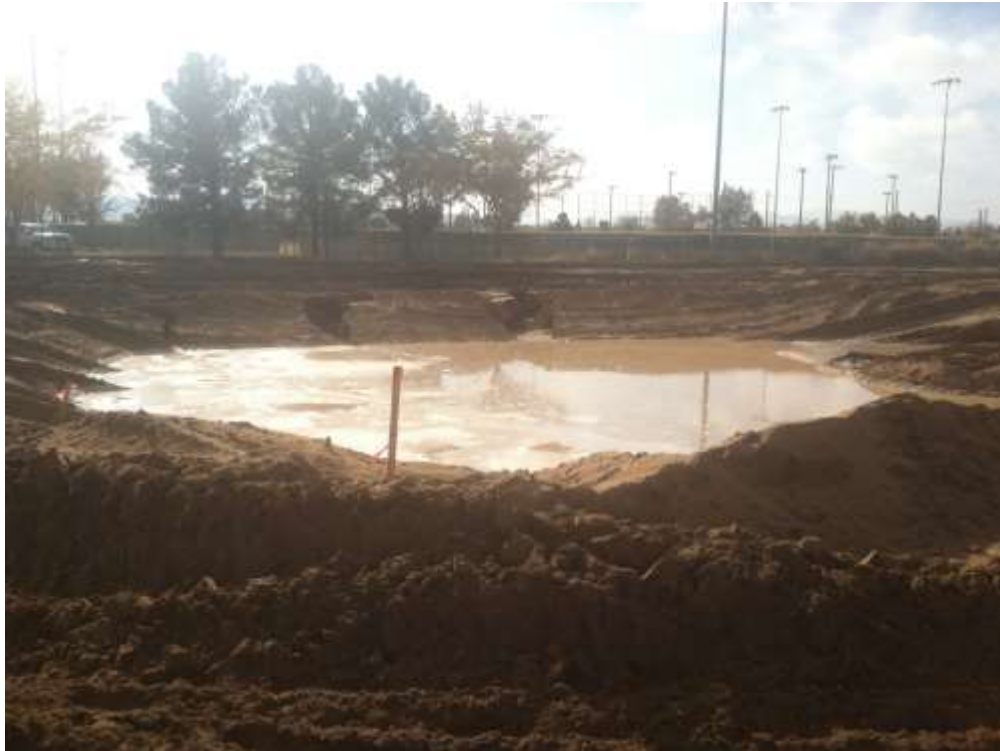
Figure 6 –Evidence of flow entering into the work area from offsite during the week’s rain. No onsite sediment was transported offsite. View south, December 4, 2014.

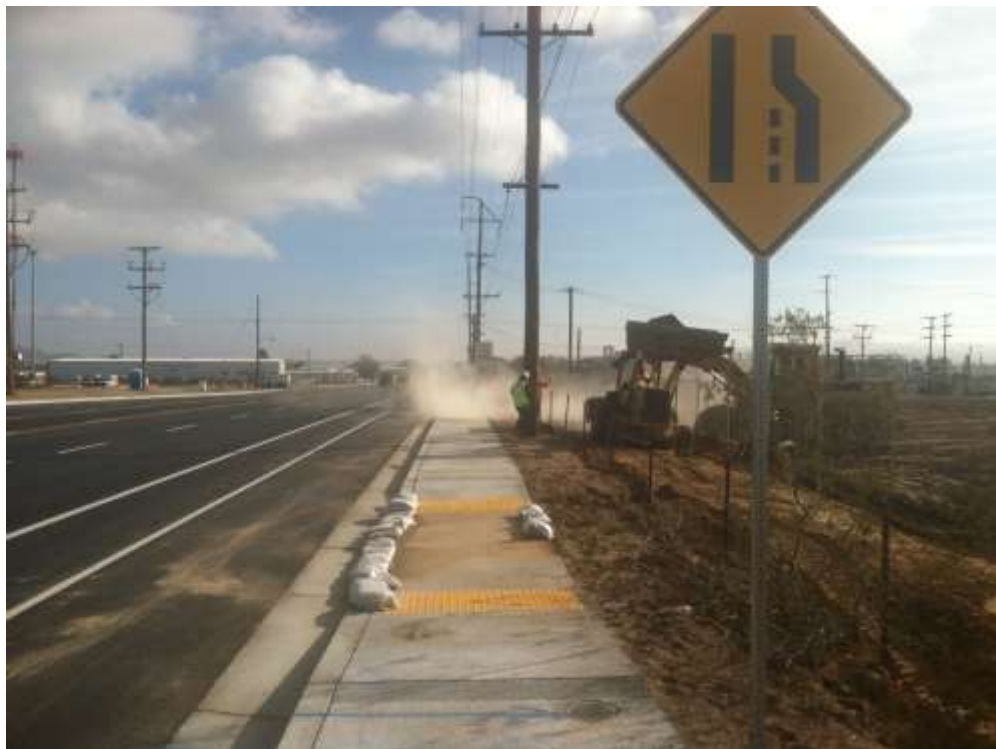
Figure 7 – Dust was observed leaving the Project site. The issue was swiftly corrected. View east, December 4, 2014.

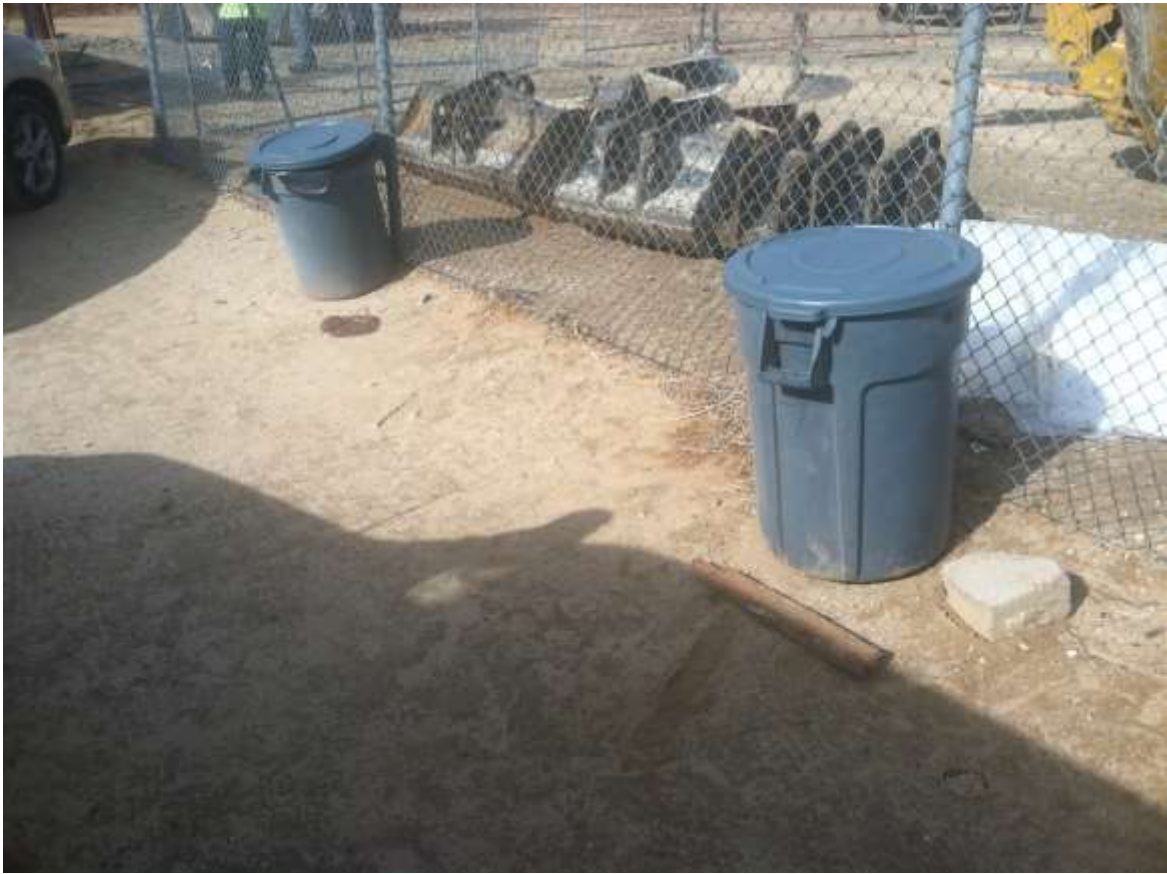
Figure 8 – Trash cans were securely covered during the subject week. View northwest, December 4, 2014.
