# El Casco System Project

## Mitigation Monitoring, Compliance and Reporting Program

# FINAL REPORT

*Prepared for*  
**California Public  
Utilities Commission**

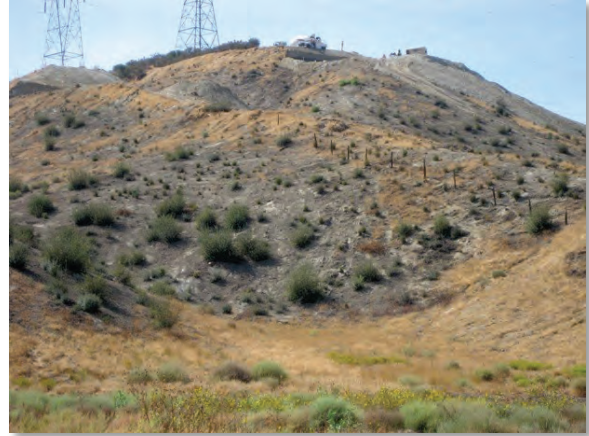
*Figure 1 — Pre-construction location of the El Casco Substation within the Norton Younglove Preserve. Geologists identified a layer of clay within the hillside. Removal of the toe of the slope increased the likelihood of slippage. Therefore, a tension cable anchor system was installed during construction.*

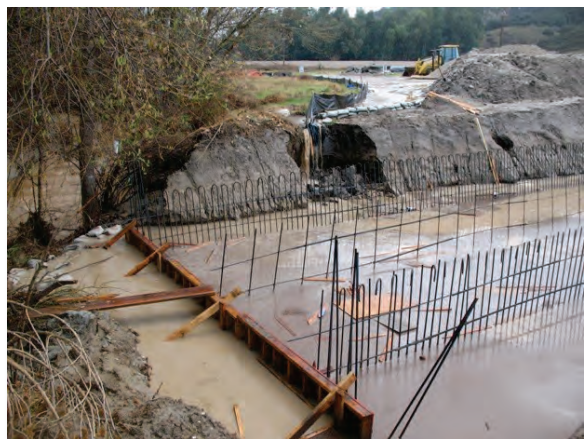
Figure 5 — The partially completed box culvert at the El Casco Substation access road was inundated with stormwater, which then poured into San Timoteo Creek. The photograph faces southeast.

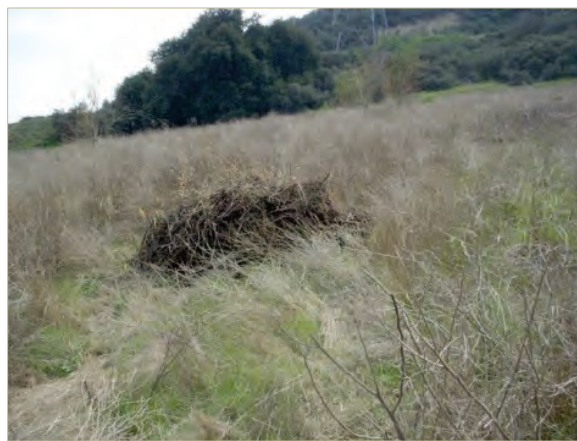
Two Project Memoranda (PMs) were issued for El Casco Substation–related work. On March 16, 2009, PM #1 was issued for failure to comply with Mitigation Measure B-18 during vegetation clearing at the El Casco Substation site. Several woodrat middens at the El Casco Substation site were placed in an adjacent field of the Norton Younglove Reserve by heavy equipment. In addition, construction equipment went outside of approved Project boundaries. PM #4 was issued March 16, 2010, when construction activity occurred within riparian habitat during nesting bird season along the El Casco Substation access road.

Figure 16 — Woodrat middens at the El Casco Substation site were placed in adjacent fields by equipment within the Norton Younglove Reserve. The photograph faces southeast.

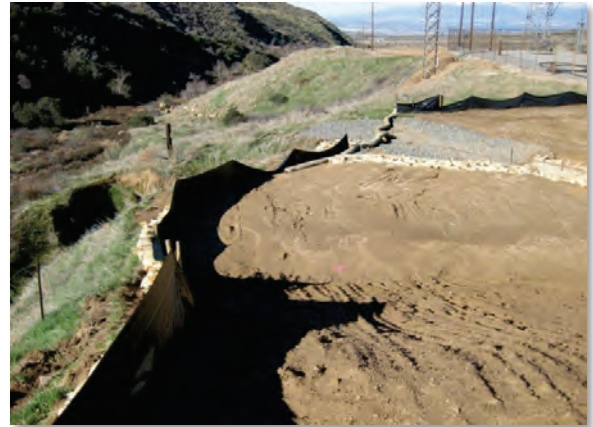
*Figure 24 — Erosion control devices mostly prevented siltation into a nearby watercourse during storms at Zanja Substation. The photograph faces west.*

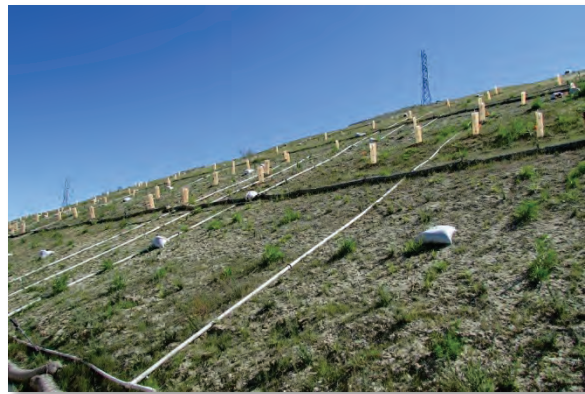
The building of the El Casco Substation impacted 6.37 acres of vegetation on slopes and flatlands, including chaparral, non-native grassland, and riparian woody vegetation. Restoration efforts have been divided into distinct segments which include manufactured slopes above and below the substation; temporarily disturbed work areas including the laydown yard, field trailer location, and edges of the access road; and small riparian areas next to two culvert construction sites. For the purpose of this discussion, substation restoration has been segregated into three subsections, including culvert riparian areas, non-irrigated areas, and slope areas which require container planting and irrigation.

Figure 28 — Engineered slope behind the El Casco Substation. Note the tubes are covering the new container plants. March 12, 2014.

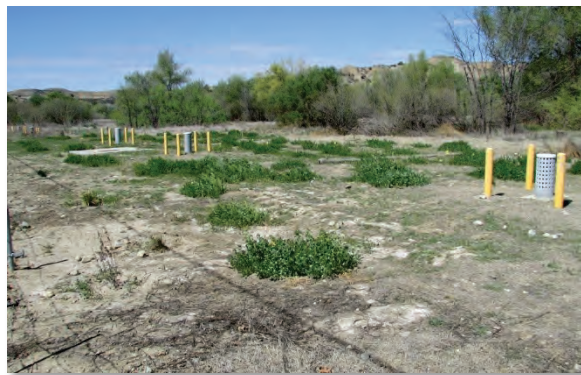
Figure 29 — View of the HDD restoration area. March 12, 2014.

As provided by SCE in their 2013 El Casco System Project Annual Restoration Report, the HDD restoration site has native cover that exceeds the 2-year and 5-year performance criteria. The site however has extensive non-native cover comprised primarily of Bermuda grass that is higher than the performance criteria which requires less than 5 percent non-native cover. There is also some sweet clover growing around the container plants that is being weeded by SCE. Recommendations include re-application of hydroseed, continued weeding, and continued monitoring.

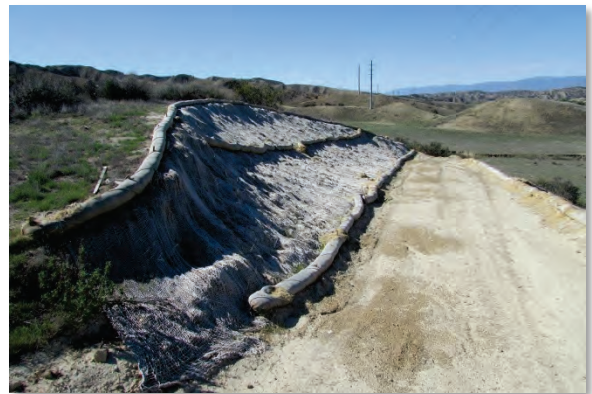
- Location #36: Work included removal of approximately 1,520 square feet of sage scrub/chaparral mixed vegetation to widen the existing spur road. One scrub oak was removed. The area received hydroseeding. However, as reported by SCE in its 2013 El Casco System Project Annual Restoration Report, the area shows almost no native plant growth and will be reseeded in early 2014. SCE also plans to plant 3 or 4 oaks in the spring of 2014.

Figure 31 — View of subtransmission restoration site 36. Note the lack of plant cover and container plants. March 12, 2014.

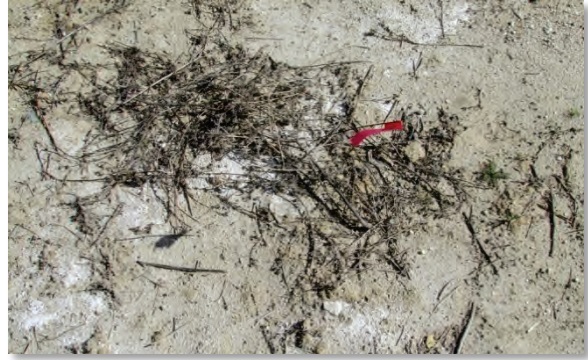
During the validation survey conducted by Aspen in March 2014 it was difficult to verify that the number of plants and area of occupancy were accurate. A follow-up visit was conducted with NRC biologists who provided photos of some of the smooth tarplant that grew in 2013 and also helped relocate a few of the dead plants in the field from the previous year. Heavy rainfall was blamed for scouring out some portion of the secondary mitigation area, which is the primary reason the plants were not easily relocated. It appears that weeds are under control in the secondary mitigation area, but the primary mitigation area appears to have largely been abandoned because of high cover of non-natives in the area. During the survey several dead plants were relocated, as well as several clusters of dead plants that were scoured.

Figure 33 — Some smooth tarplant remnants from 2013 which appear to have been pushed over by scouring flows. March 18, 2014.
