ELDORADO-LUGO-MOHAVE (ELM) SERIES CAPACITATOR PROJECT

Date: November 17, 2023

To: Eric Chiang, Project Manager, CPUCFrom: Vida Strong, Aspen Project ManagerSubject: Monitoring Report #28: October 2023

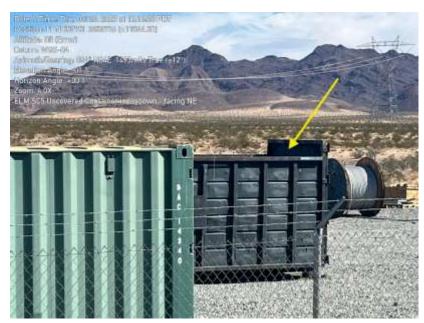
Photo 1: A container observed in SC5's laydown yard with an open-top (not covered) which may pose a waste containment/wildlife attractant concern, depending on the contents. CPUC EM notified SCE monitoring staff.

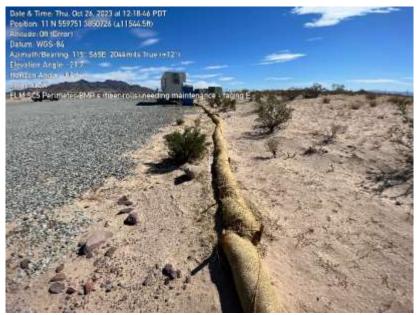
- 3. SWPPP maintenance items/corrective actions recorded during the reporting period, including the following: perimeter BMP's (fiber rolls/wattles) at both SC2 and SC5 are in need of replacements due to deterioration and/or animal damages incurred over time, novel storm-flow site concerns revealed with recent September rainfall that require addressing/solutions implemented (discussions with project QSD are ongoing), and reports of dust-generating road conditions (road between SC2 and SC5). Of note, the site SWPPP inspector stated that the remaining damaged perimeter wattles on both sites are functional, and replacement/maintenance schedules are dependent upon energization and reclamation. No additional dust control will be provided during inactive construction periods.

Photo 2: Perimeter wattle along southeastern border of SC5 slightly deteriorating and in need of maintenance/repair, as noted in the weekly environmental compliance reports (SWPPP section).

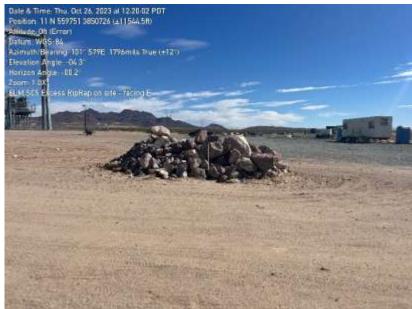
Photo 3: Excess large rock/riprap present on site at SC5.

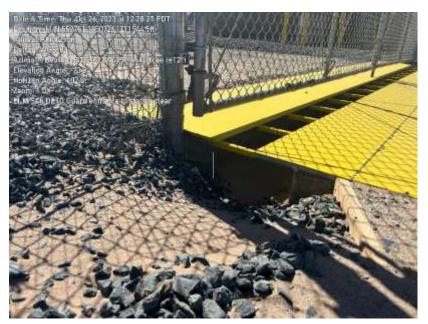
Photo 4: CPUC EM visually inspecting condition of tortoise guards on site. All tortoise guard entrances were free of debris, observed in good condition, and entrances were not occluded/remain functional.
