## **PROJECT MEMORANDUM SDG&E – MIGUEL-MISSION 230 kV #2 PROJECT**

**To:** Jensen Uchida, CPUC  
**From:** Vida Strong, Aspen Project Manager  
**Date:** December 30, 2004  
**Subject:** Weekly Report #21: December 19, 2004 – December 25, 2004  
**CPUC ENVIRONMENTAL MONITOR (EM):** Christopher Meyer

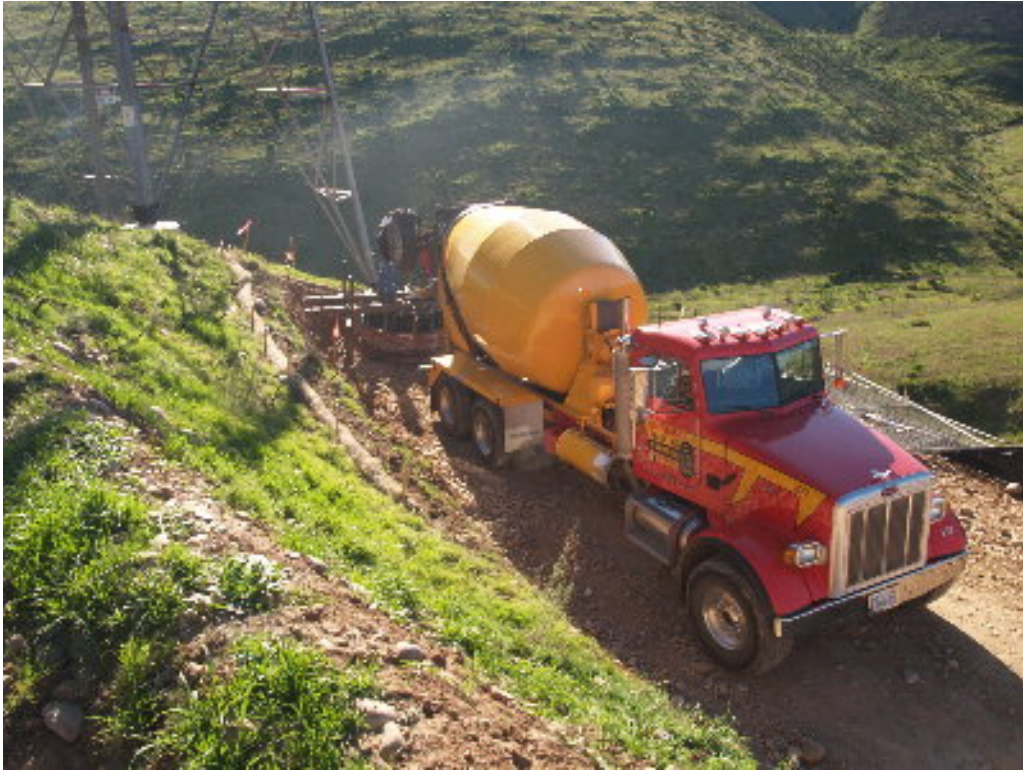
The PAR concrete crew worked on the foundations for the 230 kV towers at Fanita Junction, on Miramar, during the subject week (see Figure 1). Once the concrete has been poured to the top of the form, workers finish the surface of the foundation (see Figure 2). Drilling at Tower Site 601 continued during the CPUC site visit (see Figure 3). A rock shelf is protruding into the hole and has dramatically slowed progress. The drilling crew has reached depth with the pilot hole, but the rock shelf has slowed the reaming of the hole to the engineered width. The crews are looking for ways to expedite the work to meet the January 5 deadline for work on the Marine Air Station at Miramar.

**Figure 1** – The PAR concrete crew worked on pouring one of the foundations covered under NTP #3, on Miramar, during the subject week.

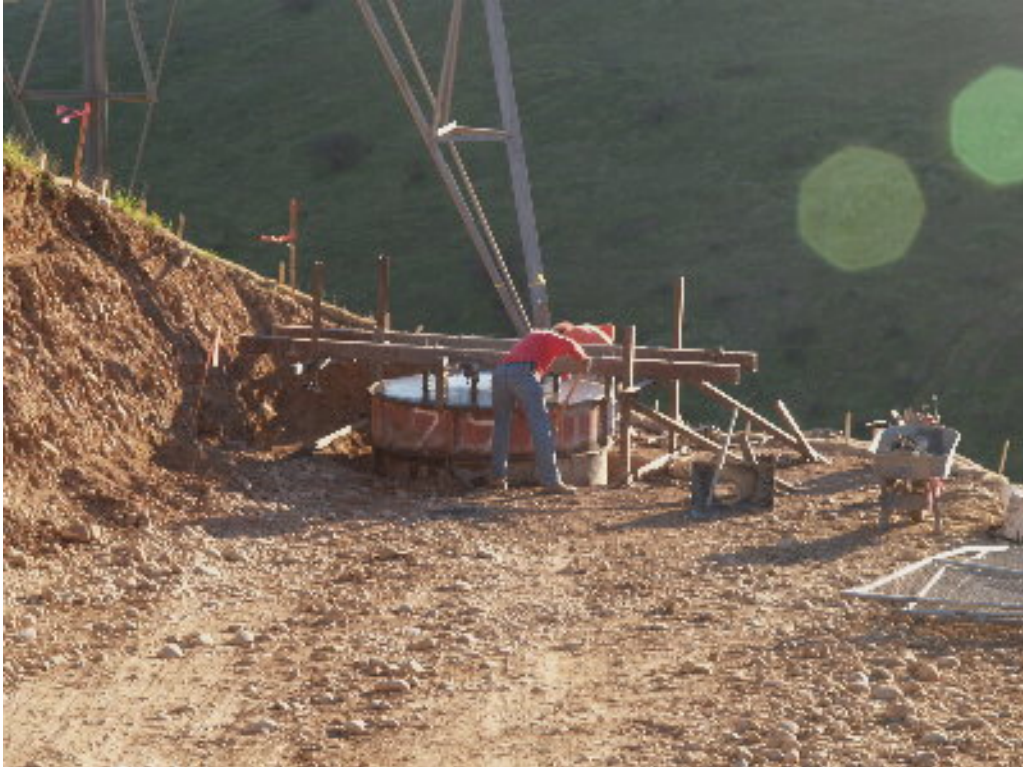
**Figure 2** – The PAR concrete crew finished the surface of the foundation on Miramar.

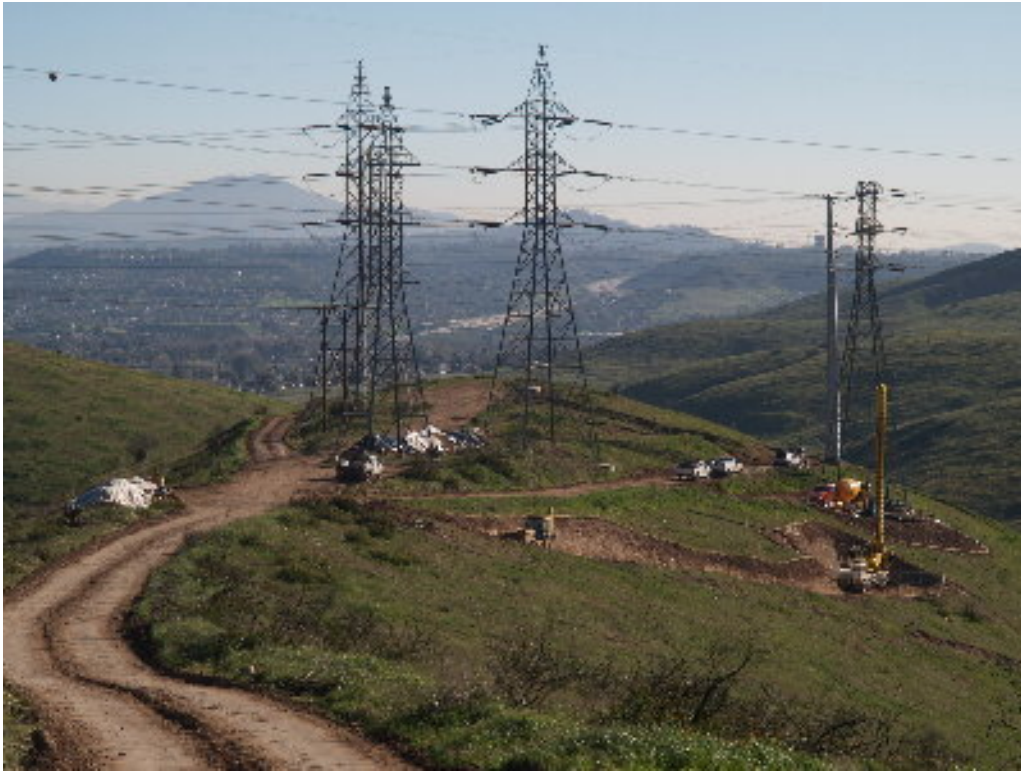
**Figure 3** – The drilling activities continued at Tower Site 601. Crews worked to complete the work prior to the January 5 deadline for work on Miramar. Note that the spoil piles have been recovered and the roads watered.

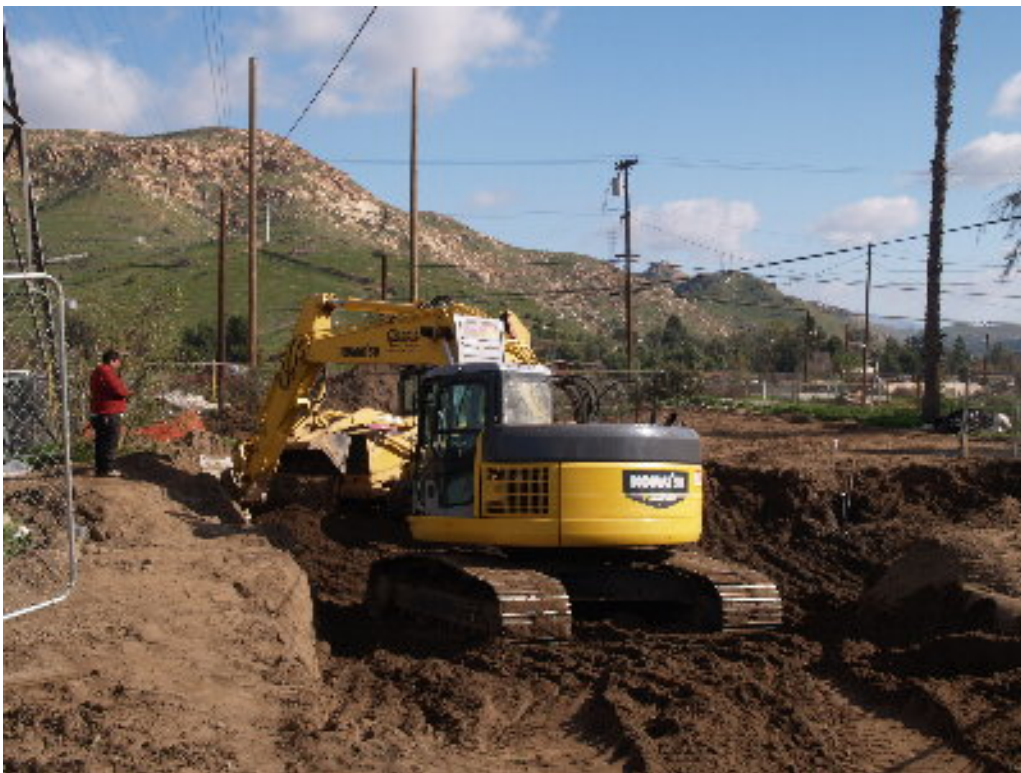
A crew worked at Tower Site 1210 where the foundation needs to be removed due to inclusions during the pour. The crew continued working to backfill the excavation in lifts to preserve compaction (see Figure 4). The moisture in the soil caused problems with compaction as water pumped from lower lifts. The contractor placed fabric and rock to address the pumping concerns and continued placing lifts of soil. A small water line serving the residence was damaged and the crew worked to restore service to the house (see Figure 5).

**Figure 4** – The contractor continued work on compaction at Tower Site 1210 after the foundation was exposed for inspection. The current foundation will be removed below grade and the entire operation repeated.

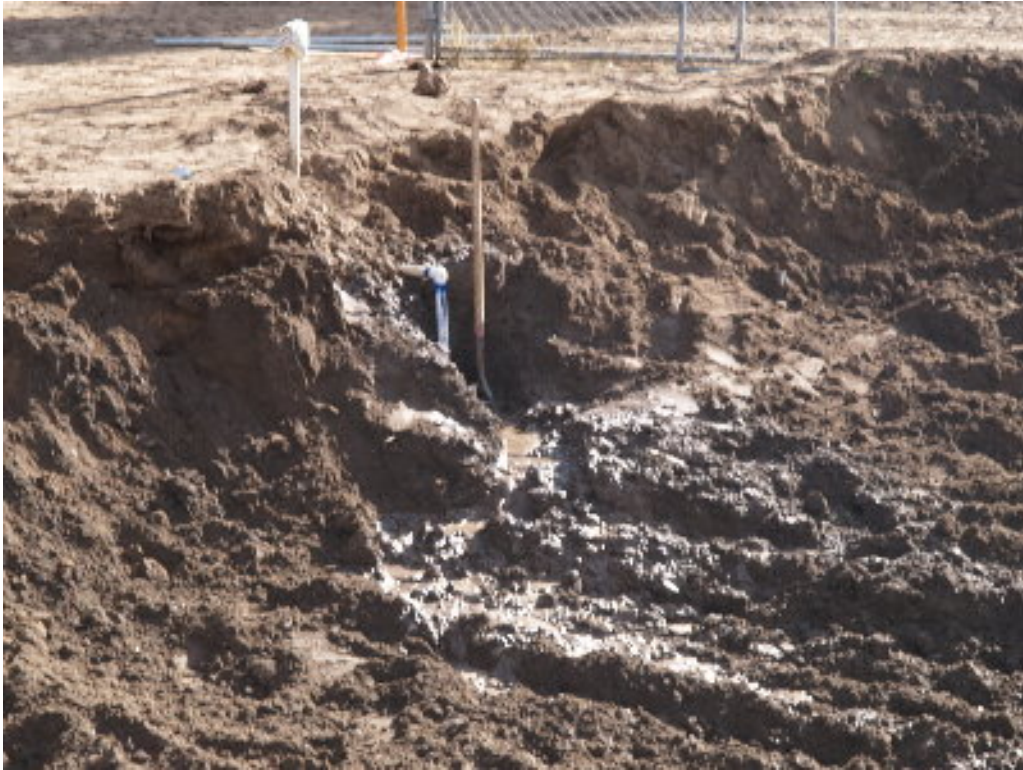
**Figure 5** – The crew at Tower Site 1210 worked to restore water service to the residence adjacent to the excavation.

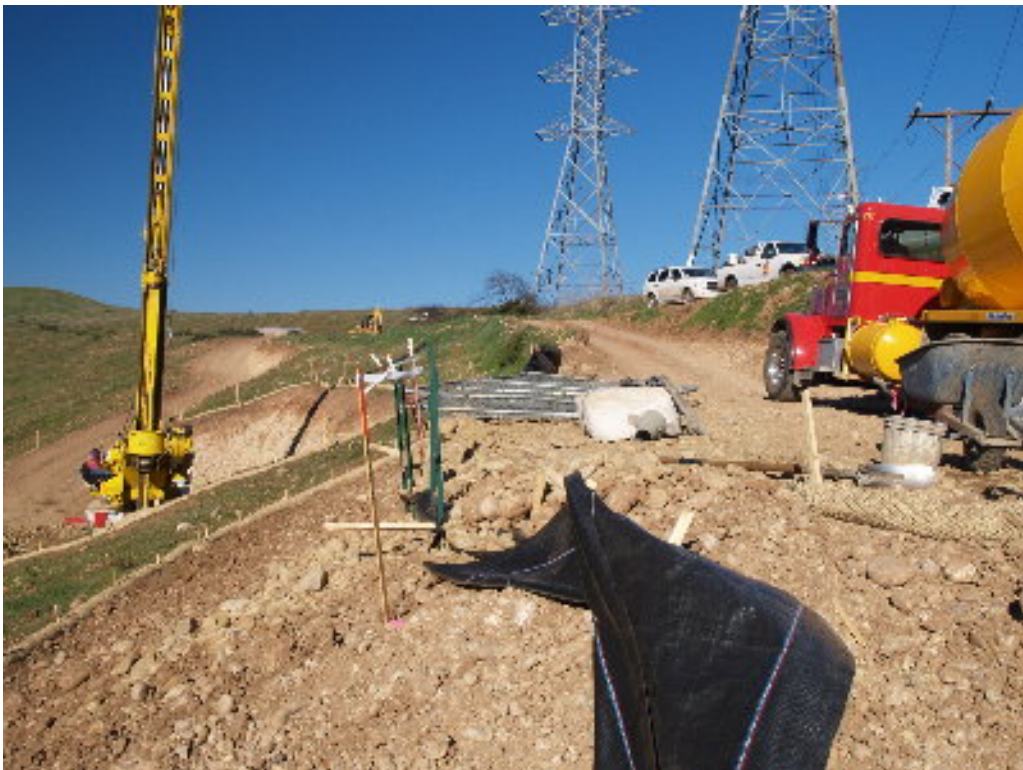
The fugitive dust issue on the right-of-way at Fanita Junction has been corrected. The spoil piles and access roads have been watered and the plastic covering on the spoil piles have been replaced. Some of the rice waddles placed around the pad site are nearly vertical on the slope and do not conform to the design of the BMP. Silt fencing was placed at Tower Site 621 to address rocks rolling down the slope (see Figure 6).

**Figure 6** – Silt fencing backed by steel T-posts was used at Tower Site 621 to control rocks and other spoils during drilling.
