Appendix E2. Hayward and Chabot Fault Location Uncertainty Evaluation for a Utility Corridor

Date: January 30, 2024

SUBJECT: Hayward and Chabot Fault Location Uncertainty Evaluation for a Utility Corridor – Oakland, CA

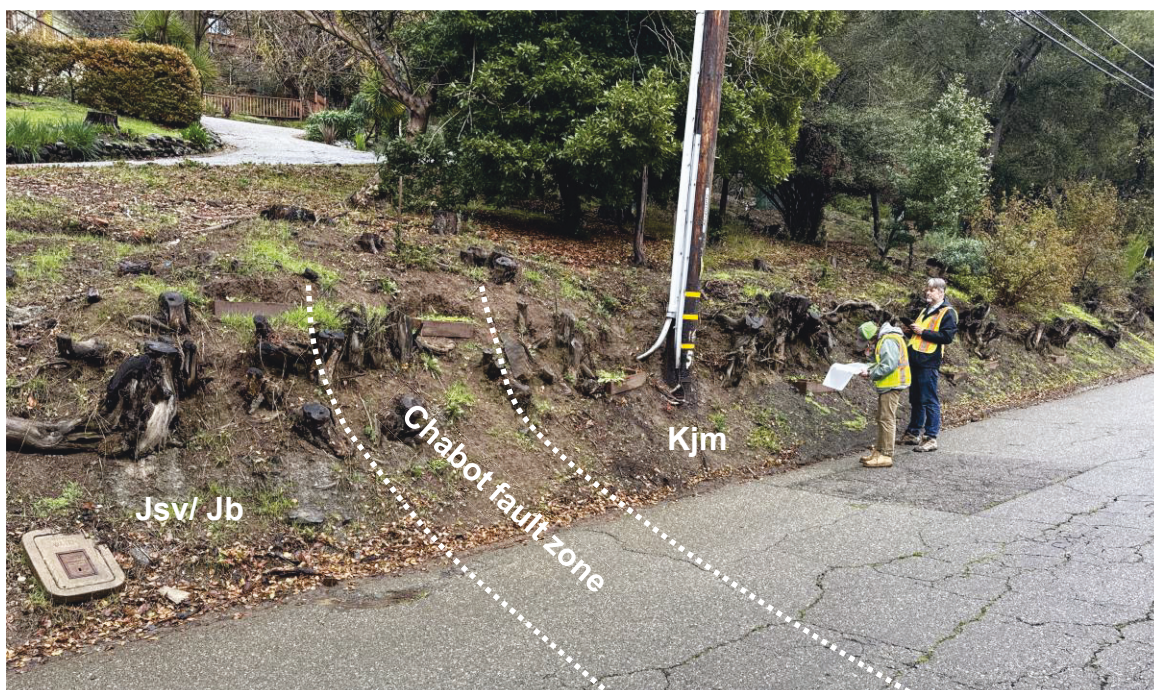
To the southwest along the Chabot fault (Field Locality 6), we mapped the Chabot fault based on juxtaposition of bedded sedimentary rocks of the Cretaceous Great Valley units (Kjm) on the east juxtaposed against diabase-basalt and graywacke on the west (Photos1 and 2). The faulted

Photo 1. Field Locality 6 – fault contact between Jurassic and Cretaceous units along Scout Rd.

contact is aligned with a topographic saddle to the northwest and a drainage deflection, and a northwest-trending linear drainage to the southeast. This fault location is 66 ft (20 m) east of the Graymer (2000) strand (Figure 1) but is consistent with geologic map relationships shown by the author.

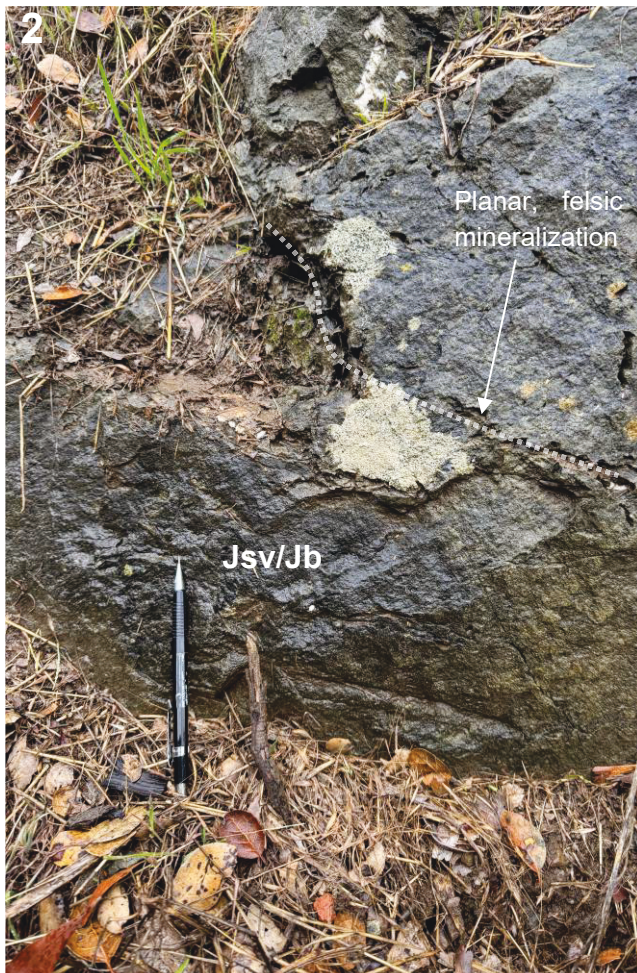
At Field localities 4 and 5, LCI confirmed a steep break in slope associated with the eastern Hayward fault trace and outcrops of rock comprising Jurassic units (i.e., basalt, diabase, graywacke, mélange or Jsv/ Jb – see Photo 2).

Photo 2: Field Locality 6 – Jurassic diabase/ basalt or graywacke (Jsv/ Jb) with planar, secondary felsic mineralization; Photo 3: Field Locality 7 – dipping beds in the Cretaceous unit (Kjm) directly northeast of linear drainage.

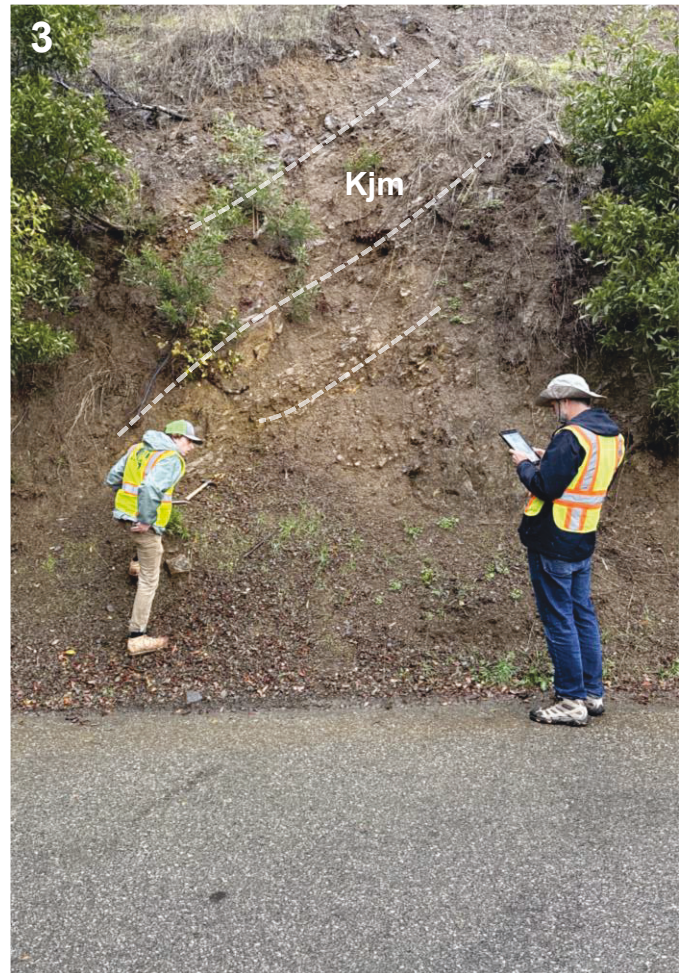
Field locality 7 is further southeast along Scout Rd. and consists of dipping shale beds of the Cretaceous sedimentary unit (Kjm; Photo 3). This road cut exposure is a near vertical wall located on the north side of Scout Rd. directly northeast of Montera School and the linear drainage that runs along Scout Rd.

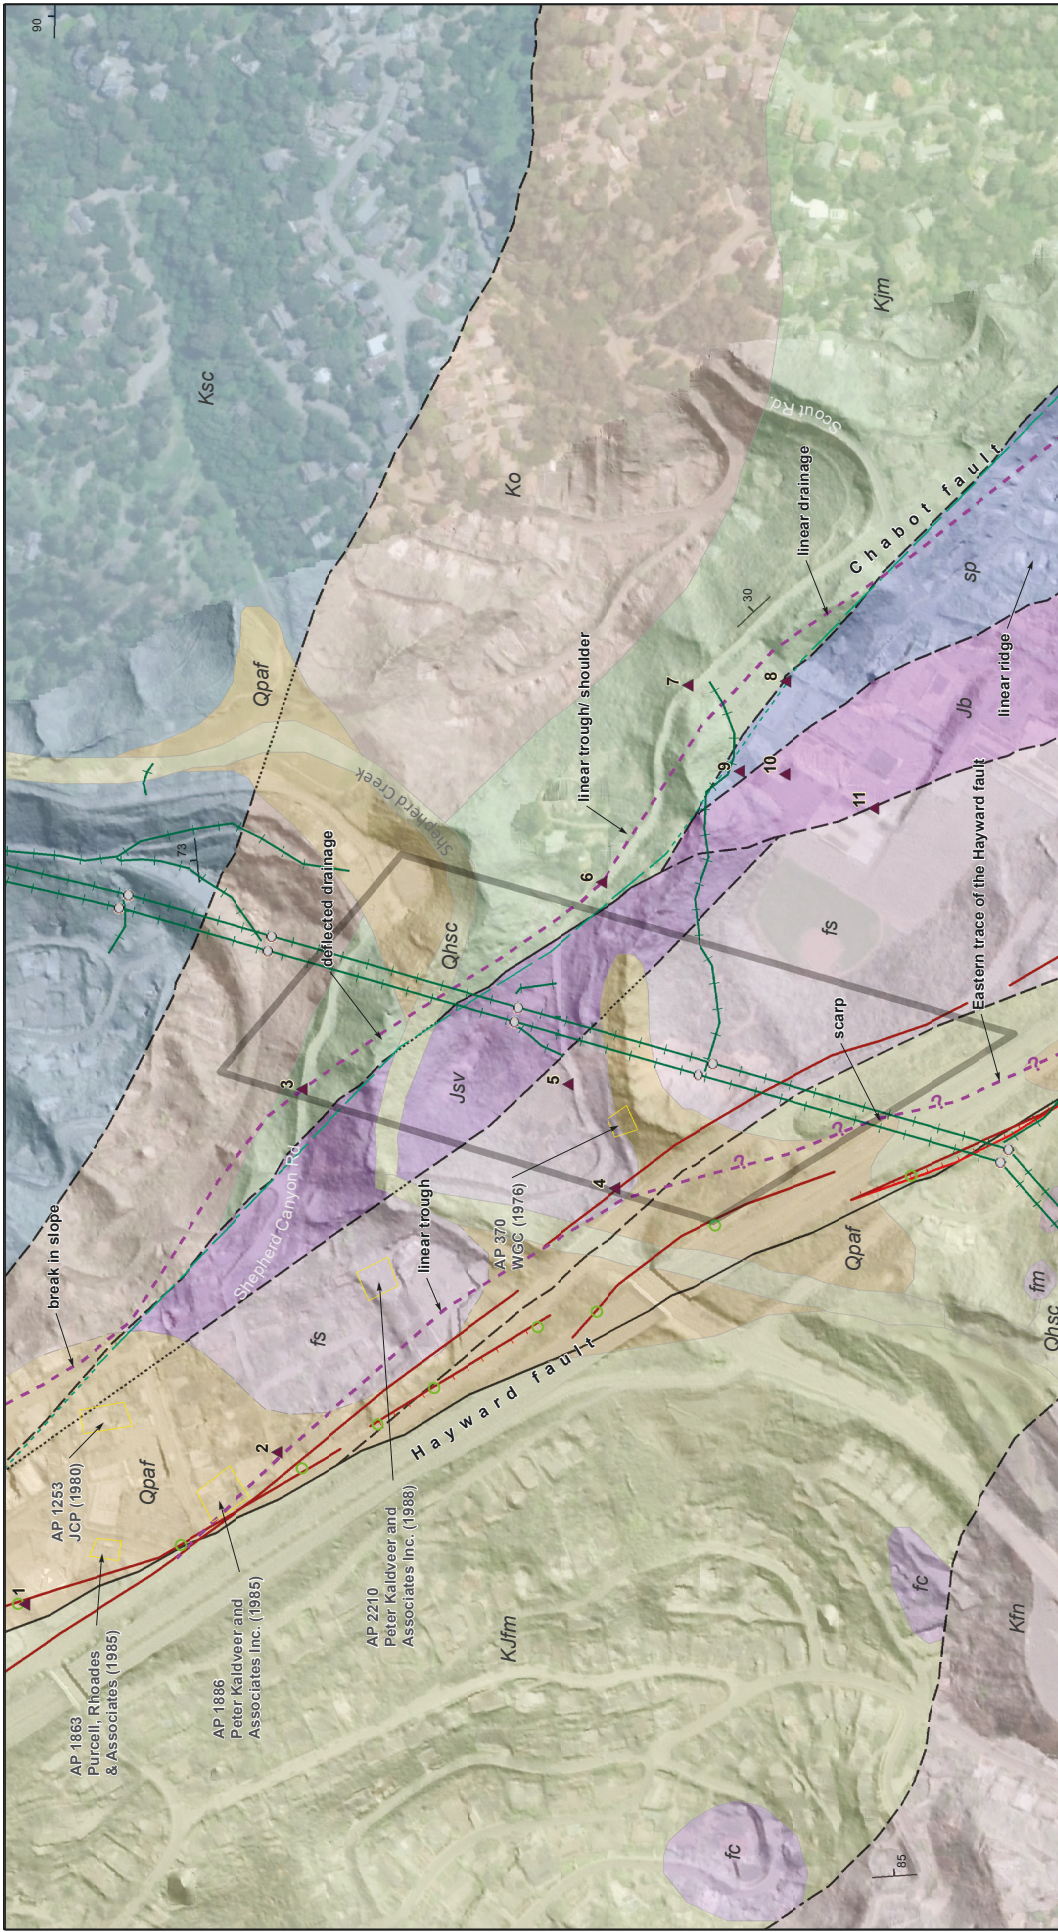
**Hayward-Chabot Utility Corridor
 Geologic Data and
 Revised Fault Mapping**

At the site, several traces of the Hayward and the Chabot faults are mapped intersecting the Moraga-Oakland utility corridor (Figure 1). In the southwestern portion of the study area, an eastern and western trace of the Hayward fault are mapped by PG&E (2022), Lienkaemper (2008), and Graymer (2000).

At Field Locality 3, LCI mapped the location of the Chabot fault (Figures 1 and 2) on Shepard Canyon Road near the Oakland Fire Station No. 24, where a roadcut exposure of dark gray basalt/mélange rocks (Jsv/ Jb units) on the west were observed juxtaposed against thinly to moderately bedded brown shale (Kjm unit) on the east side. This contact zone was semi-obscured by slope wash material; however, the contact occurred as a narrow zone (3 to 6 m or roughly 10 to 20 ft). This fault location is generally consistent with tectonic geomorphic lineaments mapped during our desktop analysis and is 92 ft (28 m) east of the Graymer (2000) mapping.

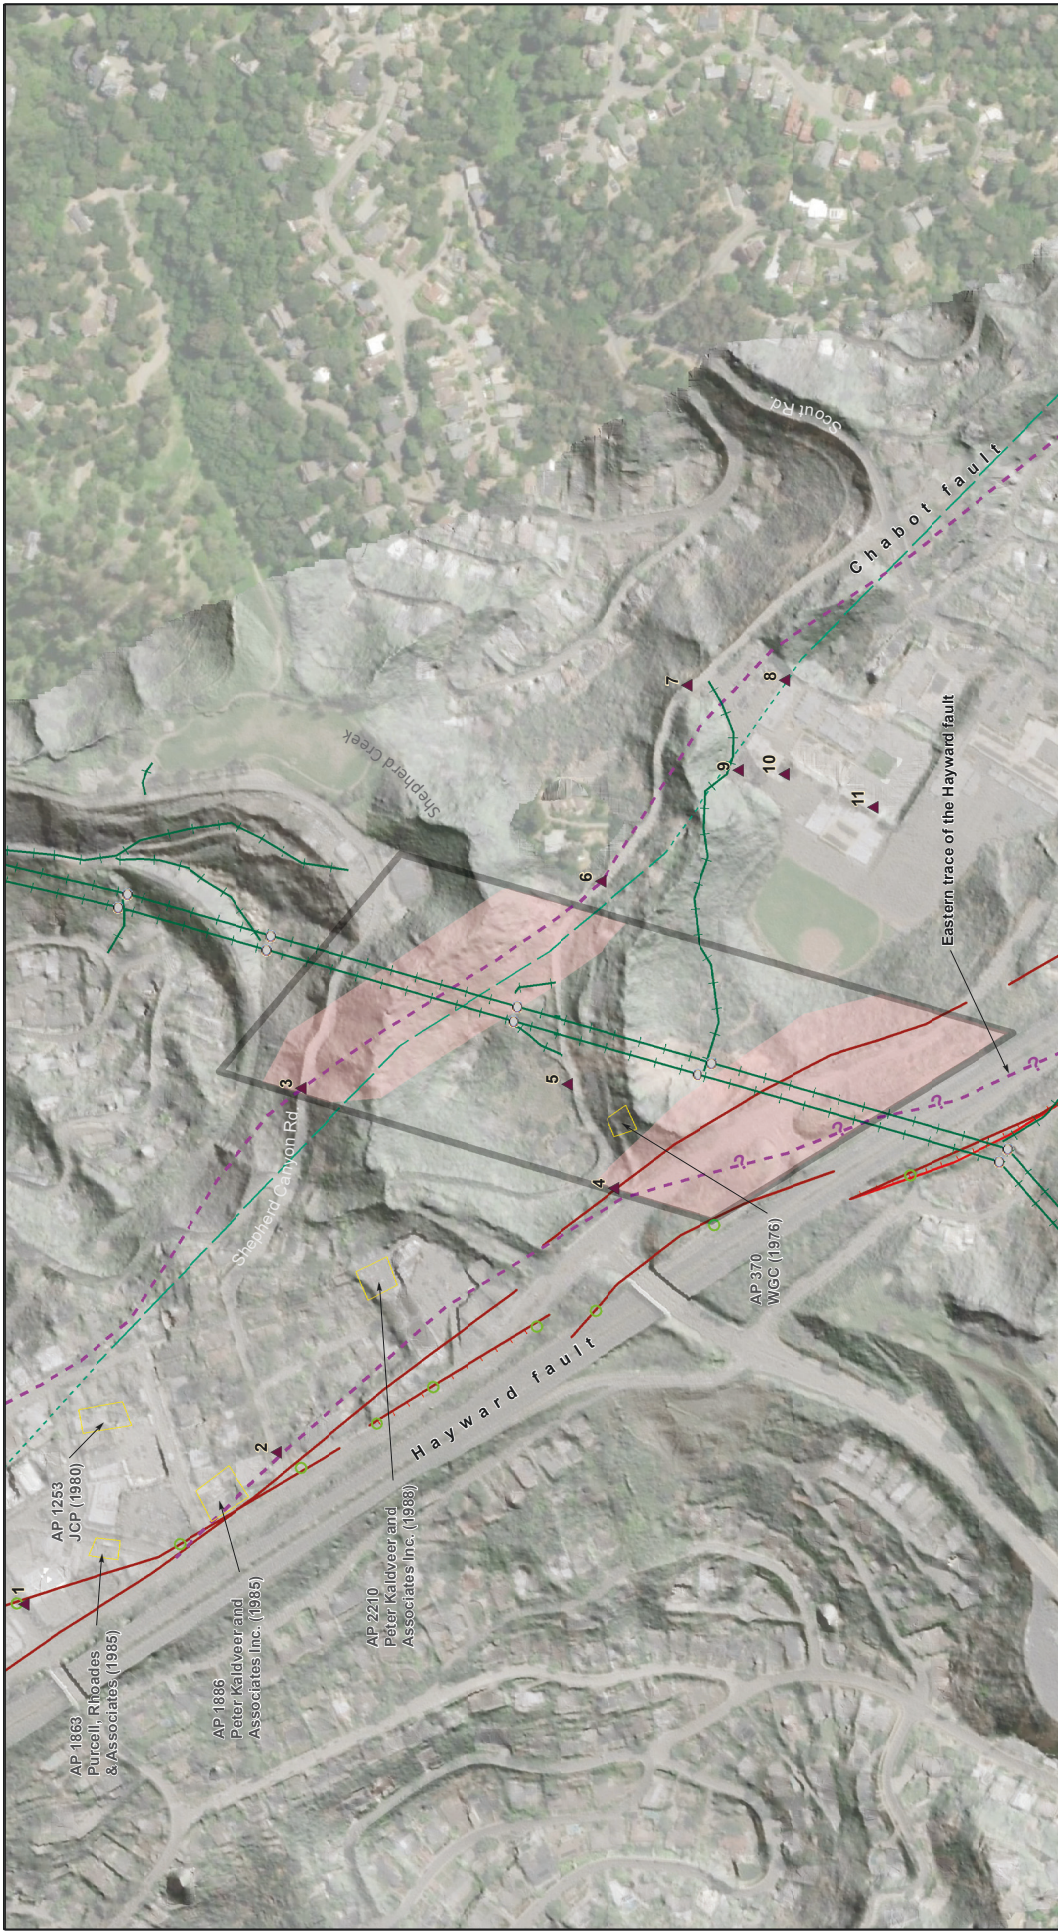
**Hayward-Chabot Utility Corridor
Fault Uncertainty Zones**

On the basis of these findings, LCI developed an approximately 279 to 335-ft-wide (85 to 102-m-wide) wide fault location uncertainty zone that parallels the western creeping strand and the eastern strand (PG&E, 2022) of the Hayward fault encompassing the western portion of the Moraga-Oakland utility corridor (Figure 2). This zone was developed based on a starting fault buffer ~289-ft-wide (88-m-wide) because the more prominent, western strand is approximately located (i.e., one standard deviation is ~44-m-wide; Table 1). This initial width was reduced so that the easternmost limit of the zone generally coincides with the break in slope observed at field locality 4. This topographic feature represents the eastern limit of the break in slope associated with the eastern Hayward fault strand (Figure 2). East of this break in slope bedrock forms broadly sloping surfaces that appear unfaulted and provide a reasonable maximum limit for the fault location uncertainty zone.

To assist with the utility alignment, LCI developed a 289-ft-wide (88-m-wide) wide fault location uncertainty zone that parallels the revised Chabot fault trace study (Figure 2). This zone was developed based on a starting fault buffer 545-ft-wide (166-m-wide) because the here is mapped as strands approximately located (i.e., one standard deviation is ~44-m-wide; Table 1). This initial width was reduced was reduced to a buffer width ~88-ft-wide (44-m-wide) for a total width of 289-ft-wide (88-m-wide) based on surface constraints from combination of the geomorphology along the fault and exposures along road cuts (Field Locality 6; Figure 1). The fault zone is also tapered based on our judgment where the fault is constrained through surface mapping (Field locality 3).
