PROJECT MEMORANDUM PG&E NORTHEAST SAN JOSE TRANSMISSION REINFORCEMENT PROJECT

To: Roosevelt Grant, CPUC
From: Vida Strong, Aspen Project Manager
Date: June 11, 2003
Subject: Weekly Report #54: June 2, 2003 – June 8, 2003
CPUC Environmental Monitor (EM): Jody Fessler

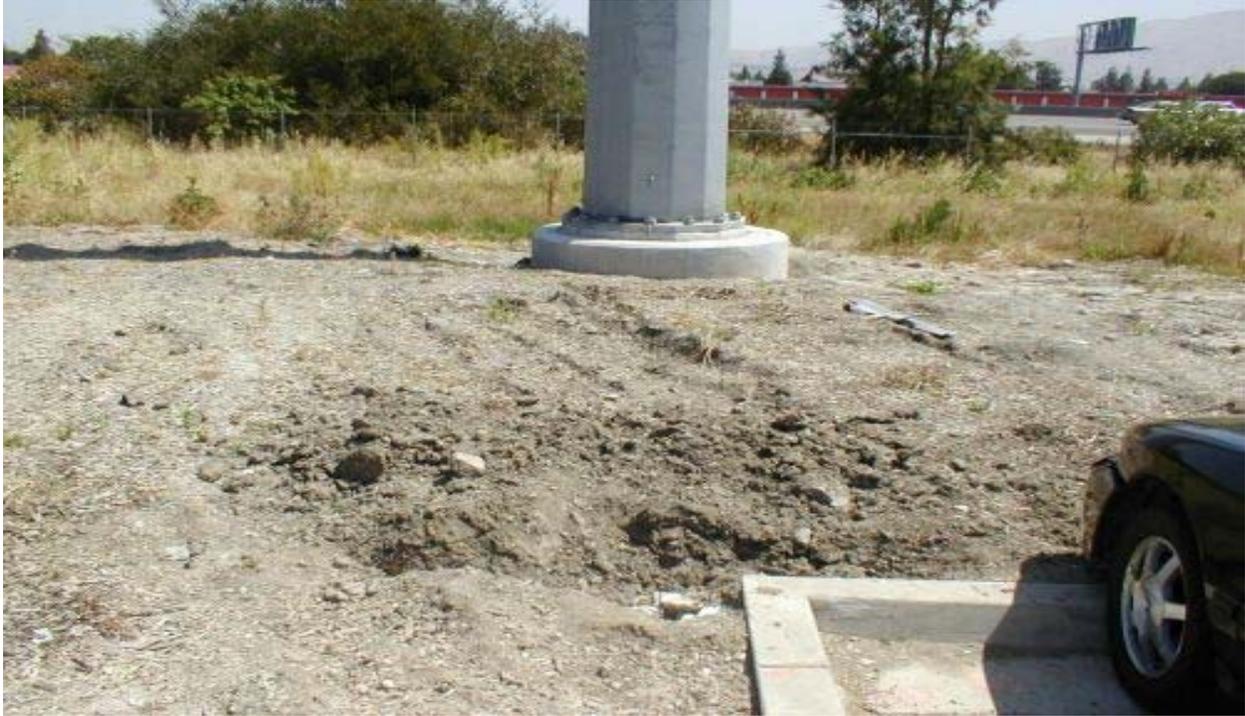
The CPUC EM conducted a site visit of poles #1 L and R in the late morning. There were some wood poles laying near the new poles that need to be removed. Some revegetation also needs to be done at that location. At pole #2, the CPUC EM noted a broken irrigation pipe that may or may not be project related. At pole #3, the CPUC EM also noted a broken irrigation pipe nearby, as well as some ruts in the ground from heavy equipment (see Figure 1). At pole #4, the CPUC EM noted some more ruts in the ground near the pole. There were two broken sandbags that are still around a couple of storm drains on the road between poles #4 and #5 that need to be removed. At pole #5, the access road is still in place as well as the topsoil that was removed and covered with plastic tarps and sandbags. No crews were observed working at those locations. The CPUC EM observed that all sites were neat and clean.

Figure 1
Broken Irrigation and Ruts in the Ground Near Pole #3
June 3, 2003

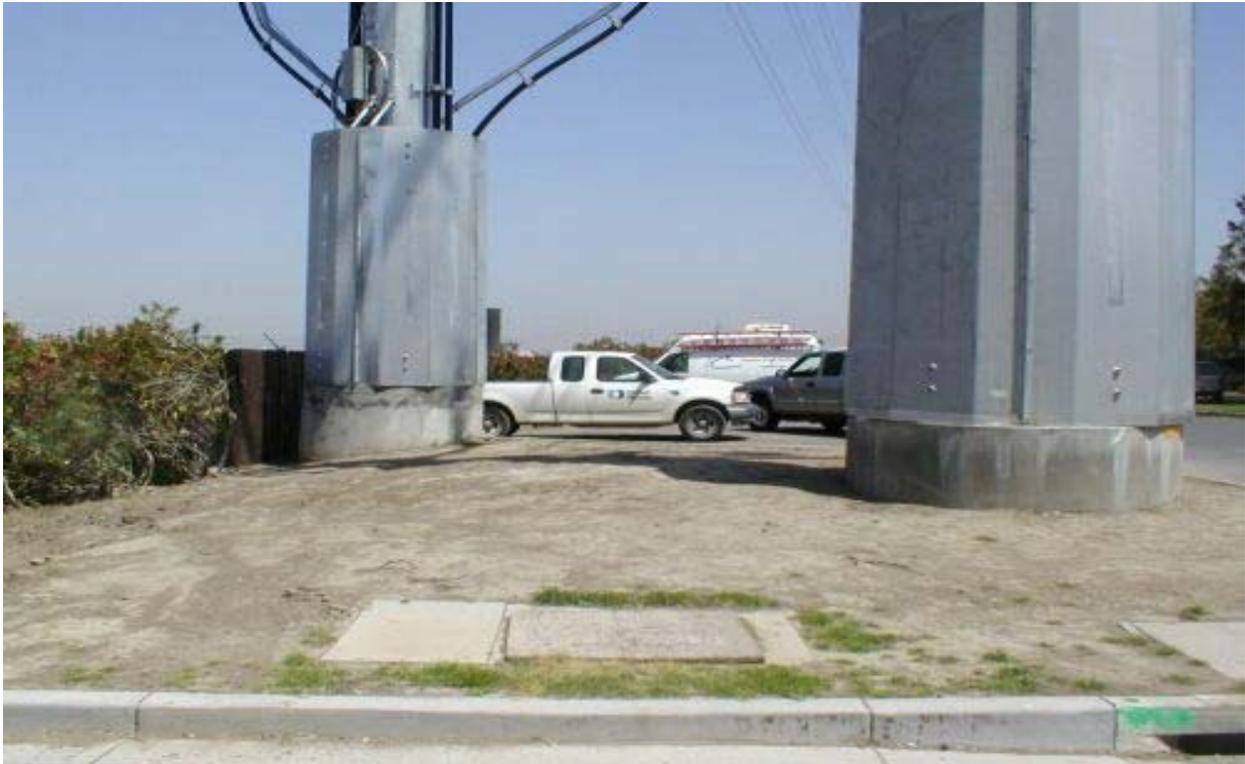
Figure 2
Area Around Poles #9 L and R that Needs Revegetation
June 3, 2003

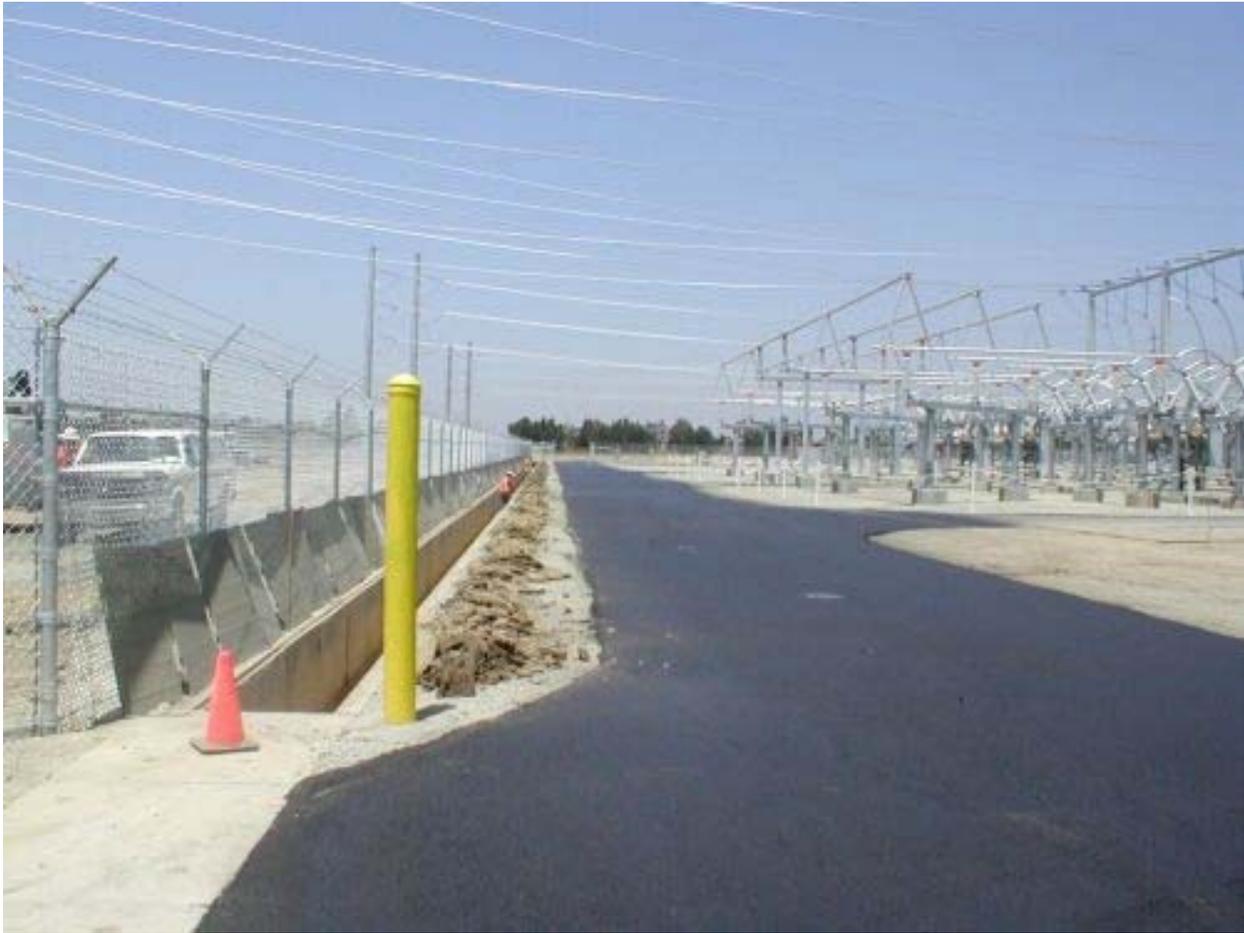
Next, the CPUC EM conducted a site visit of the Los Esteros Substation. Crews were paving roads at the site (see Figure 3). The CPUC EM observed that the site was neat and clean.

Figure 3
Paving Work at the Los Esteros Substation
June 3, 2003
