**PROJECT MEMORANDUM
PG&E SEVENTH STANDARD SUBSTATION PROJECT**

To: Monisha Gangopadhyay, CEQA Project Manager, CPUC
From: Vida Strong, Aspen Project Manager
Date: May 18, 2010
Subject: Report #5: April 25, 2010 – May 15, 2010

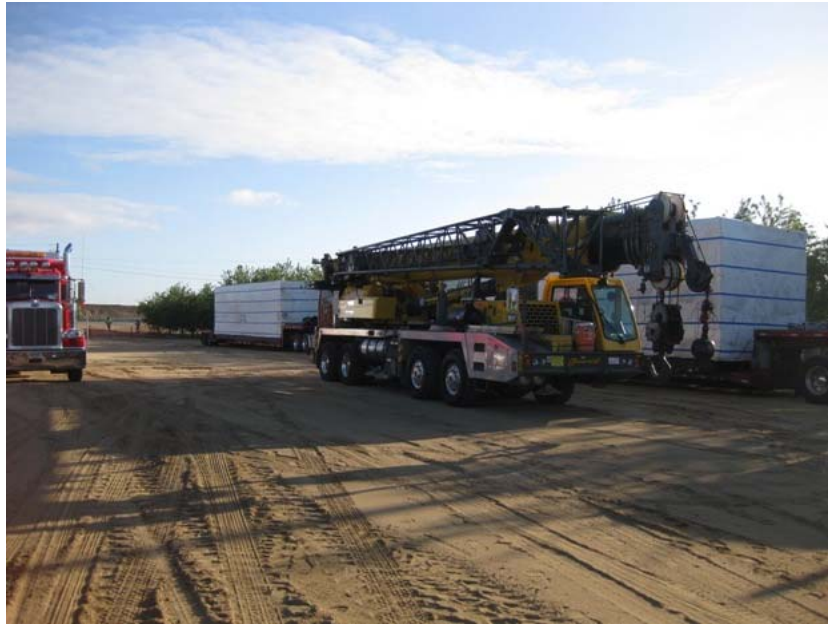
On May 11, equipment and materials for the installation of the electrical controls enclosure (Modular Protection Automation and Control enclosure) arrived on site (see Figure 1). The new crew for installation of the enclosure from Sheedy Construction and truck drivers involved in bringing in equipment and materials were given environmental training and safety instructions before they commenced work (see Figure 2). The controls enclosure was erected and bolted on to its concrete pad by the end of the subject period (see Figure 3).

Figure 1: Equipment and materials for the installation of the electrical controls enclosure (Modular Protection Automation and Control enclosure) were hauled to the site immediately after NTP #2 was issued. The photograph was taken in the access road and faces northward.

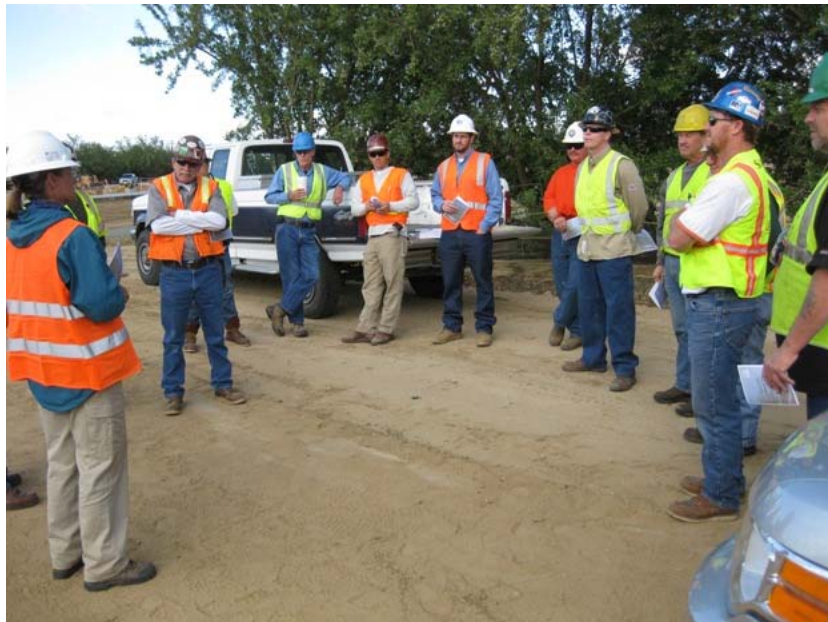
Figure 2: The new crew for installation of the enclosure from Sheedy Construction and truck drivers involved in bringing in equipment and materials were given environmental training and safety instructions before they commenced work by the Biological Monitor on the left.

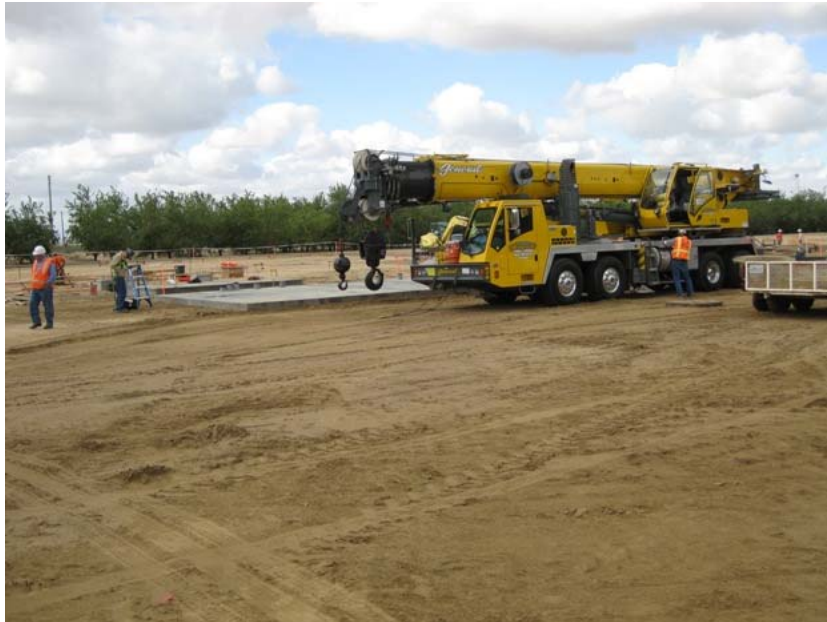
Figure 3: The controls enclosure was erected and bolted on to its concrete pad during the last week of the subject period. The crane in front of the pad is positioned to receive the four sub-units of the enclosure that were brought on site by flat bed trucks. The enclosure pad is in the northeast corner of the substation site. The photograph faces southwestward.

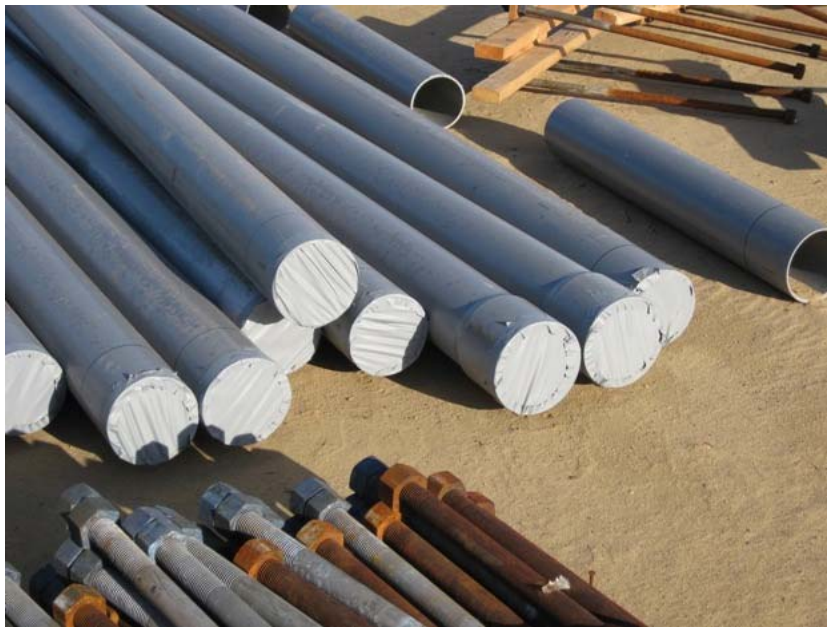
Figure 4: The pipe stored on site with diameters four inches and greater and more than four feet in length are covered to discourage usage by animals.

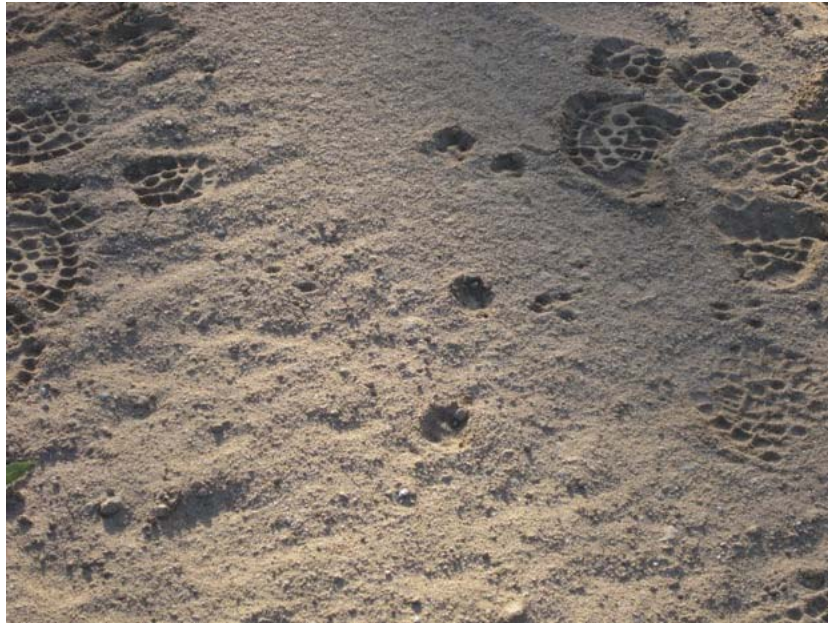
Tracks of fox were found within the substation site during the subject period (see Figure 5), as they were during the prior period. The size of the tracks was small. They may have been made by either the protected San Joaquin kit fox or the non-native red fox. Coyote continued to be seen in the adjacent almond orchard. Several bird species have been observed in the area, including mourning and collared doves, western scrub-jay, killdeer, American crow, red-tailed hawk, black phoebe, northern mockingbird, lesser goldfinch, rose-ringed parakeet and other species. No birds were nesting in the immediate vicinity of the Project during the subject period. Killdeer has the potential to attempt nesting on the disturbed ground of the site. The Biological Monitor has determined there is only a single individual present, probably an unmated male.

Figure 5: The four small tracks in the center of the photograph are from a small fox that visits the site regularly at night. The site is kept free of food-related materials and potential cover. All equipment is checked for resting animals by the Biological Monitor before work begins each day.

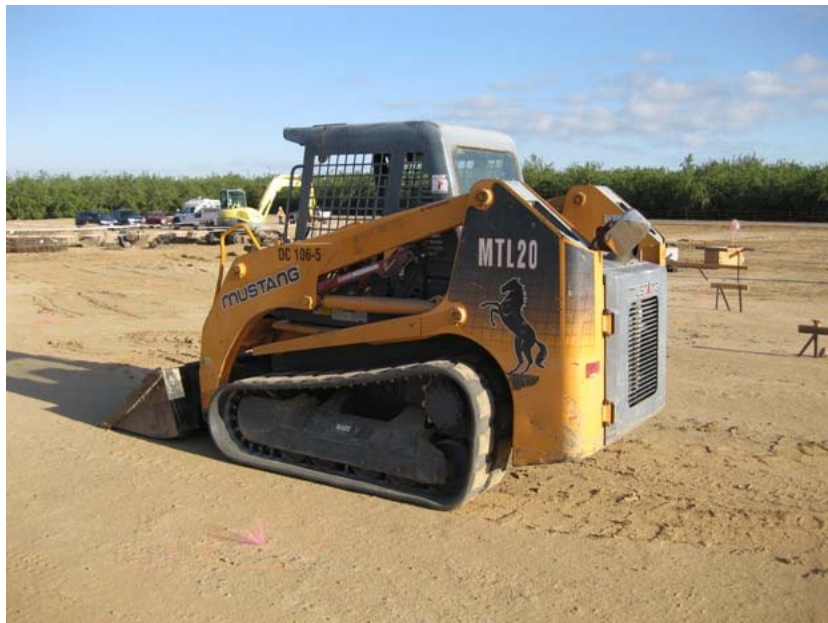
No leakage of fluids from equipment was observed. Equipment was being monitored continually. The Biological Monitor sent one piece of newly arriving equipment off site to be cleaned of caked dirt before it could be used on the project (see Figure 6).

Figure 6: This piece of equipment initially arrived on site with caked dirt on its undercarriage. The contractor was asked to take it off site and get it cleaned. The photograph faces westward.
