**PROJECT MEMORANDUM
PG&E SEVENTH STANDARD SUBSTATION PROJECT**

To: Monisha Gangopadhyay, CEQA Project Manager, CPUC
From: Vida Strong, Aspen Project Manager
Date: June 1, 2010
Subject: Report #6: May 16, 2010 – May 29, 2010

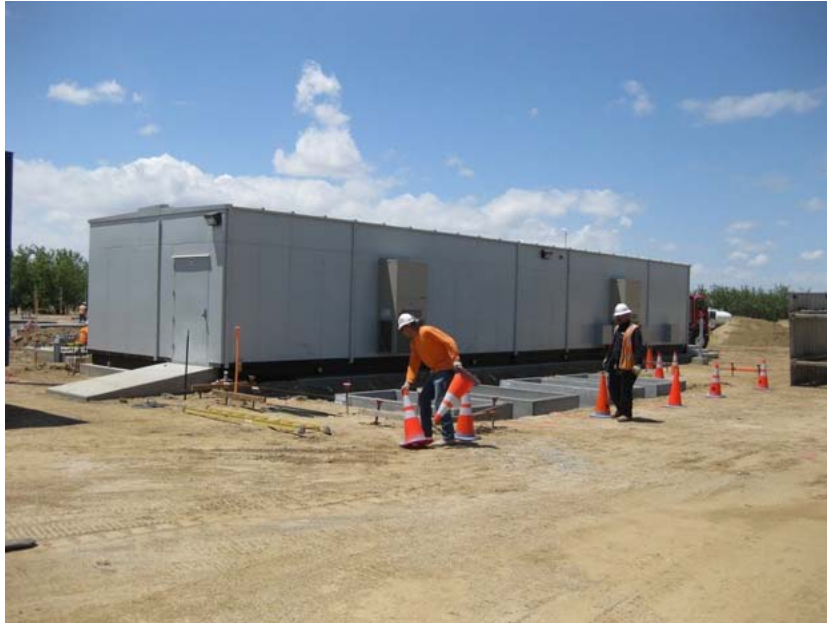
The electrical controls enclosure has been installed on its pad (see Figure 1).

Figure 1: The electrical controls enclosure has been installed. It was hauled on site in four sections, and then assembled and bolted to its concrete pad. The photograph faces southwestward.

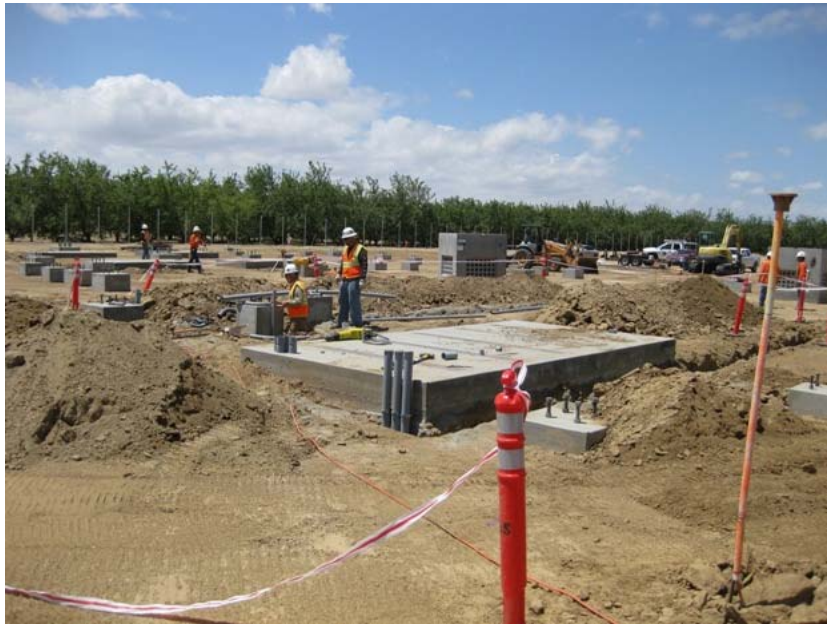
Construction of structure foundations and below-ground conduit trenches continued during the subject period (see Figure 2). Vaults for the incoming electric lines have been placed (see Figure 3), and lids to those vaults were in the process of being secured on May 27 of the subject period (see Figure 4).

Figure 2: Construction of structure foundations and below-ground conduit trenches continued during the subject period. The photograph faces southwestward.

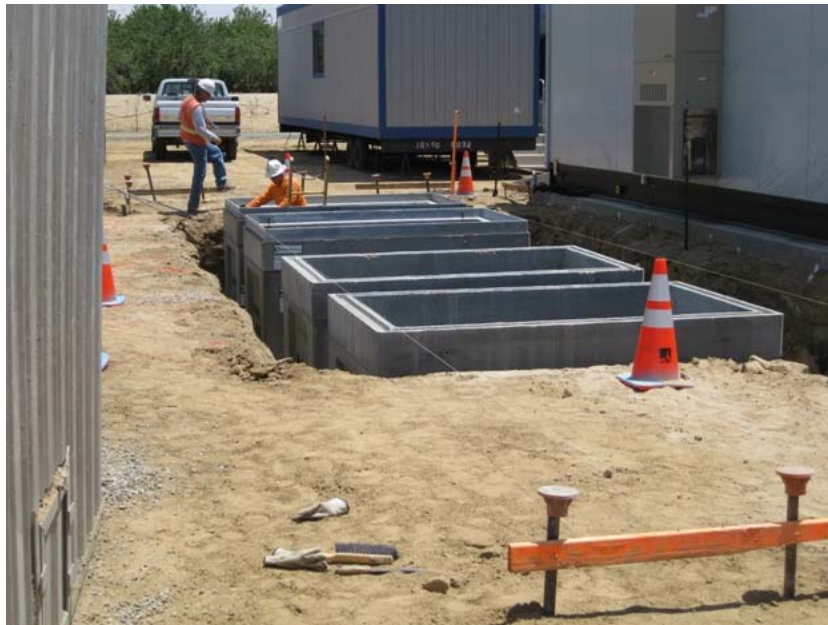
Figure 3: Vaults for the incoming electric lines have been placed next to the electrical control enclosure (to the right). One of the construction office trailers is in the distance. The photograph faces eastward.

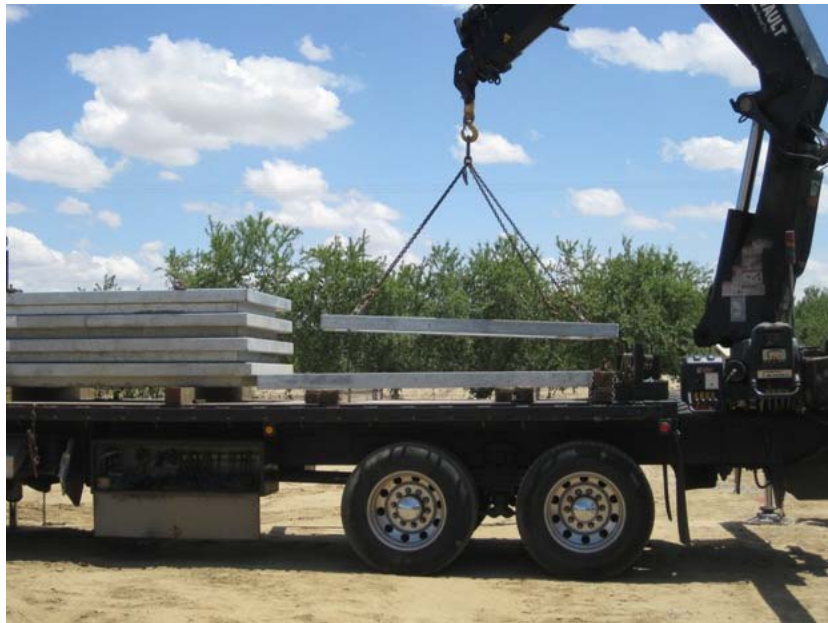
Figure 4: Lids for the incoming electric lines vault were installed during the subject period. The photograph faces eastward.

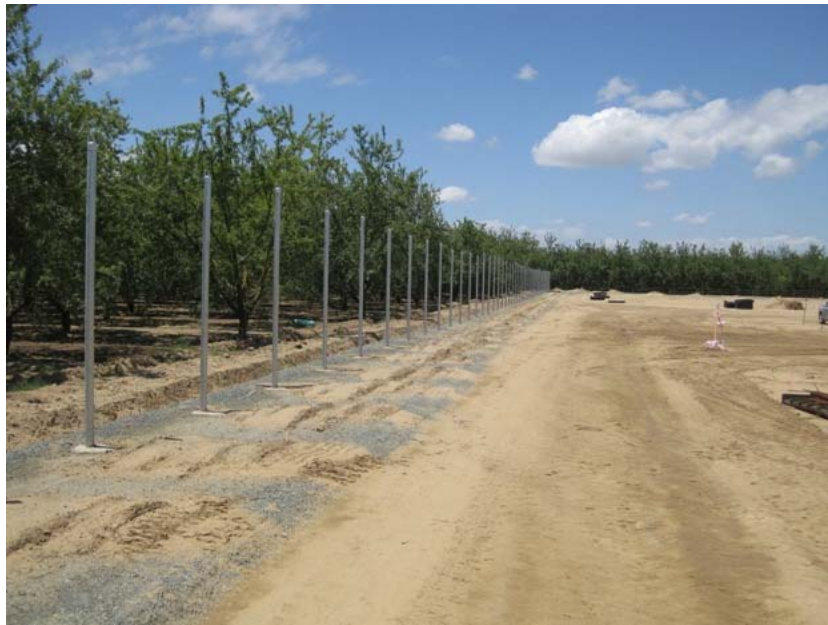
Poles for the perimeter chain link fencing were being installed during the subject period (see Figure 5). The base rock for the substation pad and the access road has been laid in the path of the fencing. Chain link perimeter fence will be placed on both sides of the access road and along the south, north and east boundaries of the substation. A concrete paneled wall will be placed along the perimeter of the west edge of the substation site in anticipation of future home development in that area. Supports for the concrete wall paneling have been placed. The pre-fab concrete panels for the wall will be arriving on site within the next few weeks.

Figure 5: Poles for the perimeter chain link fencing were being installed during the subject period. The base rock that will cover the substation pad has been laid in the path of the fencing prior to its installation. The photograph shows the south perimeter section, and faces westward.

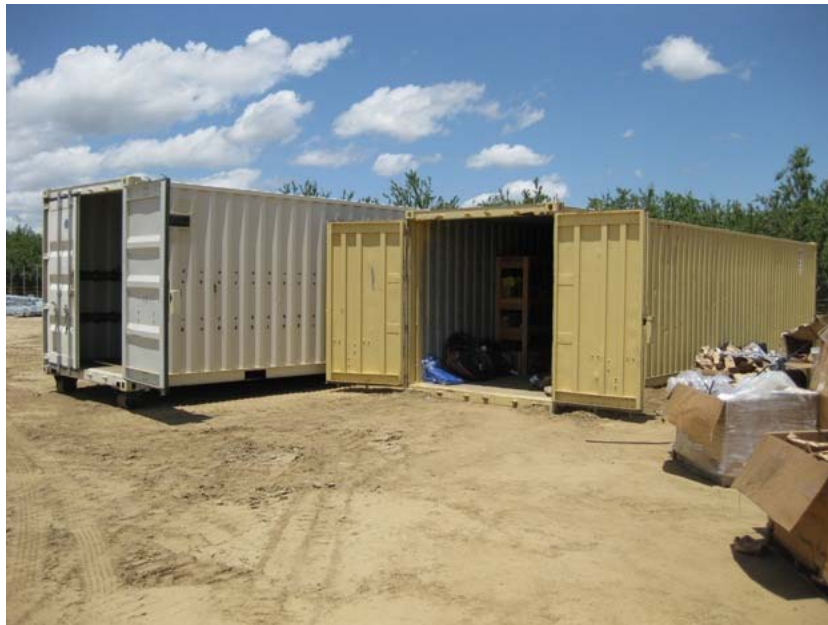
Two office trailers and two storage containers (see Figure 6) have been installed for the construction phase.

Figure 6: Two storage containers have been installed. These are closed each night to prevent animal usage. The photograph faces northwestward.

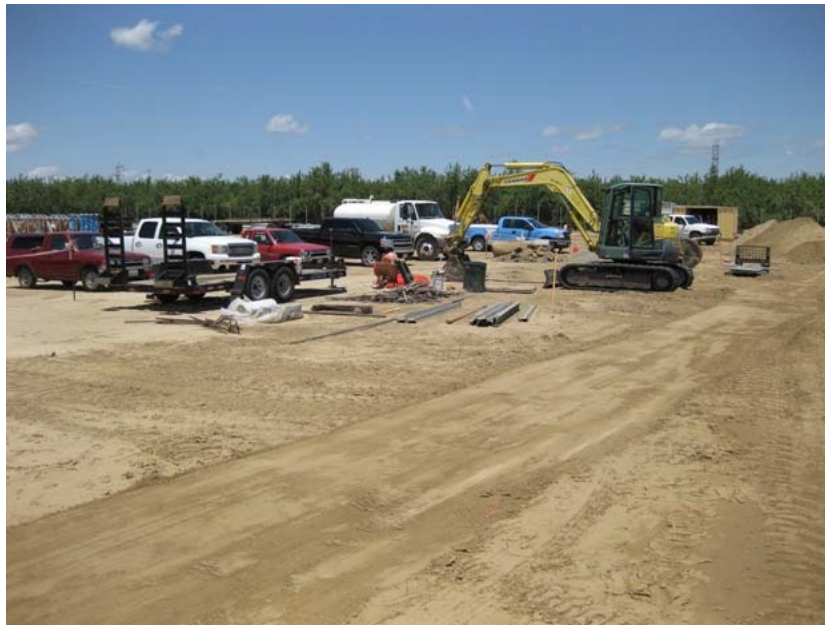
The western portion of the site will not be used for the current substation. During construction it is being utilized for vehicle and equipment parking, and for materials storage (see Figure 7). This section may be used for future substation expansion.

Figure 7: The western portion of the site will not be used for the current substation. It may be used for future substation expansion. During construction it is being utilized for vehicle and equipment parking, and for materials storage. The Biological Monitor and inspectors check this area several times each day for leaks, trash, open pipes, animals under equipment, etc. The photograph faces northwestward.

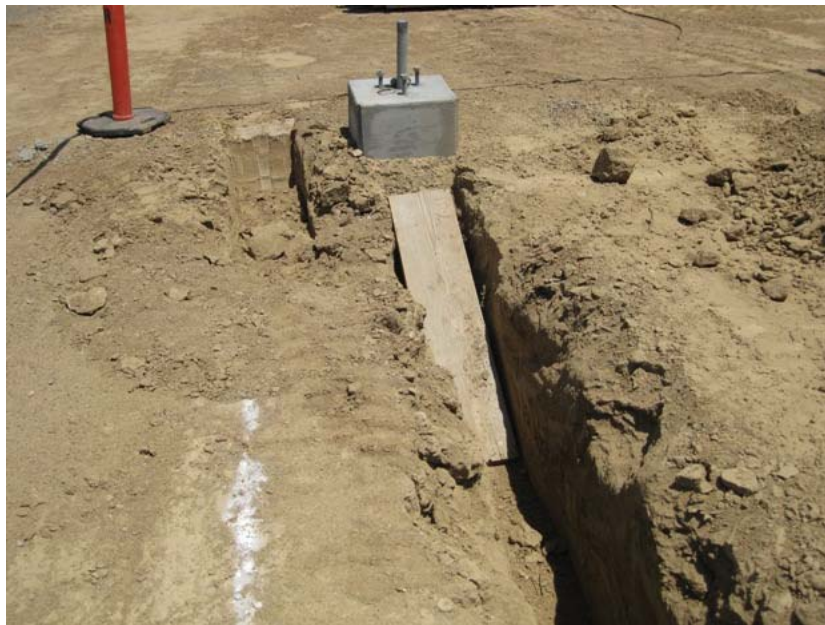
Figure 8: Construction involves the temporary excavation of many trenches and holes for foundations and conduits. All holes are covered overnight, and deep trenches are provided with ramps. These features are regularly checked by the biological monitor.

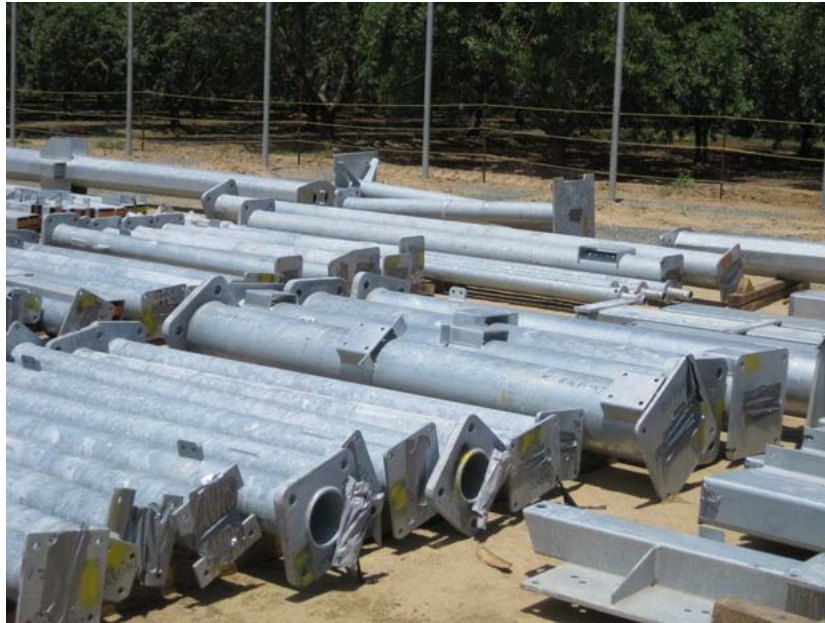
Trenches more than two feet deep were provided with animal escape ramps (see Figure 8). One new shipment of pipe was insufficiently sealed (see Figure 9). Shrink-wrap was being purchased to replace the former sealing.

Figure 9: This batch of tower parts was sealed with tape upon delivery on site. The combination of poor quality tape, improper installation, and temperature changes caused some of the seals to fail. The contractor was directed to use different material to seal the pipes properly. The photograph was taken in the laydown yard in the western portion of the site, and faces northwestward.
