**PROJECT MEMORANDUM
PG&E SEVENTH STANDARD SUBSTATION PROJECT**

To: Monisha Gangopadhyay, CEQA Project Manager, CPUC
From: Vida Strong, Aspen Project Manager
Date: August 9, 2010
Subject: Report #10: July 25, 2010 – August 7, 2010

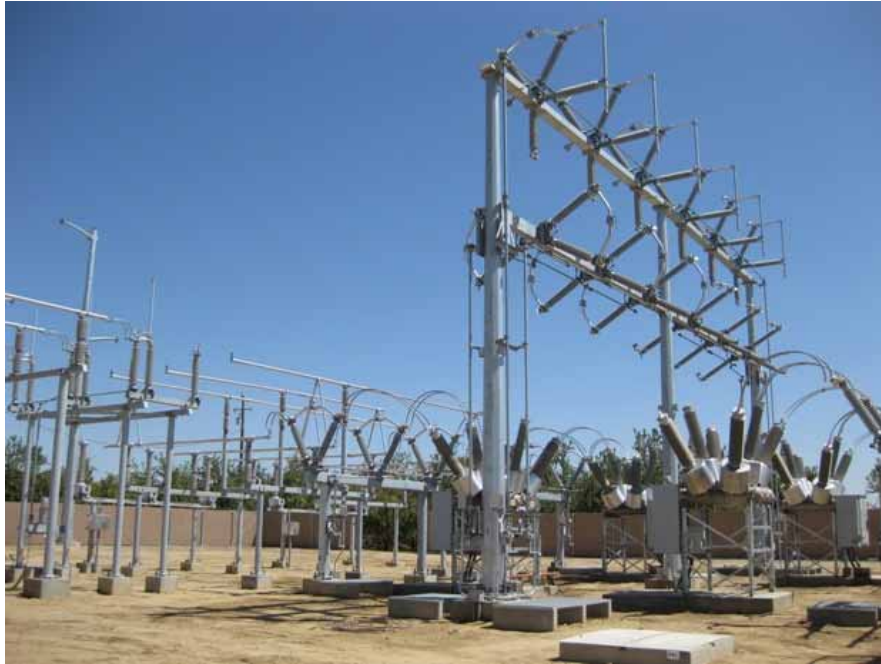
During the subject period, erection of structures continued (see Figure 1). Construction of below-ground conduit trenches and installation of wiring continued (see Figure 2).

Figure 1: Erection of structures continued during the subject period. The photograph faces southeastward.

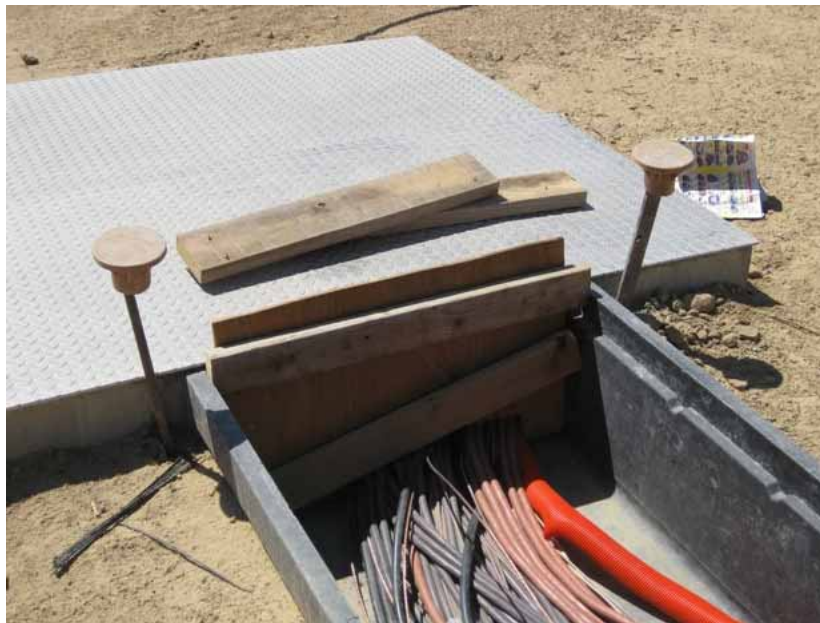
No evidence of kit fox was found within the substation site during the subject period. The only mammal detected on site was domestic dog. No other mammal, reptile, or amphibian activity was noted. The ends of pipe with diameters four inches or greater, and lengths of four feet or greater were kept capped. An opening from a conduit trench into a closed vault was blocked to prevent usage by foxes and other animals (see Figure 2).

Figure 2: Construction of below-ground conduit trenches and installation of wiring continued. An opening from a conduit trench into a closed underground vault was blocked (wood covering in shaded area) to prevent usage by foxes and other animals.

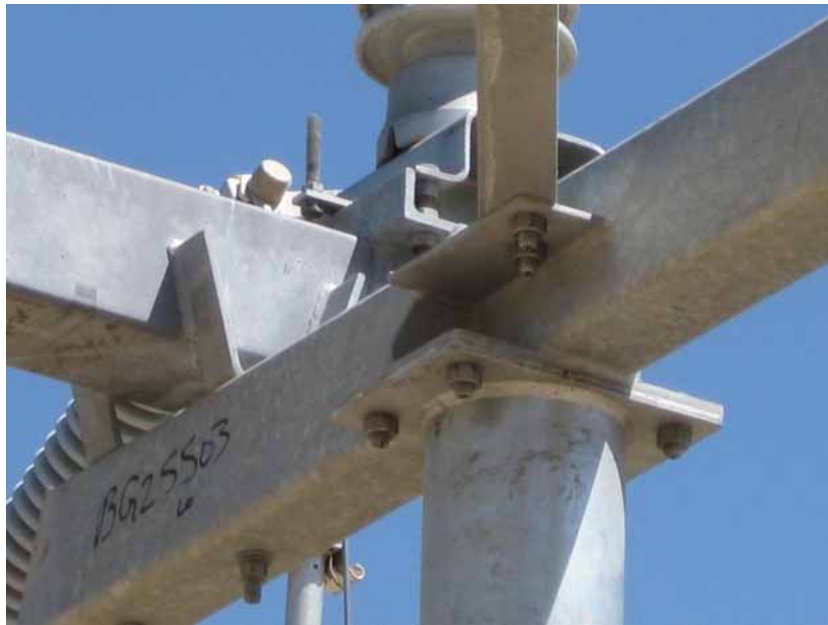
Several bird species have been observed in the area. Black phoebes and western kingbird continued to frequent the site during the subject period. Both species will utilize human structures for nesting (see Figure 3). Storage containers on site were kept closed, and netting was placed around the opening under trailers. The measures put in place to discourage nesting by bird species has been successful to date. If nesting attempts occur, the nests will be removed before eggs are laid. The killdeer nest that was discovered earlier in the season in the storage section was protected until nesting was successfully completed.

Figure 3: Several Project structures and construction facilities create potential nesting opportunities for several bird species. This small shaded ledge on the partially completed substation structure is an example. The measures put in place to discourage nesting by bird species have been successful to date.

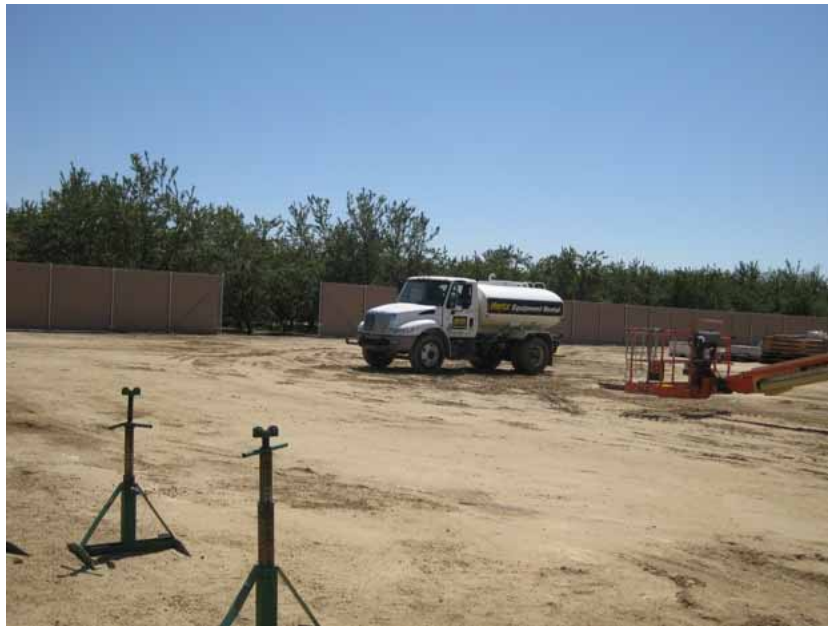
The contractor (TTR) continued to use water trucks (see Figure 4) for dust control. Watering occurred on dirt surfaces on the entire site as much as three times per day when necessary. On one Friday during the subject period, the contractor only worked the first half of the normal work period. The contractor was asked to bring back the water truck operator later in the day, and adequately prepare the site for the weekend. At the end of each work day, the site surface consists of either well-compacted dirt, or, in areas recently disturbed, the loosened soil has a fairly thick crust from watering. Fugitive dust did not appear to be an issue during the subject period. Applicant Proposed Measures #6 and #7 continued to be enforced.

Figure 4: The contractor continued to use water trucks for dust control. Especially important has been the preparation of the soil surface at the end of each work week in order to prevent fugitive dust from occurring during the weekend. The photograph faces southwestward.
