**PROJECT MEMORANDUM
SDG&E'S SUNRISE POWERLINK PROJECT**

To: Billie Blanchard, Project Manager, CPUC
From: Vida Strong, Aspen Project Manager
Date: March 8, 2011
Subject: Weekly Reports 23 – February 20 to February 26, 2011

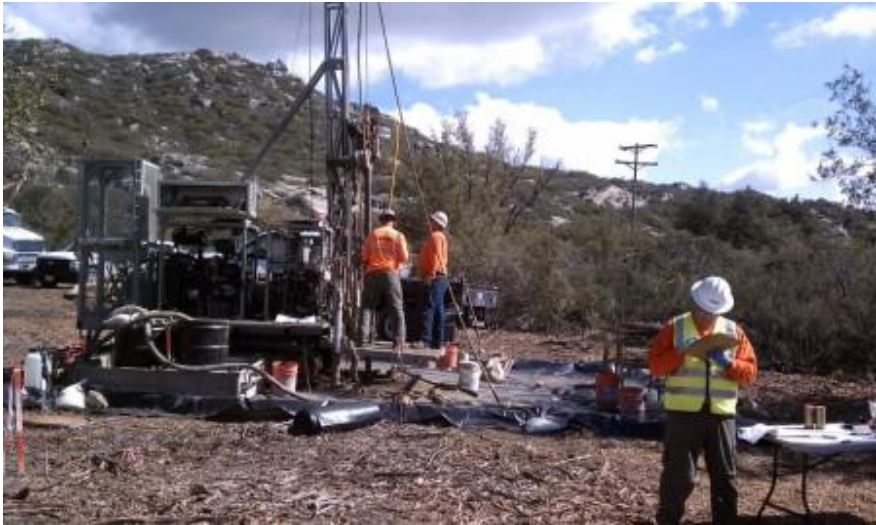
2. Link 2: Installation of a radio communications site occurred at the EP 87-1 TSAP. Soil boring was conducted at EP 85-2 (see Figure 1).
3. Link 4: Excavation continues at the exit pit to the Interstate 8 (I-8) jack-and-bore (north side of I-8), and at Vaults 2L, 15L, 18L, 8L, 13L, 2L, and 9L. Potholing was conducted along Alpine Boulevard west of South Grade Road and from 1850 Alpine Boulevard west to Tavern Road. Drilling/saw cutting was conducted at Vaults 7L, 6R, 13L, 3R, 4R, 5R, 19L, 16L, and 7R. Trenching was conducted at Vaults 7, 15, 14, 18 and east of West Willows Road. Work continues on the Bauer Bridge.

Figure 1: Soil boring at EP 85-2, Link 2.

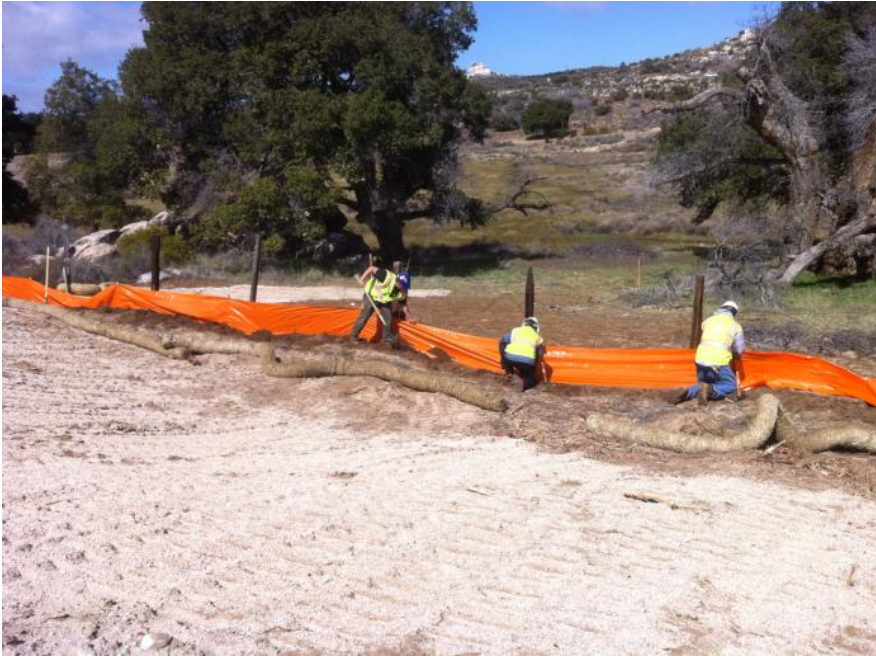
1. Biological, Cultural, and Native American monitors were present as applicable during all transmission line construction activities.
2. Work was conducted inside of a red tailed hawk nest buffer to repair a BMP failure at EP 220, Link 1 (see Figure 2). A Biologist was on site to monitor the nest.

Figure 2: BMP repair at EP 220 within Red Tailed Hawk nest buffer, Link 1.

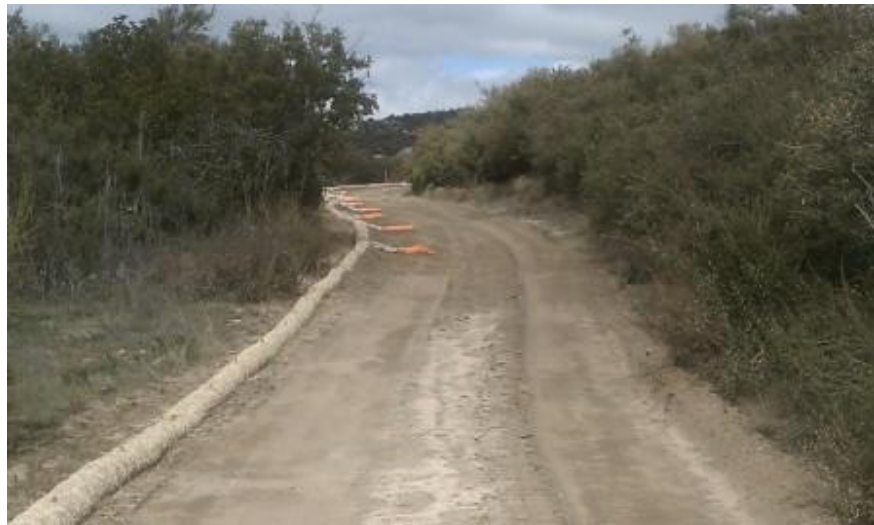
4. Erosion repair and BMP maintenance was conducted on access roads to EP 84 and EP 85-2, Link 2 (see Figure 3).
5. In Link 2, a precipitation event of 1.5 inches was recorded in a period of less than 24-hours, causing a breach of some BMPs. A post-storm inspection identified areas where BMP maintenance and improvement were required and initiated (see Figure 4).

Figure 3: Access road and BMPs to EP 84 & EP 85-2, Link 2.

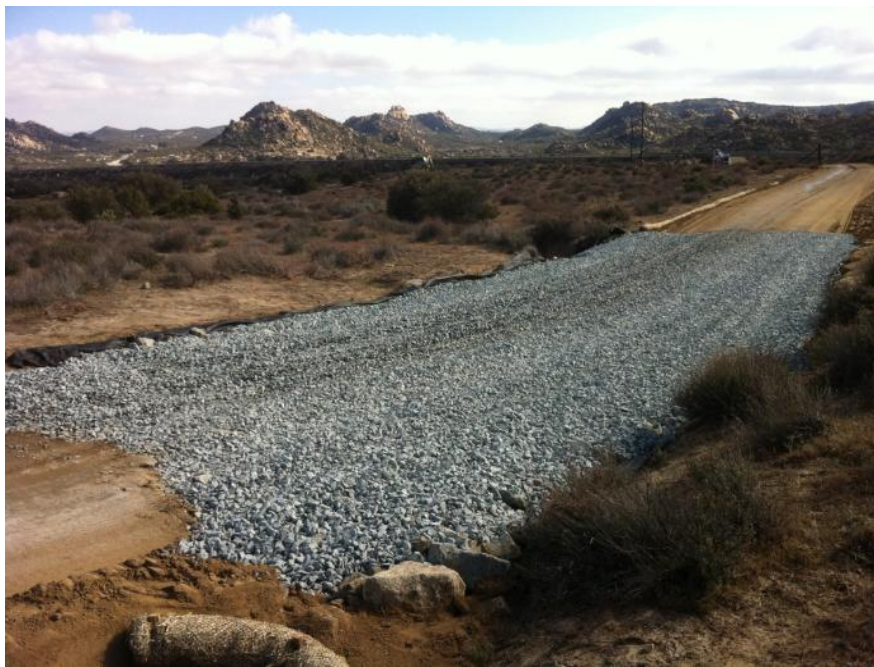
Figure 4: Implementation of BMPs; rocked dip section along access road, Link 2.

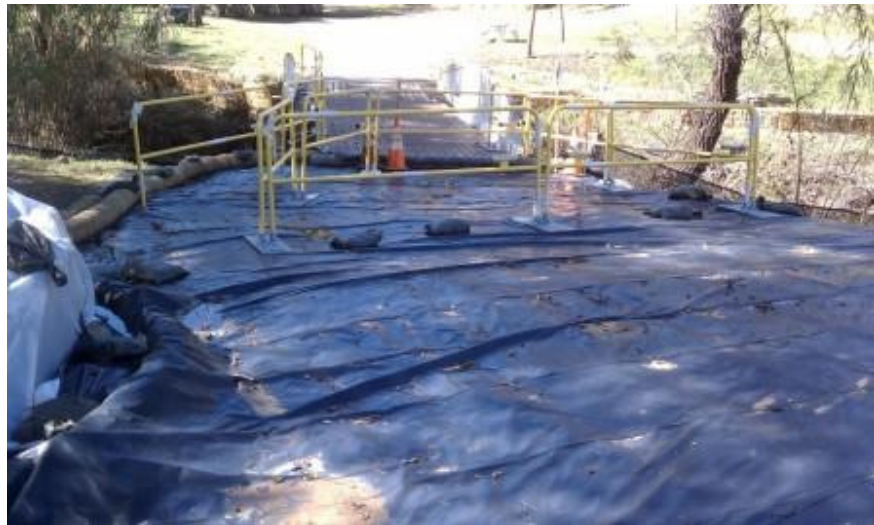
6. BMPs in Link 4 were checked for any needed maintenance before expected rain.
7. BMPs at the Bauer Bridge and the adjacent creek have been adequate during the recent rains, Link 4 (see Figure 5).

Figure 5: Bauer Bridge BMPs, Link 4.

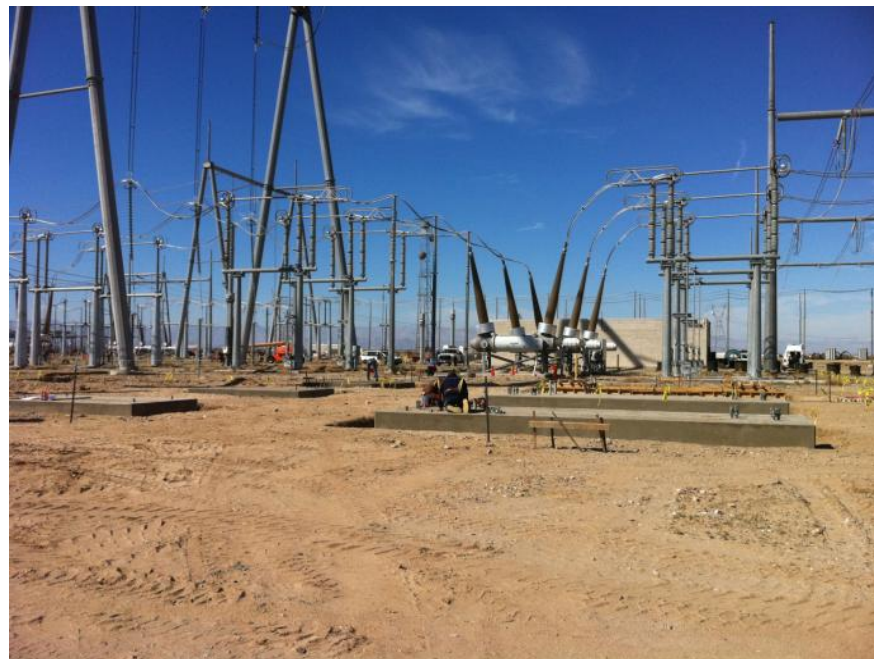
2. Imperial Valley Substation Upgrade: Foundation work continues for new 500 circuit breaker stands. Drilling was conducted for the piers (see Figure 6). Speed limit signage was installed along the access road into the substation (see Figure 7).

Figure 6: Foundation work at Imperial Valley Substation.

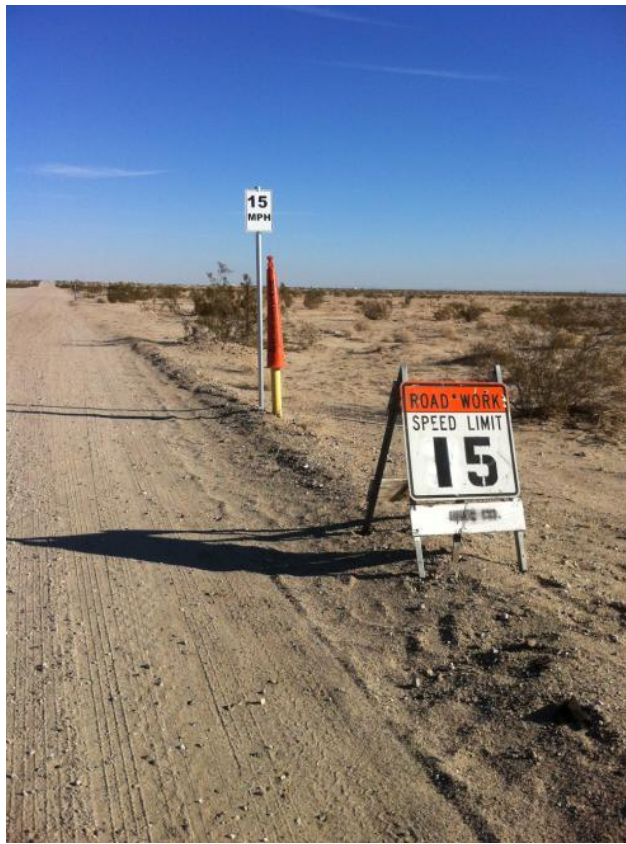
Figure 7: Speed limit signage along Access Road to Imperial Valley Substation.

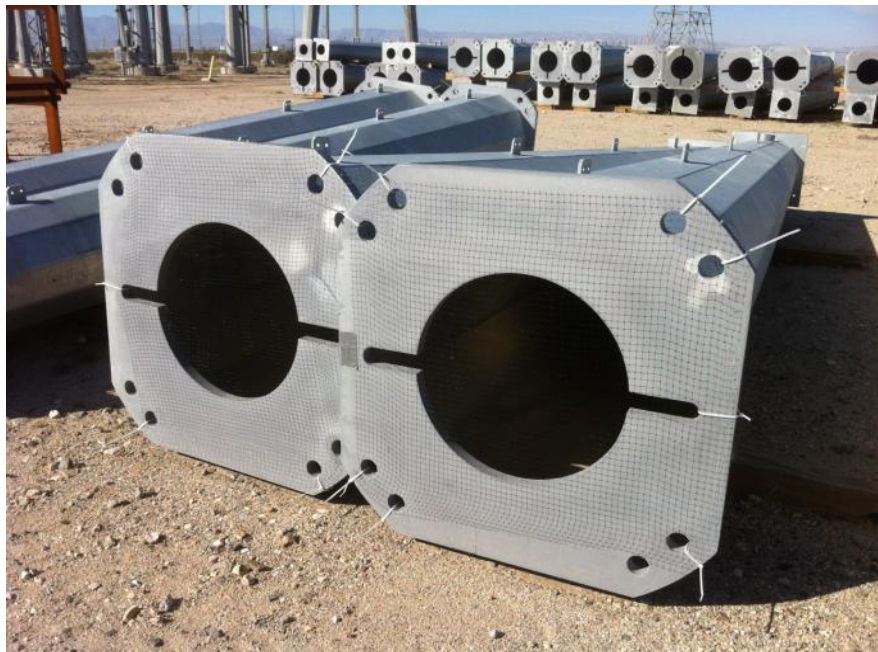
Figure 8: Bird netting installation at Imperial Valley Substation.

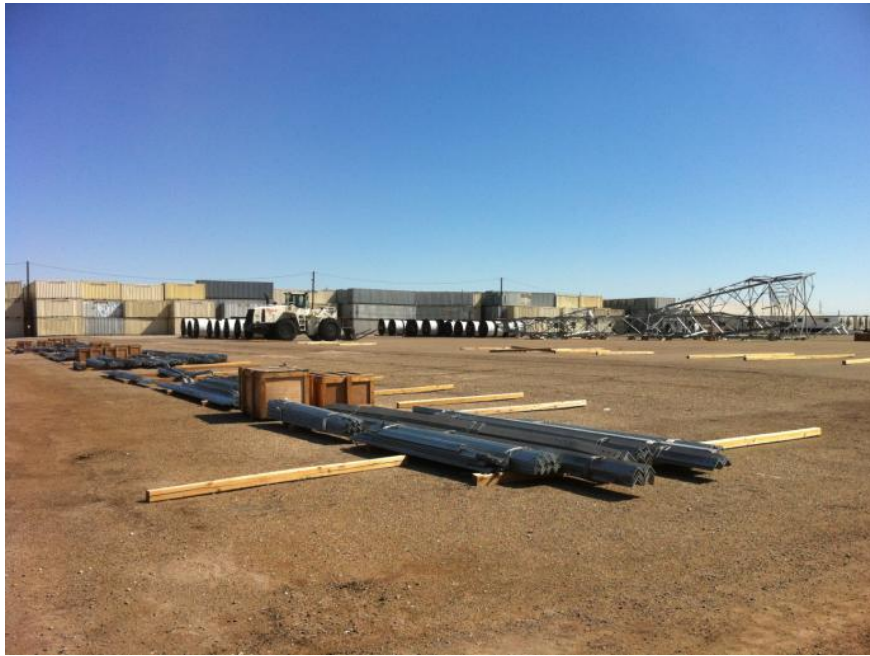
3. Steel deliveries and driveway improvements continue to be made at the Rough Acres Construction Yard.
4. No ground disturbing work being conducted at the Thomas Construction Yard; material delivery and storage continues. The Link Lead was onsite monitoring for burrowing owls. One tower has been constructed at this location for practice to trouble shoot and take notes on any manufacturer problems (see Figure 9).

Figure 9: Tower construction at Thomas Yard.

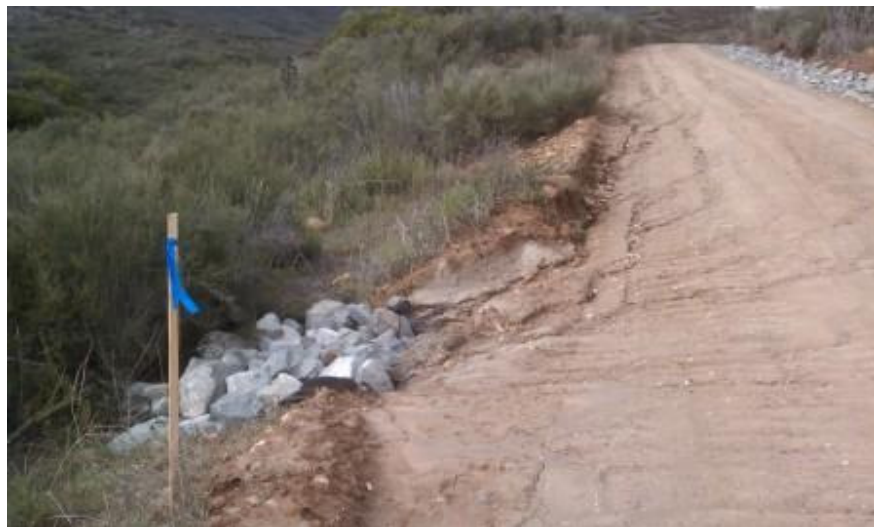
9. Yard preparation occurred at the SWAT Construction Yard. The access road was improved (see Figure 10).
10. Yard preparation occurred at the Kruetzkamp Construction Yard.

Figure 10: Access road to SWAT Construction Yard.
