PROJECT MEMORANDUM PG&E – TRI-VALLEY 2002 CAPACITY INCREASE PROJECT

To: Ken Lewis, CPUC
From: Vida Strong, Aspen Project Manager
Date: January 23, 2004
Subject: Erosion and Revegetation Monitoring Report #2, 12/22/03 – 1/22/04
CPUC Environmental Monitor (EM): Anne Sweet

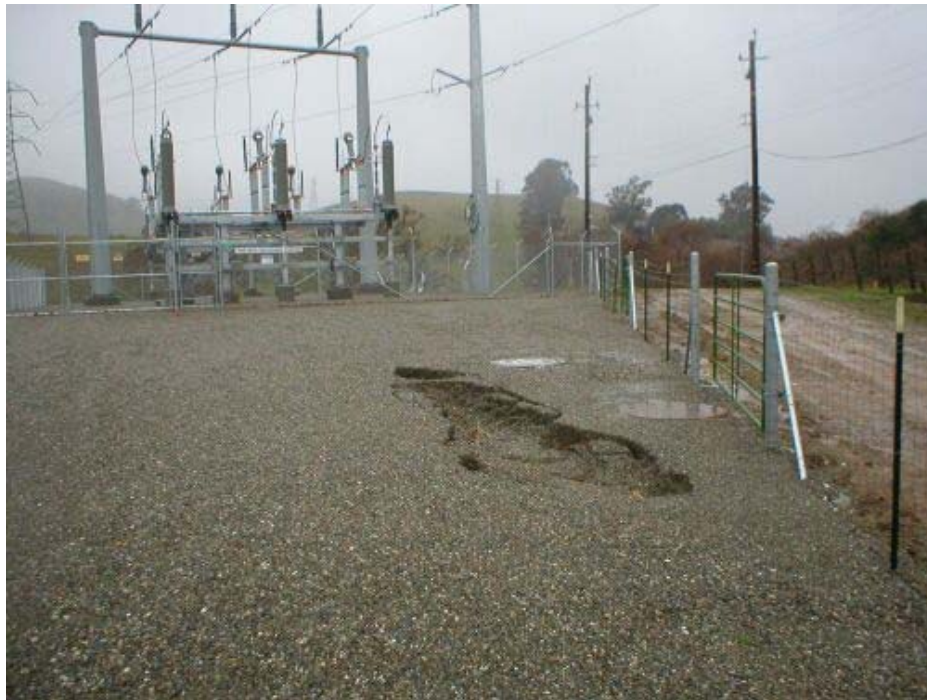
At the Transition Station, the seed, which was planted in the late spring of this year, has grown in some areas, but shows little growth in others. One area of particular concern lies on a high slope area approaching the station pad. This area is upslope of a sensitive creek area and signs of some erosion are already evident. After inspections, PG&E reported that the area should be seeded in order to protect the station pad from further erosion. Seeding has not yet occurred; however, PG&E has designated a contractor for the work and seeding should commence shortly. During a tour on January 1, the CPUC EM viewed a sinkhole, which had formed near the Vault 1 location within the Transition Station Pad (see Figure 1). Messages were left for the PG&E Project Manager and planner on January 2, reporting the sinkhole at the station. PG&E responded that they had toured the site after the notification and discovered other slumping and compaction issues throughout the Phase One alignment. PG&E called Mueller Pipeliners (the original contractor) back to the site to restore the areas. During a tour on January 6, the EM noted that the sink hole at the station had expanded slightly and that caution tape had been strung around the vaults and hole. Construction fencing had also been placed around the Vault 3, 4, and 15 locations, and the EM observed that sinkage had occurred around these vaults as well (see Figure 2). During the tour on January 22, the EM observed that the land sinkage problems at the vault locations had been filled in and contoured (see Figure 3 and 4).

Figure 1 – Transition Station Sinkhole at the Vault One area, Phase One.

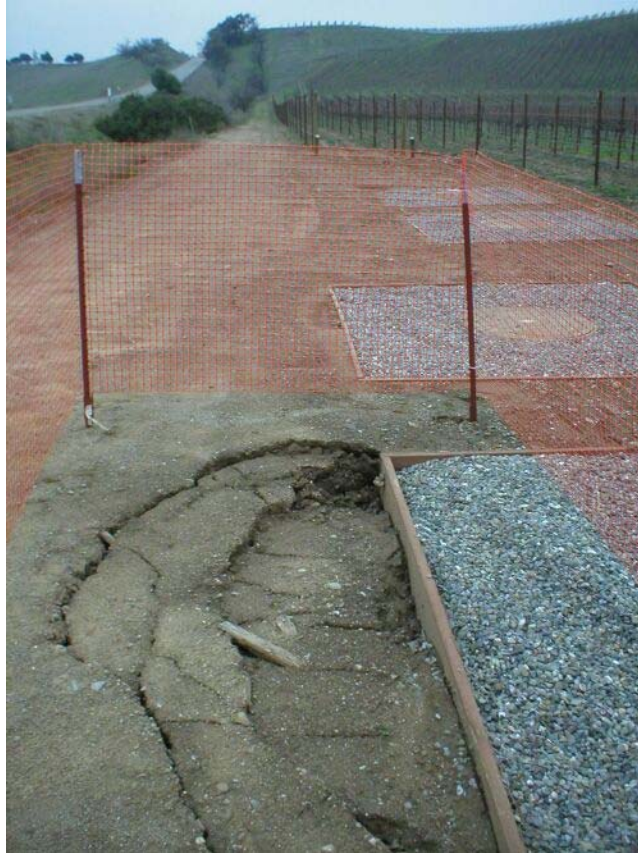
Figure 2 – Slumped soil at the Vault 3 location, Phase One.

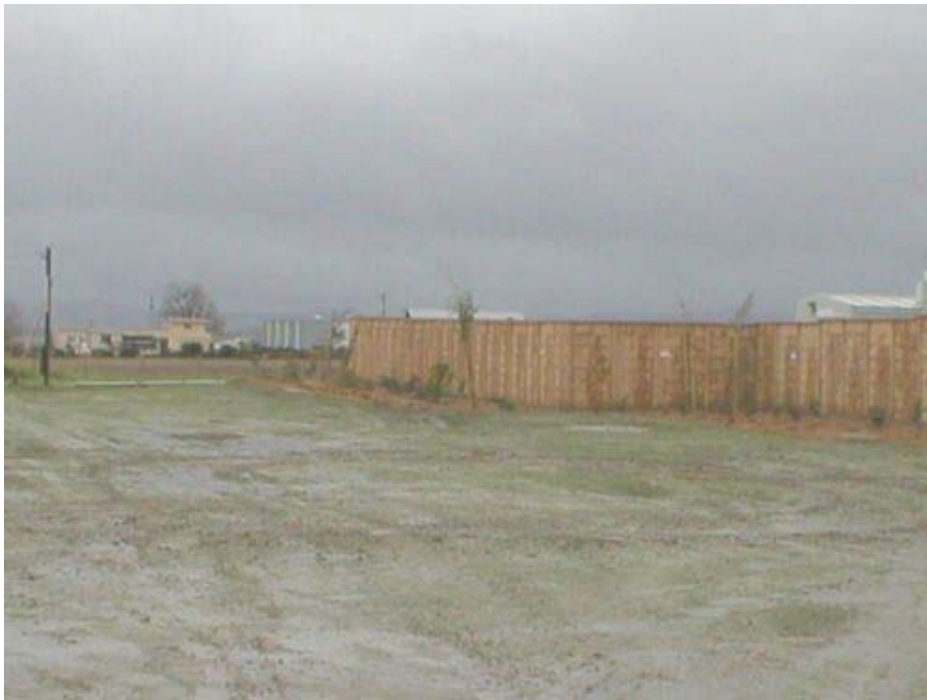
At the Cayetano Substation site, landscaping around the perimeter is complete and crews have hydro-seeded the area surrounding the station. During the tour on January 1, the CPUC EM observed that the area, which had recently been seeded, had been driven on, and circular rutted tire tracks were still apparent. The Essex EI had commented previously that public joy riding had probably occurred (see Figure 5). A number of trees planted as landscaping around the station were slumped over. A storm drain at the station was flooded and did not appear to be draining. During the tour on January 22, the CPUC EM noted that a fence and gate had been installed between the Station driveway and the seeded area. The trees that had been slumped over were adjusted upright, and the drain had cleared of water.

Figure 5 – Cayetano Substation, note vegetation and rutted foreground area, Phase Two.
