PROJECT MEMORANDUM

PG&E – TRI-VALLEY 2002 CAPACITY INCREASE PROJECT

Subject: Weekly Report #50: August 25, 2003 – August 31, 2003

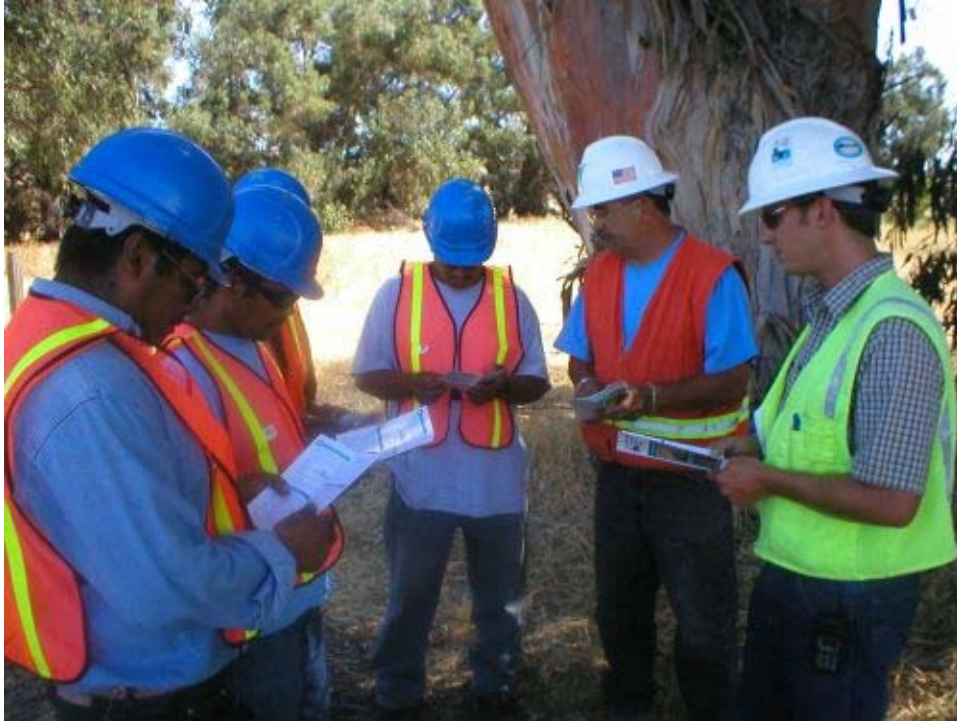
Figure 1 – Essex EI conducting an environmental training of new construction personnel at the Cayetano Substation, Phase Two.

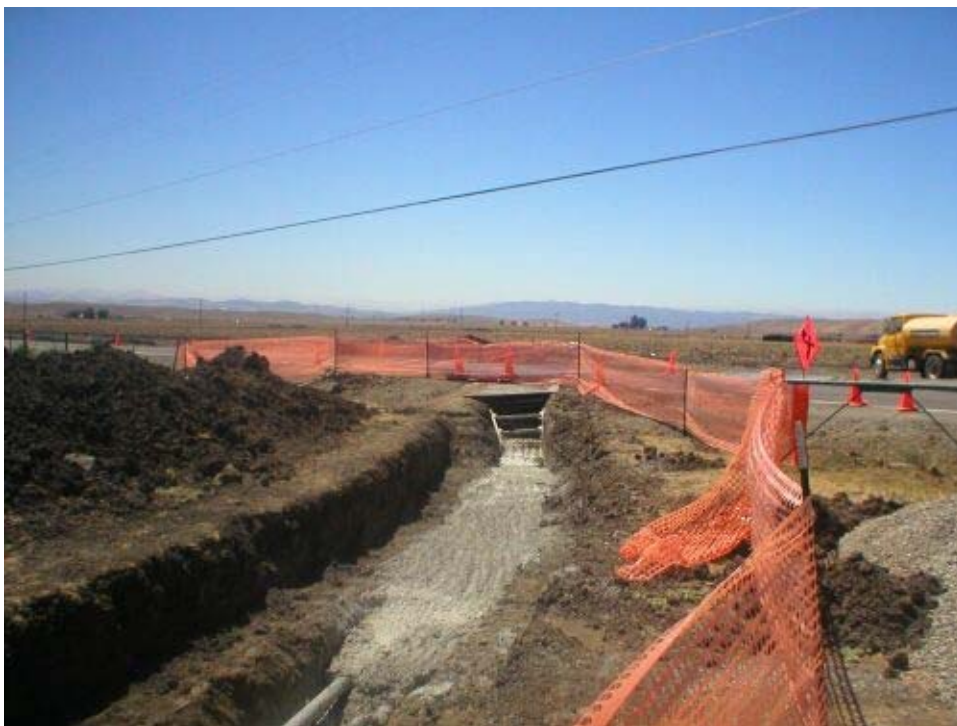
Crews also continued trenching and conduit installation northbound along Dagnino Road and then across Dagnino Road (see Figure 2). On August 27, when the CPUC EM arrived at the Dagnino roadway trench, it was observed that a lane of traffic was closed. Two concrete trucks and a backhoe, as well as a crew working in the trench line were occupying the closed lane. However, no traffic control flaggers were on-site directing traffic. The Dagnino Road is a two-lane road and the view of the open lane of traffic was obstructed (see Figure 3). The EM asked the Inspector why traffic flaggers were not in place. The response was that they went to get some equipment. The Essex EI was immediately notified. Later, the area was again reviewed and proper traffic control was in place; however, after a few moments the flagger had left his post. The project foreman was notified and the flagger supervisor's employment was terminated for safety infractions.

Figure 2 – Trenching and conduit installation leading to and crossing Dagnino Road , Phase Two.

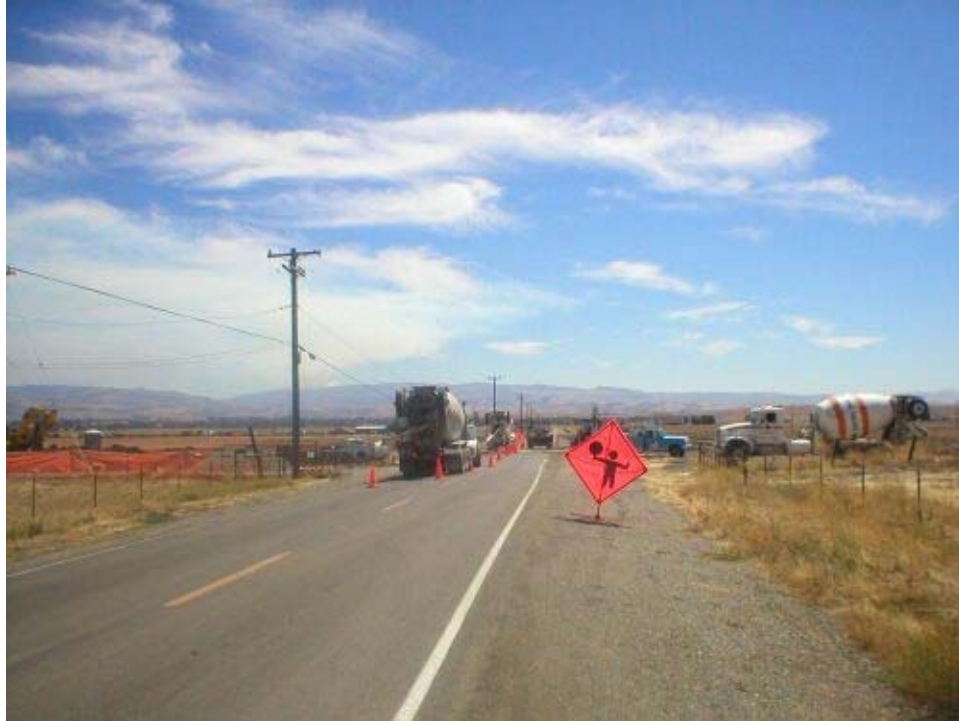
Wednesday, August 27, crews were working in a closed lane along Dagnino road without adequate traffic control. After warnings, the problem persisted and consequently the crew supervisor's employment was terminated for safety infractions.

Figure 3 – Closed lane of traffic due to construction along Dagnino Road, Phase Two.
Note that no flaggers were on-site at the time of the photo.

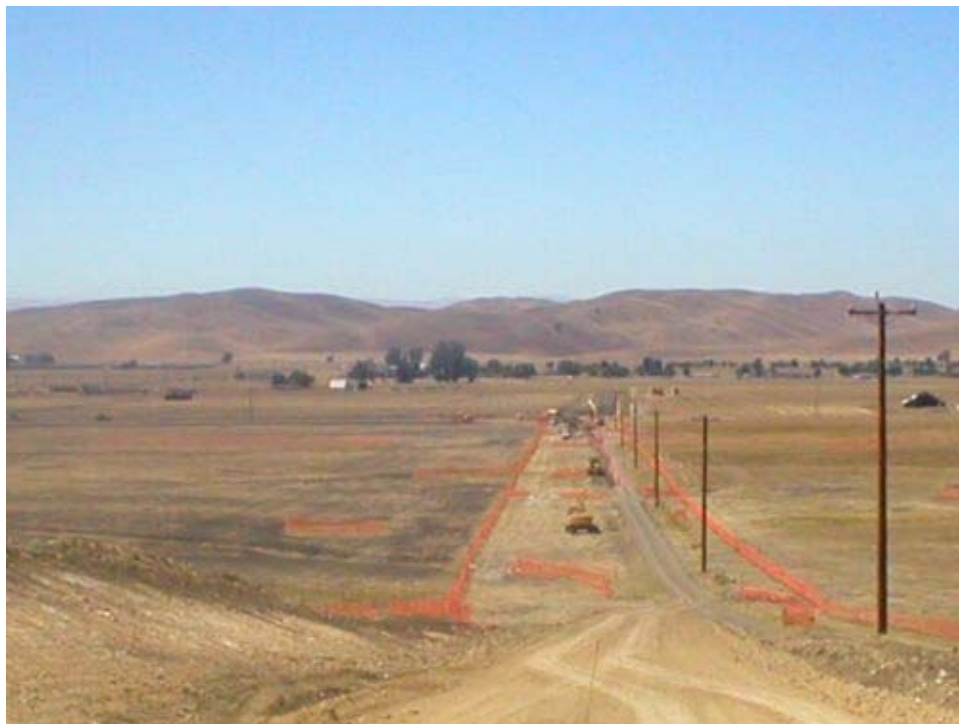
Crews continue trenching east along the access road, which follows the alignment to the Transition Station (see Figure 4), part of which lies within a wetland exclusion buffer and future wetland mitigation site for the Dublin Ranch Development. Based on documentation submitted by PG&E stating that the seasonal wetland east of Dagnino Road did not provide suitable habitat for sensitive species and the subject area will be graded for the creation of the Dublin Ranch Development mitigation site, the required 100-foot buffer was reduced. However, exclusion fencing was installed to prevent any construction activity from entering the mitigation site and subject seasonal wetland area. As an added protection measure, sandbags were also placed around the site. On August 28, a kitten was rescued near active construction along the trench line. The Essex EI took the kitten off-site. Landowners were contacted about the lost cat and the kitten was adopted by a local resident.

Figure 4 – Construction along the access road between Dagnino Road and the
Transition Station, Phase Two.
