PROJECT MEMORANDUM PG&E – TRI-VALLEY 2002 CAPACITY INCREASE PROJECT

To: Roosevelt Grant, CPUC
From: Vida Strong, Aspen Project Manager
Date: November 14, 2002
Subject: Weekly Report #8: November 4, 2002 – November 10, 2002
CPUC Environmental Monitor (EM): Anne Sweet

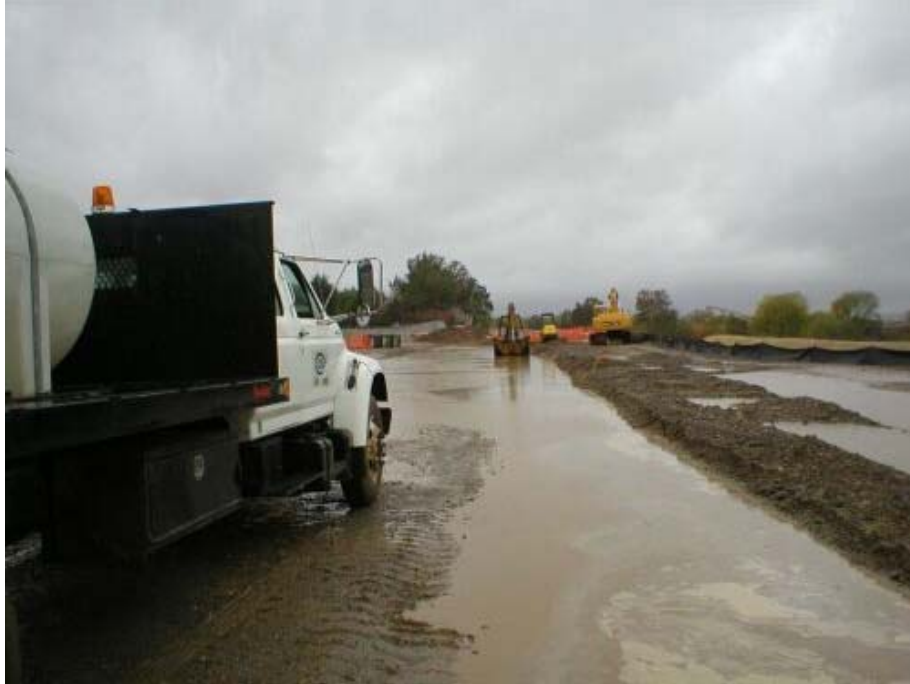
Early in the subject week, the CPUC EM observed trenching and conduit installation along New Vineyard Road west of Station 49+00. On Wednesday, November 6th, crews started trenching under the storm drain located between Stations 50+50 to 51+00. On Friday, November 8th, the CPUC EM toured the trench and conduit installation along this area and discovered that the road was flooded (see Figure 1). The CPUC EM met with the City of Pleasanton Public Works Inspector, Jim Gotcher, who was on-site investigating the flooded area. Mr. Gotcher believes that the storm drain was impacted by the PG&E work, thus contributing to the flooding. Crews were on site working to correct the problem. On Saturday, November 9th, the CPUC EM toured the previously flooded area along New Vineyard Road where the water had since dissipated.

Figure 1
New Vineyard Road Flooding on November 8th.

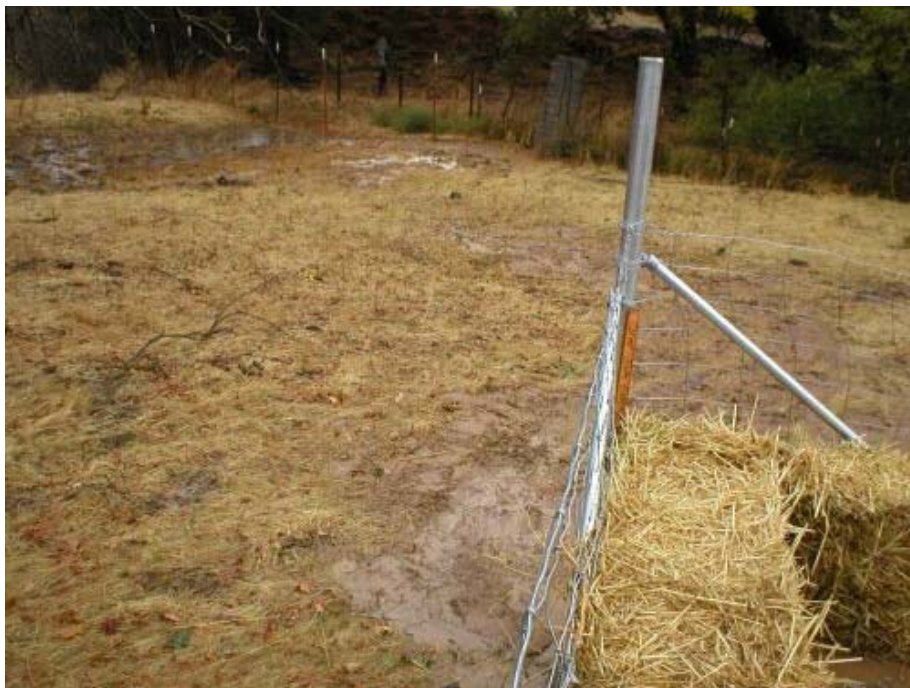
November 5th, a visquene tarp weighted with sandbags had been placed over the lower spoils pile. Silt fence had also been installed around the down slope of this pile. On Friday, November 8th, subsequent to the heavy rainfall, the CPUC EM observed that most of the construction fencing placed along the trench has been blown down by the storm event. The visquene tarp weighted with sandbags that had been placed over the lower large spoils pile had also blown off to a large extent. Underground channels were created from the rainfall at the base of the silt fence installed around the Transition Station site (see Figures 2 and 3). A steady trickle of sediment-laden water was carried from the Transmission Site to the nearby creek down slope. Crews were called in to place hay bales over the area to stop the flow. Access to the Transmission Station site has been via vineyard dirt roadways, including the road along which the trench line occurs. However, due to the rainfall, these roads became extremely muddy and a contractor truck got caught in the mud. A backhoe was brought to the site. Access to the Transmission Station site was very difficult. An extension of the Zone 7 Access Road runs parallel to this area; however, it is gated and locked. The contractor has access to the road, but did not have a key to the locked gate. The restricted access made repairs to the erosion control at the Transmission Station site difficult. On Friday, November 8th, the CPUC EM received verbal confirmation from the Essex EI that the necessary repairs to erosion control measures had been made. On Saturday, November 9th, the CPUC EM toured the Transition Station site with the Essex EI. The visquene tarp weighted with sandbags, which had been placed over the lower large spoils pile, had been repaired. Hay bales had also been placed to block underground flow from channels along the silt fence surrounding the Transmission Station site (see Figure 4). The site appeared secure.

Figure 2
Erosion control breach at the Transition Station site.

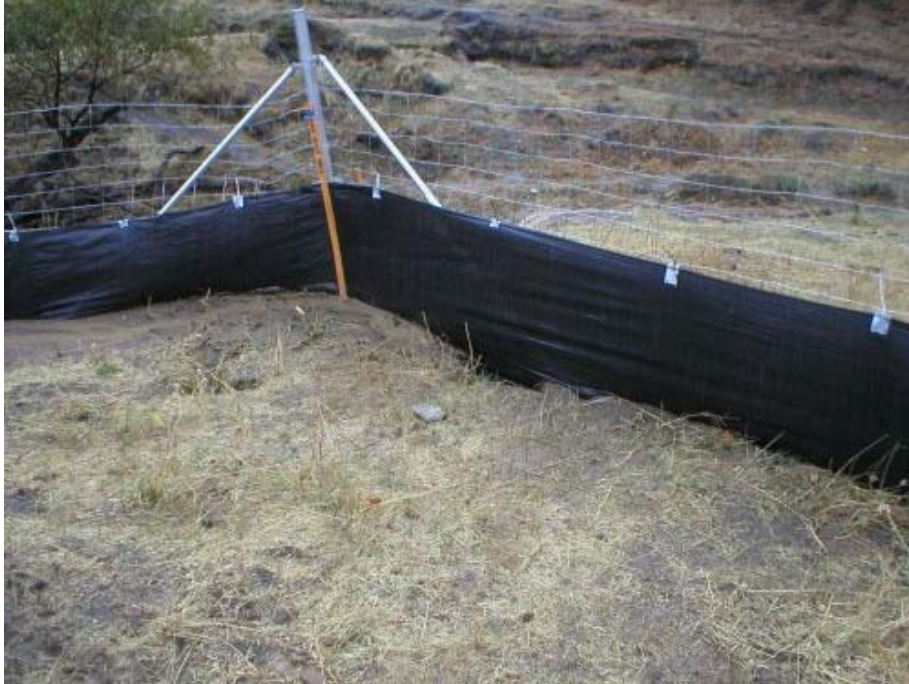
Figure 3
Erosion control breach at the Transition Station site,
where channels were created underneath the installed silt fence.

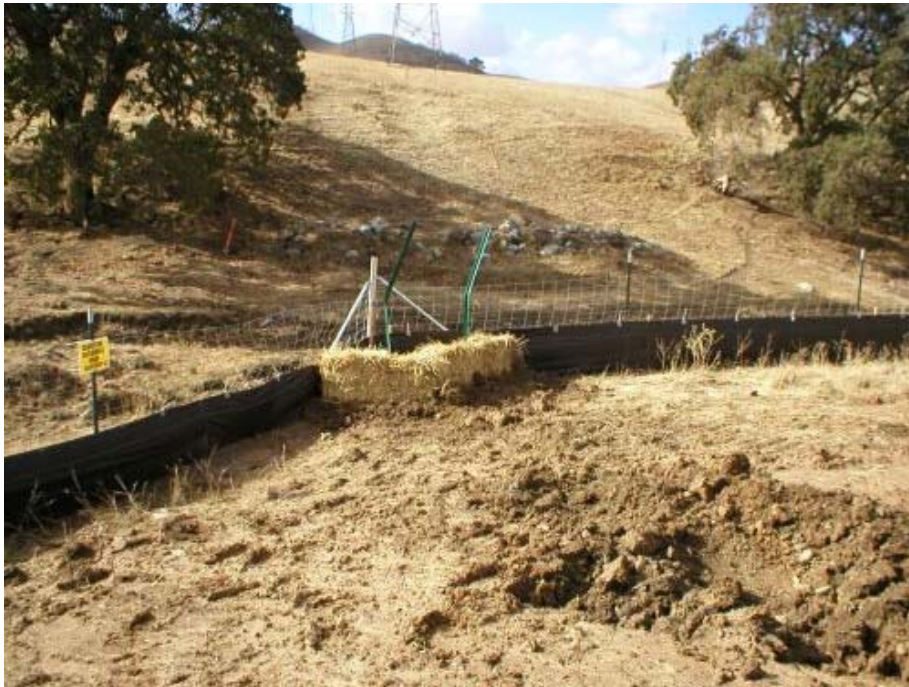
Figure 4
Added erosion control device installation at the Transition Station site.
