SCE VALLEY SOUTH SUBTRANSMISSION PROJECT

Date: March 5, 2020

Subject: Monitoring Report #22: February 16 to February 29, 2020

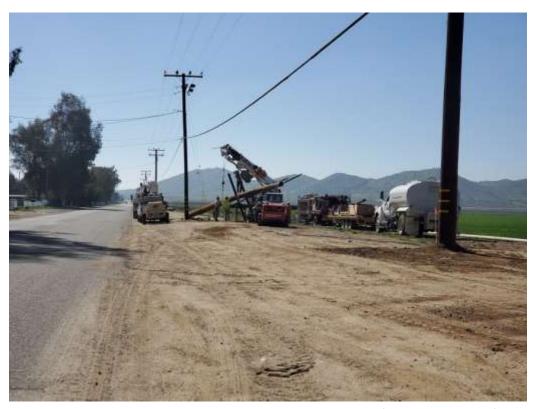
Photo 1 – Setting wood pole at Construction Area UNK23 (February 19, 2020).

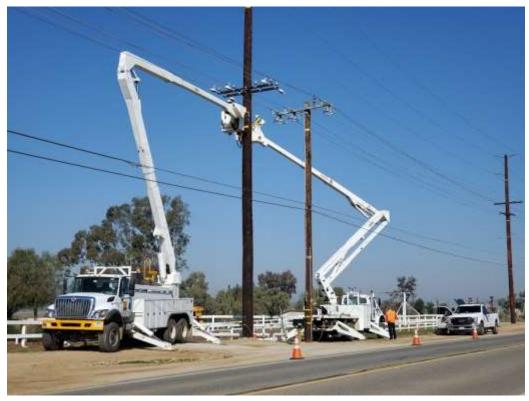
Photo 2 – Distribution activities at Construction Area UNK159 (February 19, 2020).

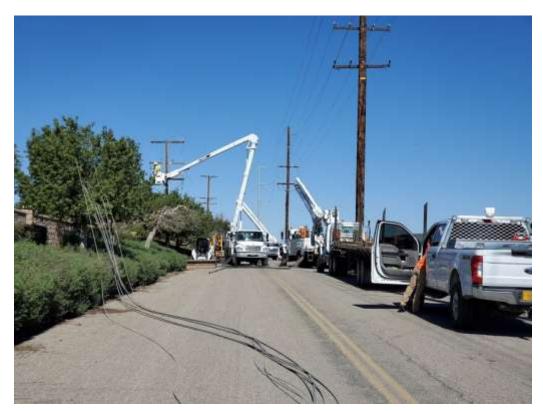
Photo 3 – Distribution cutover construction activities at UNK224 (February 25, 2020).

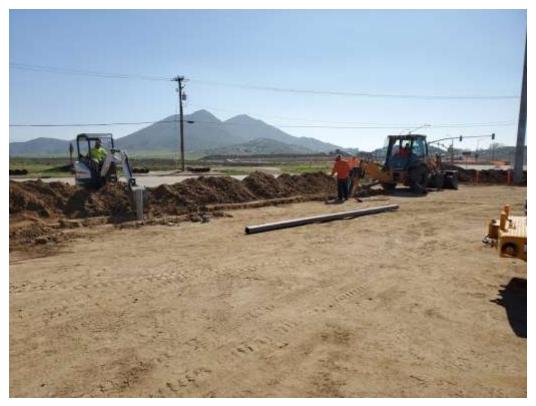
- 3. On February 19, the CPUC EM observed distribution riser trenching outside of approved project disturbance limits between Construction Areas UNK44 and UNK45 (see Photo 4). Wilson's Environmental Manager was notified of the observation. The CPUC EM issued a Level 1 incident for construction activities outside of the approved project disturbance limits. SCE responded on February 26 that the project management team will ensure a thorough review of any engineering changes to determine if work can occur or if additional areas need to be requested and thorough review of types of approved construction activities for work areas, roads, and overland travel access roads will be conducted with the crews and field monitors. Minor Project Change #7 was submitted on February 27 to address the subject work area (see Table 2 below).

Photo 4 – Trenching outside approved project disturbance area limits between Construction Areas UNK44 and UNK45 (February 19, 2020).
