SCE VALLEY SOUTH SUBTRANSMISSION PROJECT

To: Eric Chiang, Project Manager, CPUC **From:** Vida Strong, Aspen Project Manager

Subject: Monitoring Report #29: May 24 to June 6, 2020

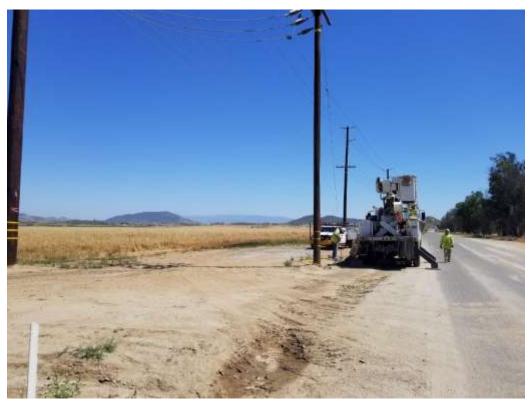
- 4. Wilson Construction activities on Segment 1 included: Wire wreck-out at poles 4726844E through 4726839E, 4703349E, and 4718490E through UNK54; anchor replacement at Construction Areas UNK95 and UNK98 (see Photo 1); span guy wire relocation at Construction Area UNK155; bird guard installation at poles 4532622E and 4230212E; distribution cutover reconductoring at Construction Areas UNK54 through UNK56; wreck-out distribution wire and energize poles at Construction Areas UNK34 through UNK45 and UNK47 through UNK98 (see Photo 2); punch list items at Construction Areas UNK125, UNK45 through 4606546E, 4601313E, 4936626E, 4937061E, and 4936626E; clean-up and demobilize equipment from Construction Areas UNK44 and UNK45; and energize capacitor banks at Construction Areas UNK65, UNK66, UNK156, and UNK233 (see Photo 3).

Photo 1 – Anchor replacement at Construction Area UNK98 (May 27, 2020) (Photo courtesy of SCE).

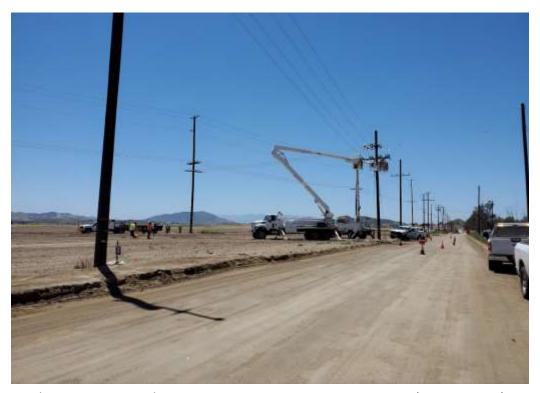
Photo 2 – Wire wreck-out activities at Construction Area UNK93 (May 26, 2020).

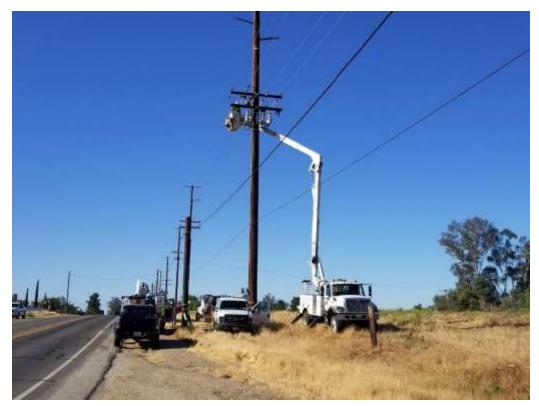
Photo 3 – Capacitor bank energization activities at Construction Area UNK156 (May 27, 2020) (Photo courtesy of SCE).
