PROJECT MEMORANDUM SCE – VIEJO SYSTEM PROJECT

To: Jensen Uchida, CPUC
From: Vida Strong, Aspen Project Manager
Date: April 27th, 2006
Subject: Project Status Report
CPUC Environmental Monitor (EM): Jenny Slaughter

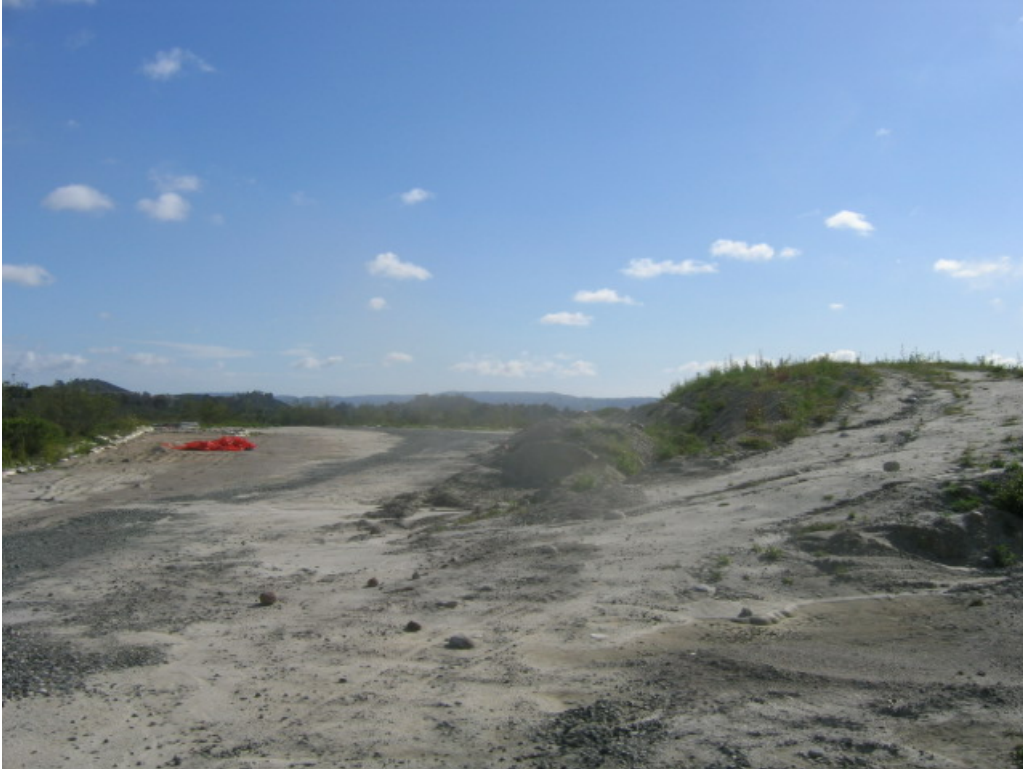
The large spoil pile in the laydown yard adjacent to the Viejo Substation is still in place and needs to be removed in order to restore the area to pre-construction conditions (see Figure 1). The access road from the back of the Viejo Substation to the transmission line corridor crosses a small drainage. A concrete wet-crossing has been installed to provide all-weather access without causing an increase in turbidity (see Figure 2).

Photo 1: Spoil pile in laydown area behind the Viejo Substation that needs to be removed (mound in center of frame).

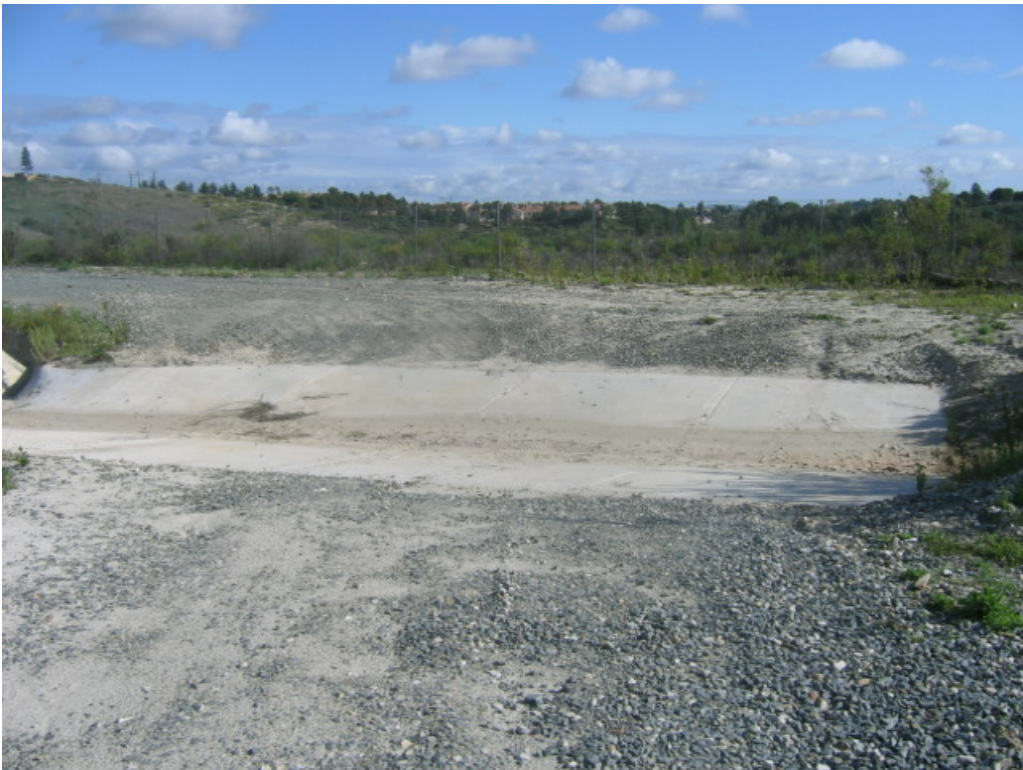
Photo 2: Wet-crossing on access road behind Viejo Substation.

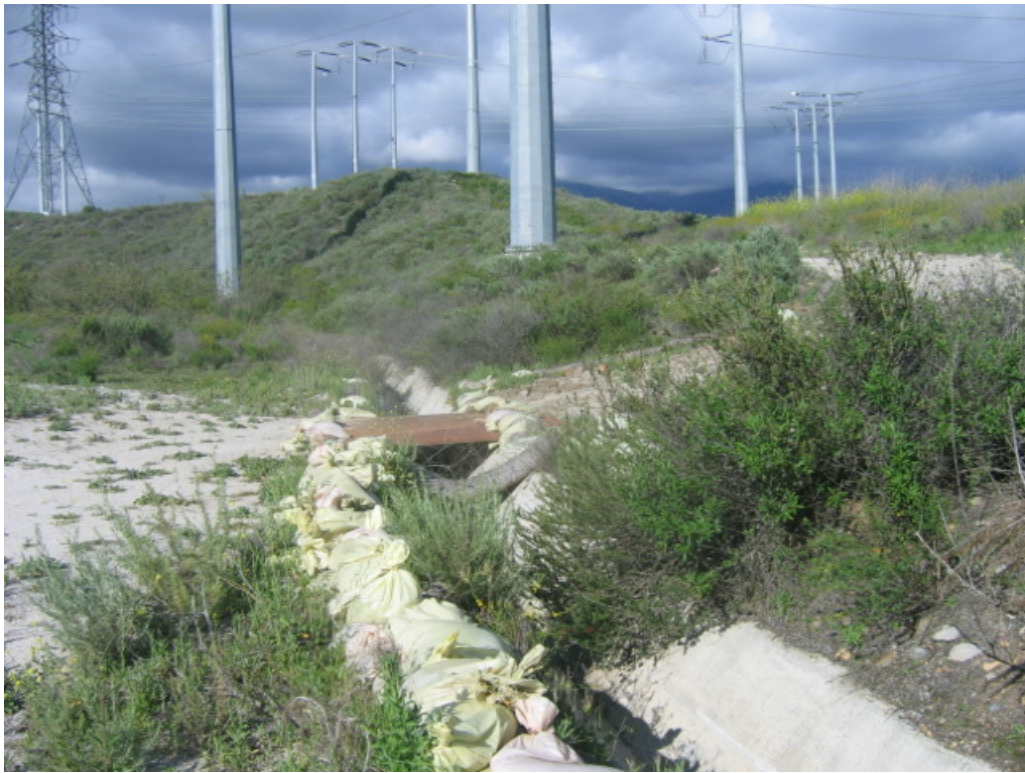
Areas of the overhead corridor near the Viejo Substation have been previously restored and v-ditches were installed for drainage (see Figure 3). Many of the erosion control measures have been left in place until the soils in the area can stabilize. A project access road near Olympiad Park has also been restored to original condition; however, some sandbags remain in the area for erosion control (see Figure 4).

Photo 3: Area behind the Viejo Substation where a v-ditch was installed for drainage.

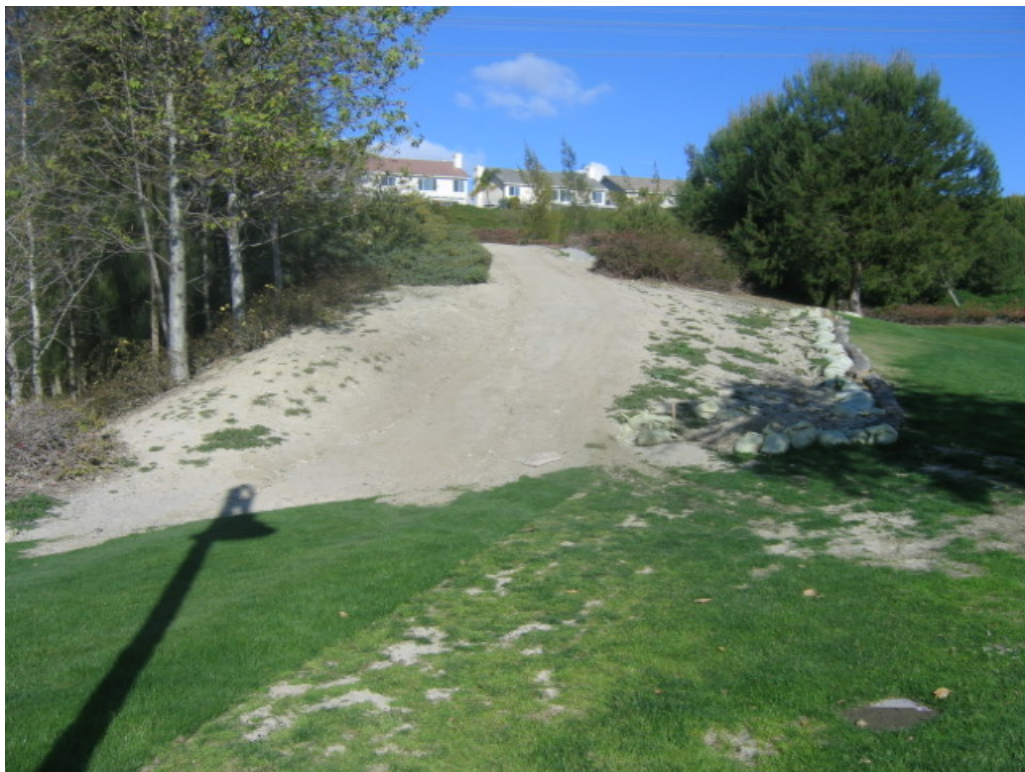
Photo 4: Restoration of a pre-existing access road near Olympiad Park.

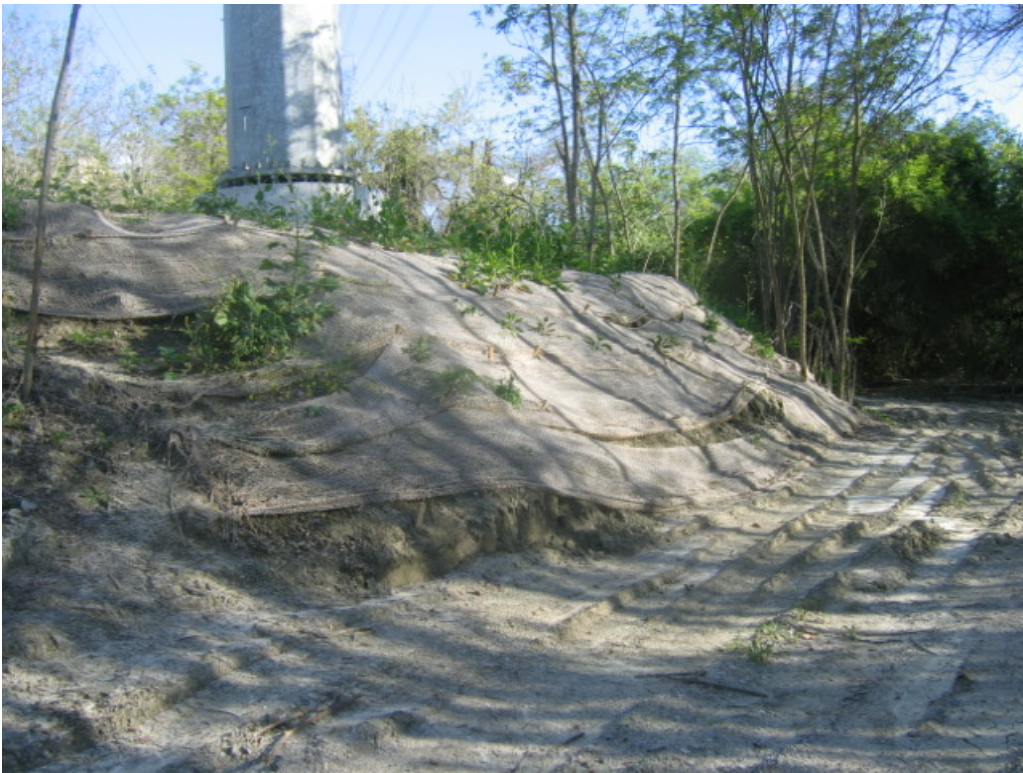
Near the Chiquita Substation, jute netting was used to help stabilize a slope leading to a tower pad (see Figure 5). Some non-native vegetation has started growing on the slope and the success of stabilization will be evaluated at a later date.

Photo 5: Restored area near Chiquita Substation. Jute netting was used to stabilize the slope leading to the tower pad.
