PROJECT MEMORANDUM SCE – VIEJO SYSTEM PROJECT

To: Jensen Uchida, CPUC
From: Vida Strong, Aspen Project Manager
Date: November 2, 2004
Subject: Weekly Report #13: October 24, 2004 – October 30, 2004
CPUC Environmental Monitor (EM): Christopher Meyer

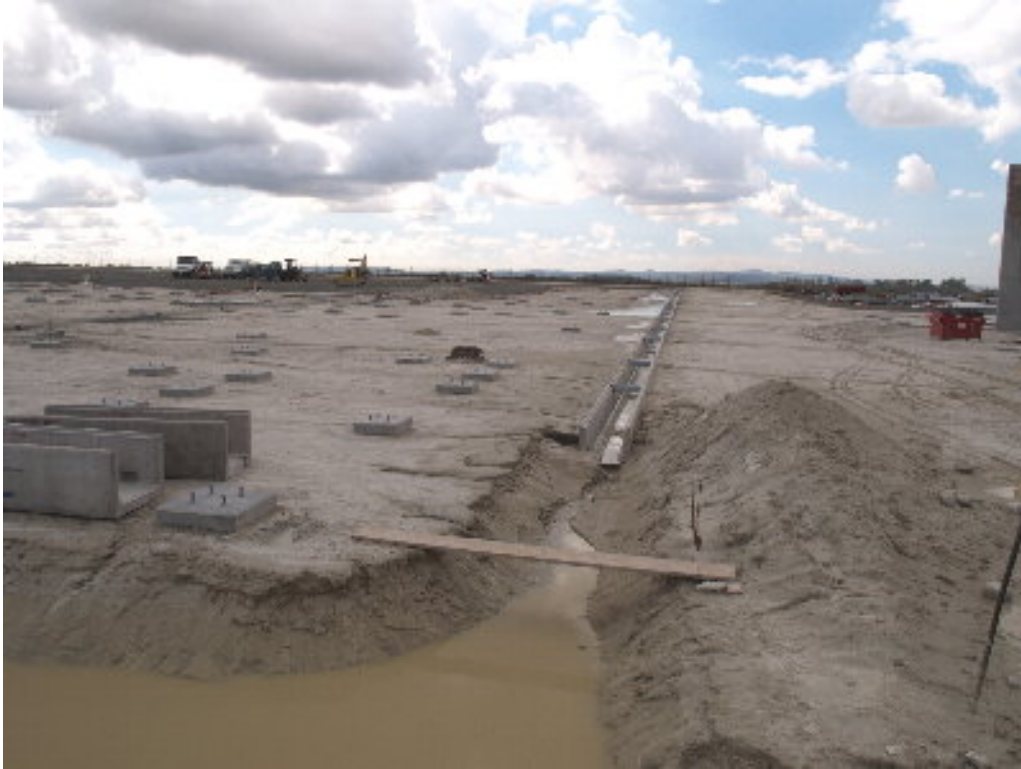
No concrete pours were scheduled during the projected rains. Several foundations will need cleaning or re-excavation before concrete can be poured. The crews successfully placed the pre-formed concrete trenches despite the rains (see Figure 1). It was necessary for the crews to pump storm water from several of the trenches due to very slow natural drainage through the hard material.

Figure 1 – The pre-formed concrete trenches were set during the week despite the rain. Note the final two pre-form pieces sitting above the trench to the left.

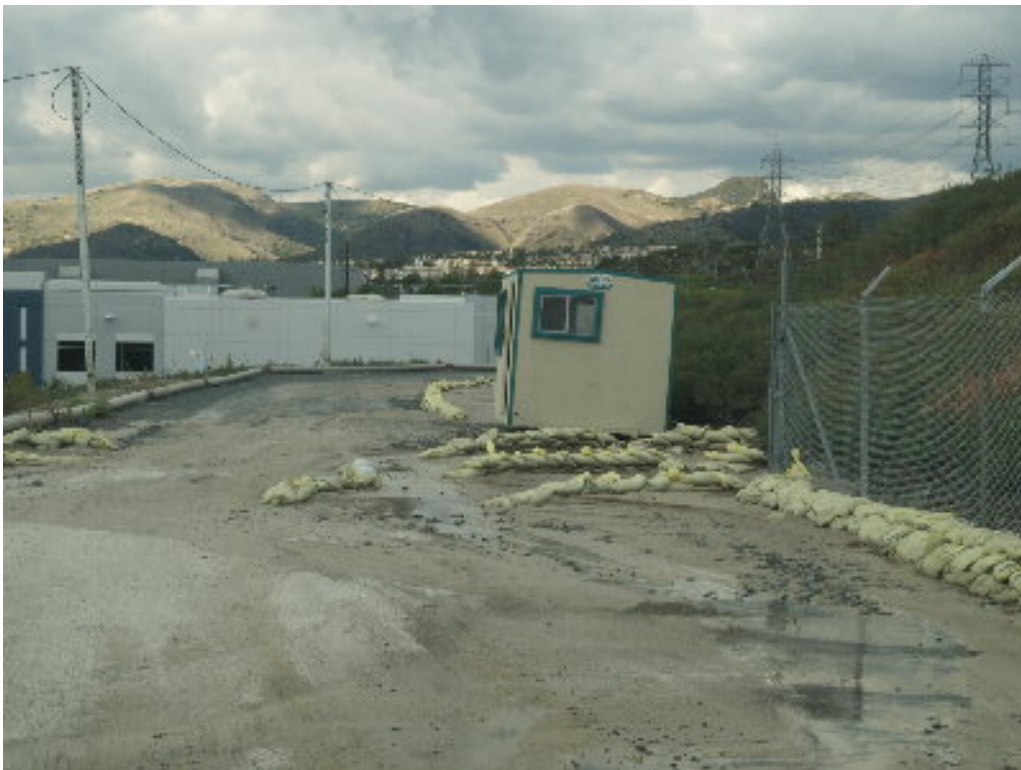
The Best Management Practices (BMPs) installed on the substation site appeared to be functioning properly in most cases. The reliance on straw waddles instead of silt fencing for sediment control will require additional maintenance and was overwhelmed by some flows during the heavy rainfall. Several additional rows of sandbags were placed on the north end of the project near the guard shack to control the excessive run-off and sediment (see Figure 2). No off-site impacts were noted during the site visit.

Figure 2 – Additional rows of sandbags were placed near the guard shack to control the large amount of water run-off and sediment. The rear of the guard shack settled in the saturated soil.

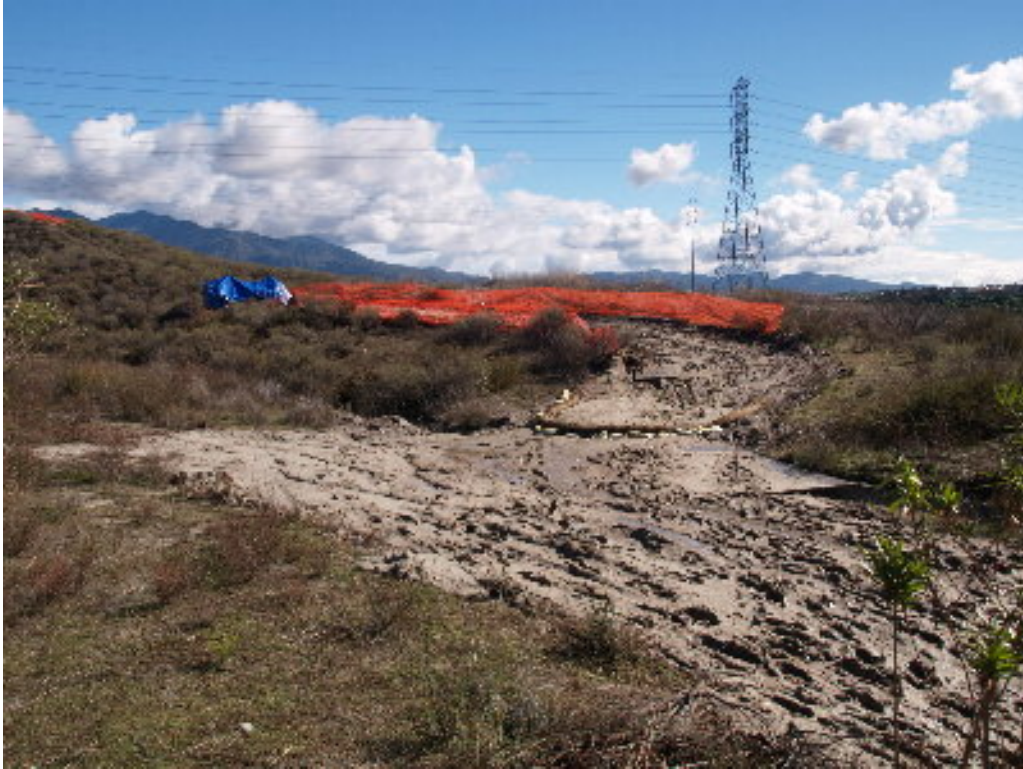
Some of the BMPs installed on the 220 kV right-of-way appeared to have been effective during the recent storms; however, the heavy rains and resultant sediment overwhelmed the straw wattles in several places. Straw wattles have been installed on the tower pad sites and the access roads. The spoil pile for the drilling operation was partially covered with jute netting and surrounded with straw wattles to minimize sediment transport. Steel plates have been installed over the drainage ditch on the access road from the substation site to allow vehicle passage without impacts to the water. Sediment has migrated down from the tower site immediately uphill from the crossing and needs to be removed from the concrete-lined drainage ditch (see Figure 3). The access road across the natural drainage is holding water due to the grade of the road (see Figure 4). Erosion of the road continues despite the sandbags and straw wattles that have been placed. Much of the water from the access road to the upper pads flowed to this lower access road and increased the erosion, despite efforts to direct the run-off west into the concrete v-ditch.

Figure 3 – Sediment flowing down from a pad on the transmission line right-of-way toward the concrete drainage ditch.

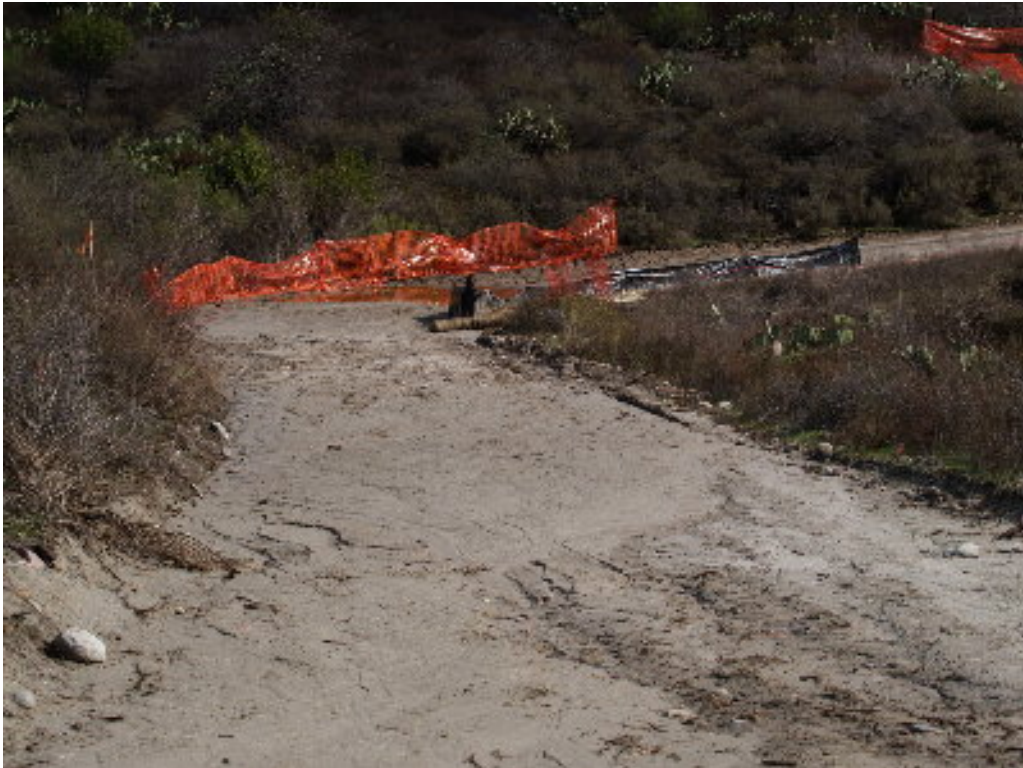
Figure 4 – Water from the natural drainage and from along the access road has settled in the low area at the crossing.
