PROJECT MEMORANDUM SCE – VIEJO SYSTEM PROJECT

To: Jensen Uchida, CPUC
From: Vida Strong, Aspen Project Manager
Date: November 17, 2004
Subject: Weekly Report #15: November 7, 2004 – November 13, 2004
CPUC Environmental Monitor (EM): Christopher Meyer

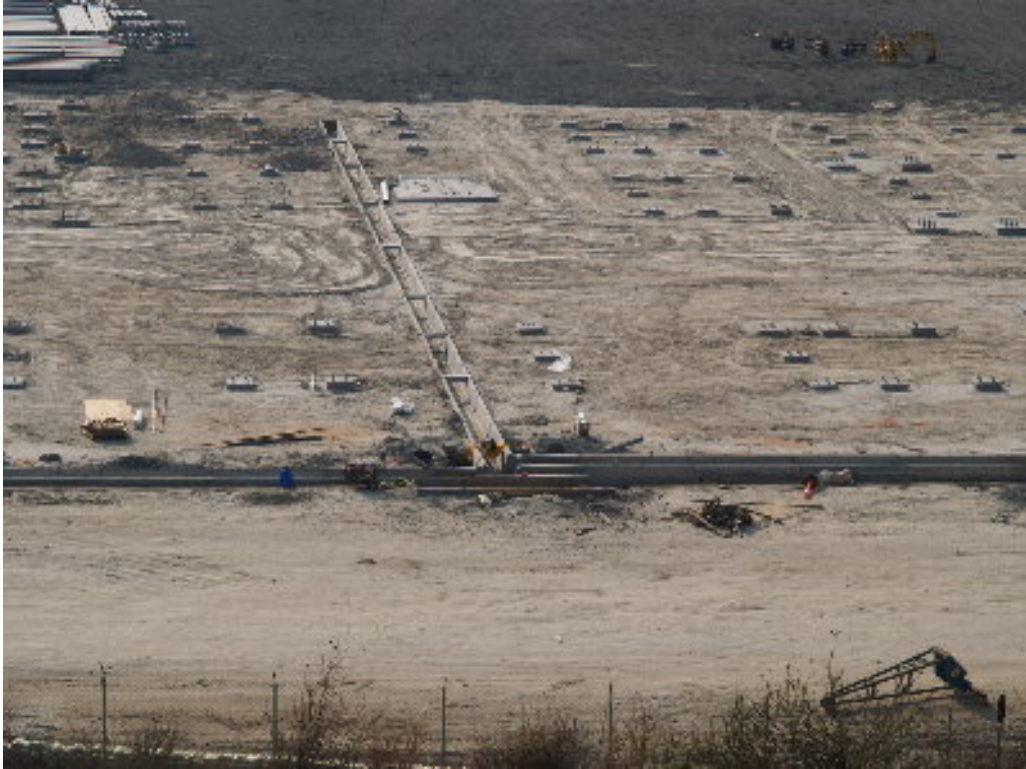
Several crews continued the work on preparation of the pre-cast concrete electrical trenches (see Figure 1). Metal cross braces have been installed over the trench in some locations to support the grating that will be in place during operation (see Figure 2).

Figure 1 – Crews continued working on the preparation of the pre-cast concrete electrical trenches on the substation site.

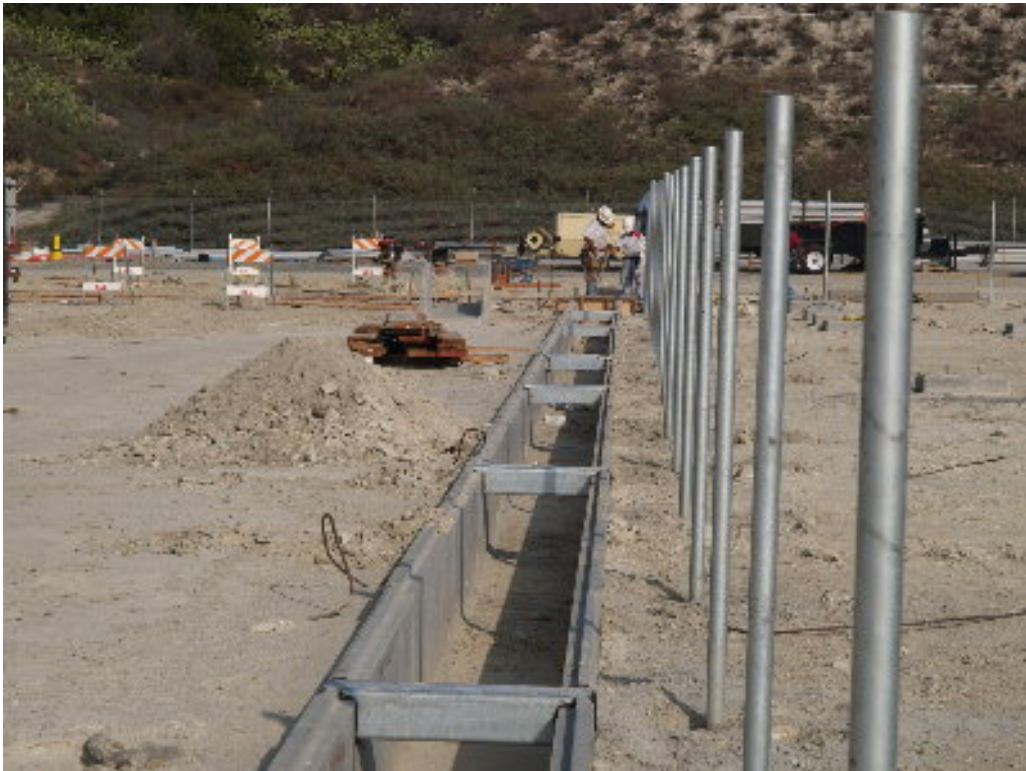
Figure 2 – Metal braces for the grate system were set on some of the pre-cast concrete electrical trenches on the substation site.

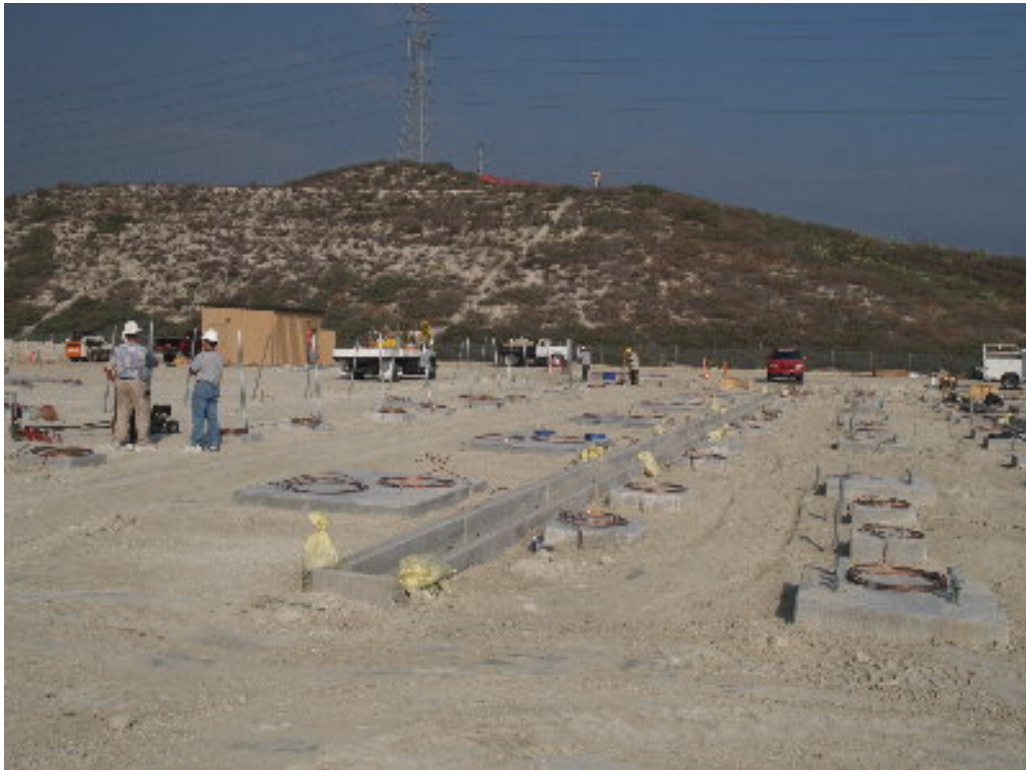
One crew worked on connecting the foundation structures to the grounding grid for the substation site (see Figure 3). This system insures that all buildings and overhead structures such as supports and light poles within the substation site are properly grounded.

Figure 3 – A crew worked on attaching foundations to the grounding grid.

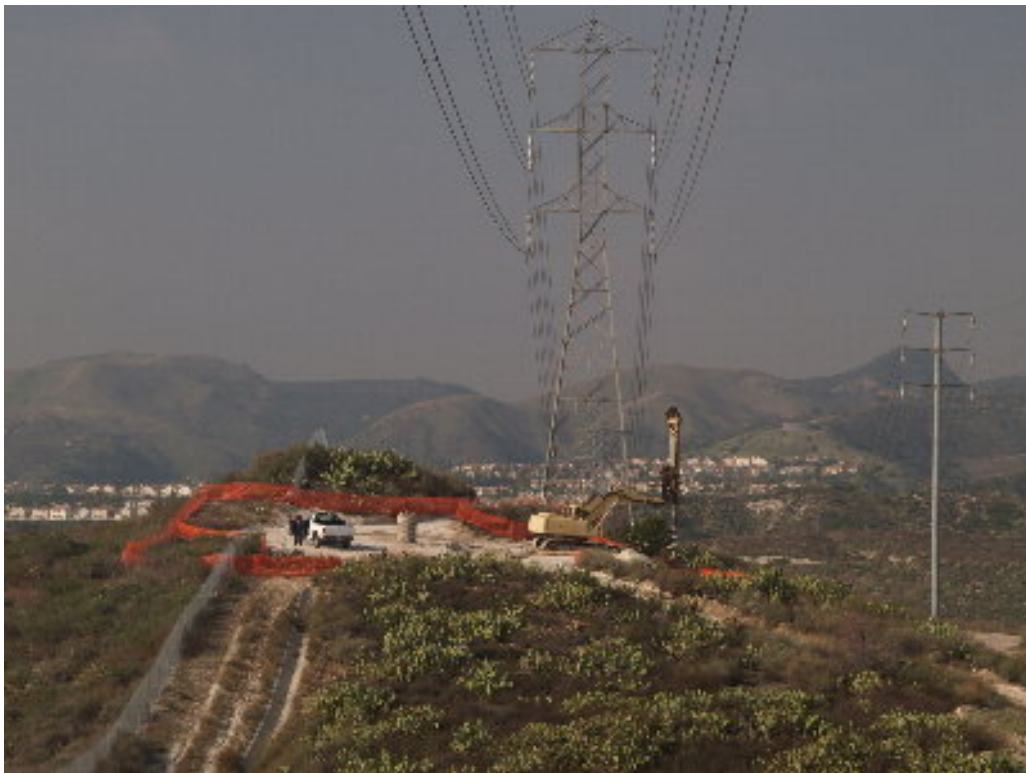
The drilling crew worked on the final foundations along the 220 kV transmission line corridor, above the substation site during the subject week (see Figure 4). The crew loaded up several of the drill bits that are no longer needed for removal from the project site.

Figure 4 – The drilling crew worked on the last foundations for the tower east of the substation site on the 220 kV transmission line corridor.

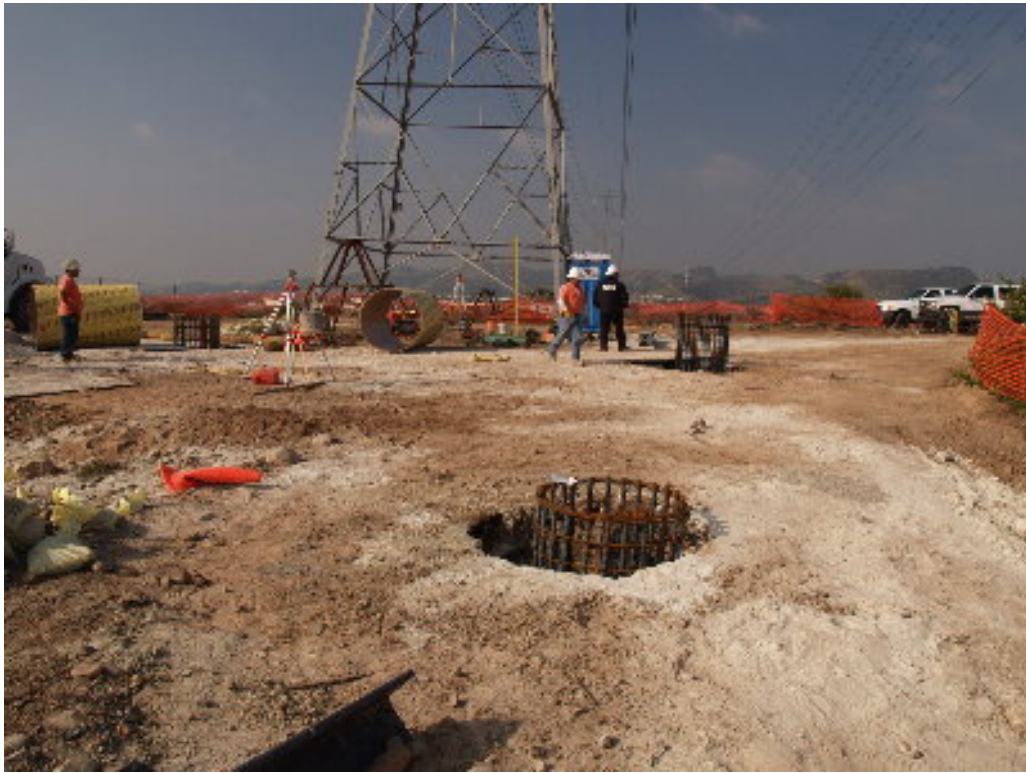
A crew worked with a backhoe and small crane to set the rebar cages into the foundation excavations that have been completed by the drilling operation (see Figure 5). All four cages were set for the lattice tower foundation and the angle-iron anchors are on-site for the concrete pour. The lattice tower foundations on the lower site that were drilled last week have been poured (see Figure 6).

Figure 5 – A crew set rebar cages in the lattice tower foundation excavations on the hill southeast of the substation site.

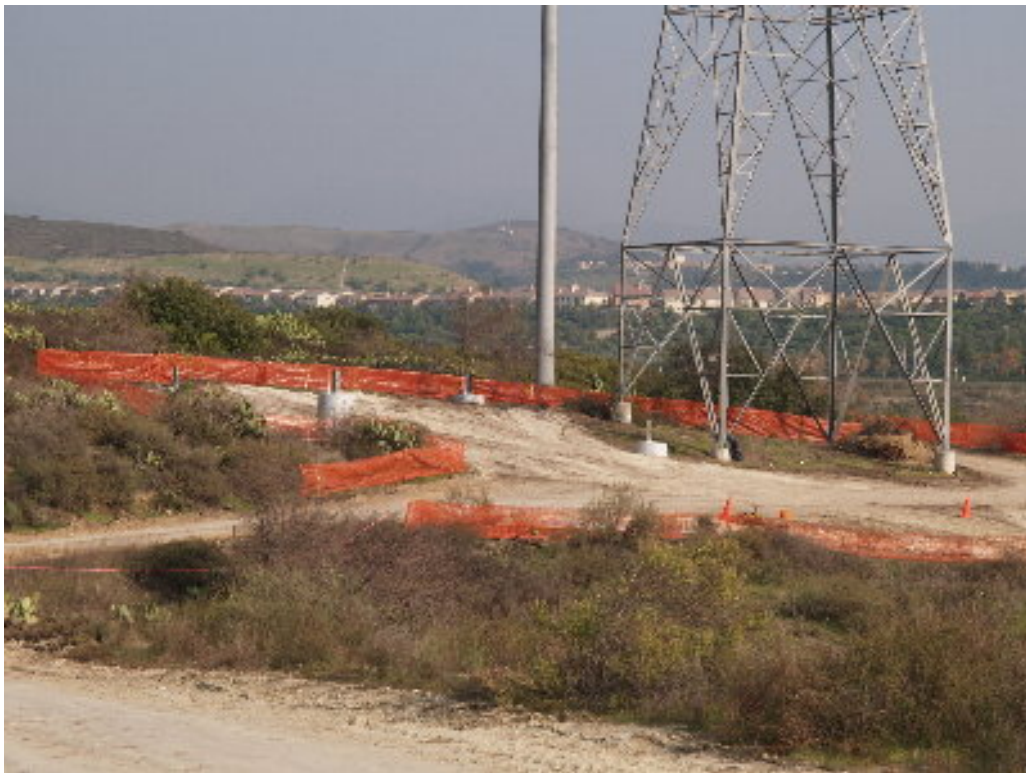
Figure 6 – The foundation for the lattice tower at the base of the hill southeast of the substation site has been completed. Note the size compared to the existing lattice tower.
