PROJECT MEMORANDUM SCE – VIEJO SYSTEM PROJECT

To: Jensen Uchida, CPUC
From: Vida Strong, Aspen Project Manager
Date: December 22, 2004
Subject: Weekly Report #20: December 12, 2004 – December 18, 2004
CPUC Environmental Monitor (EM): Christopher Meyer

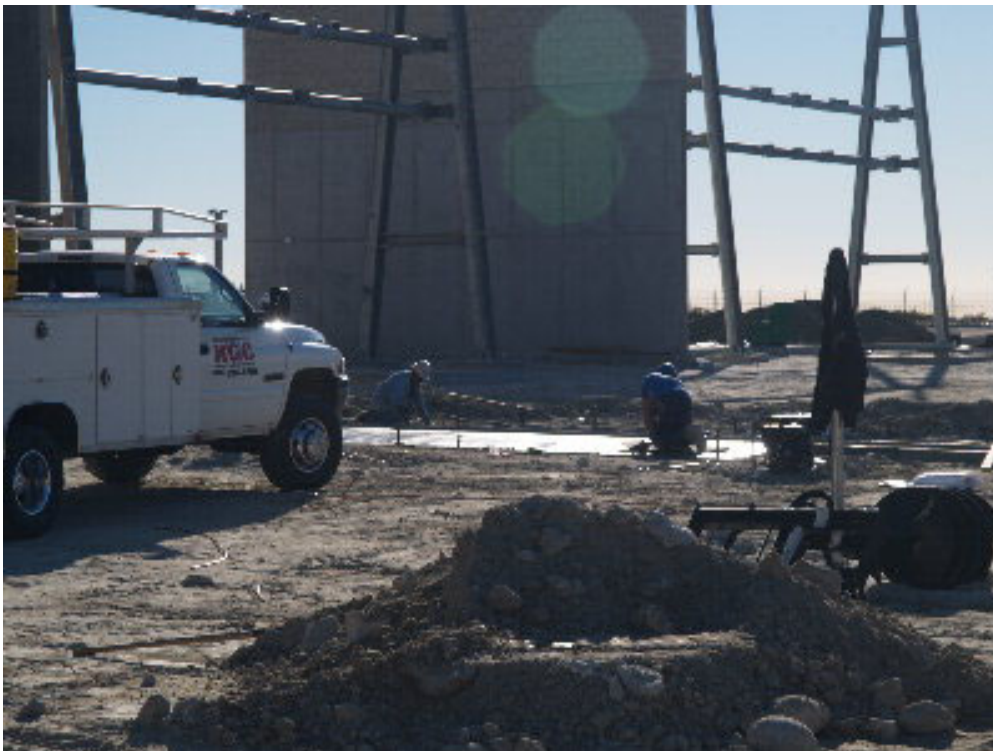
Crews on the northern portion of the substation site worked to prepare support structures prior to raising (see Figure 1). The concrete work on the south side of the Mechanical Electrical Engineering Room (MEER) #1 has been completed and the crew started work on the ramps on the north side. A crew was finishing the surface of a concrete walkway on the north side of MEER #1 (see Figure 2).

Figure 2 – A crew worked on finishing the concrete slab outside the northern wall of MEER #1.

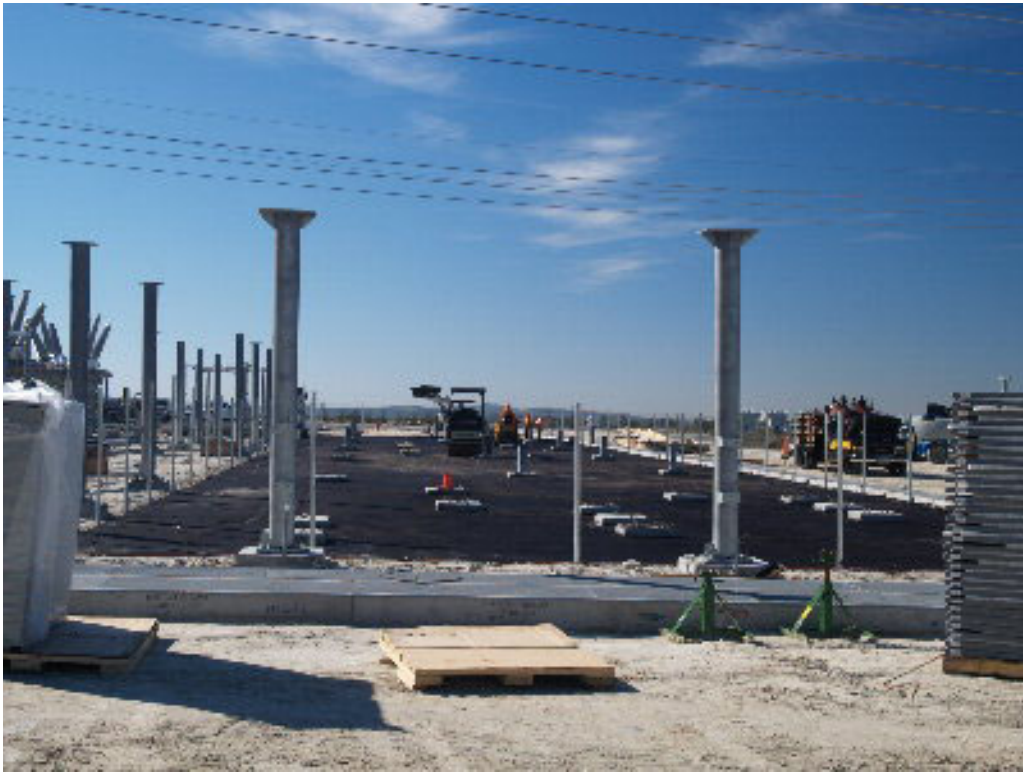
A crew started laying asphalt on a section of the substation south of MEER #1 (see Figure 3). Other crews prepared for the delivery of the A transformers on December 20. Sandbags on sections of the access road were removed to provide room for the larger truck trailer used to move the transformers into the substation site. The larger trailer has rear-wheel steering to maneuver within the confines of the substation.

Figure 3 – A crew worked to lay asphalt north of MEER #1.

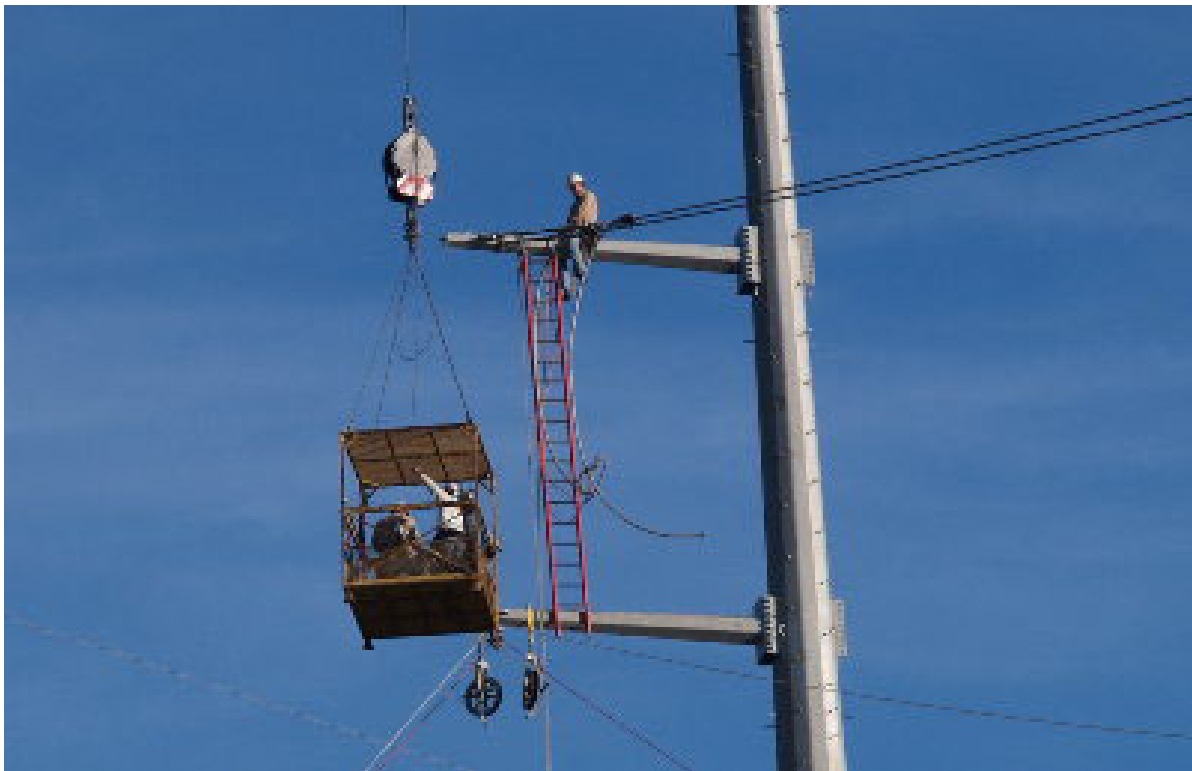
Figure 4 – The Hill Crane held a basket to allow workers to connect cables and insulators to the steel pole arms.

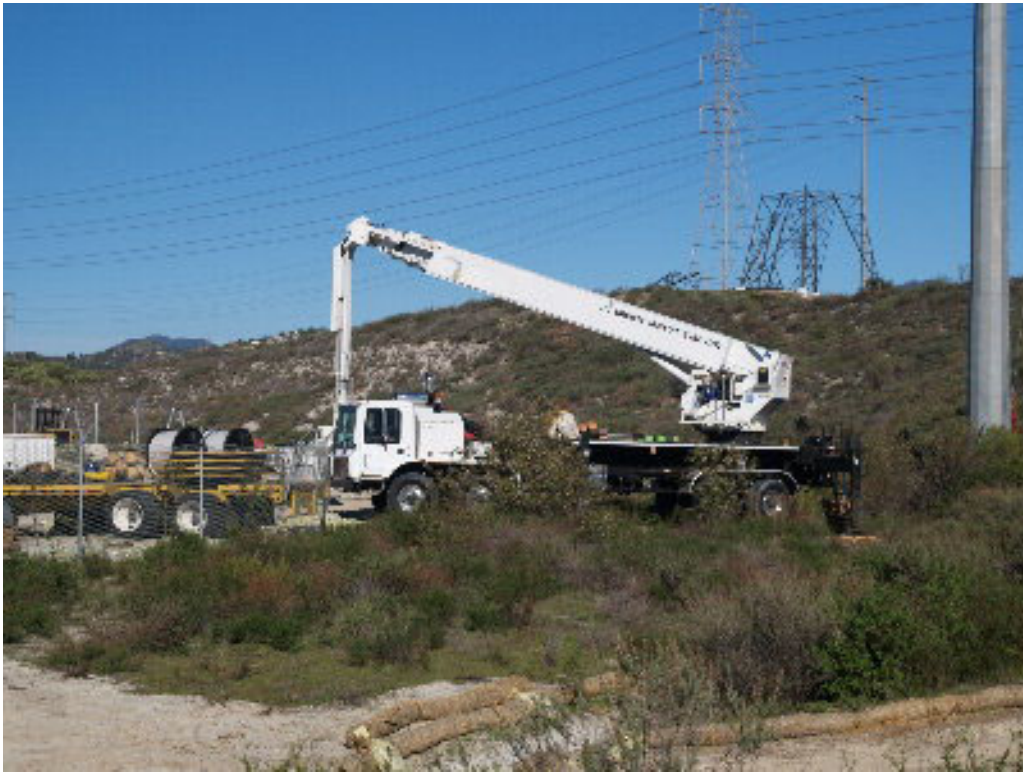
The large mobile Hill Crane remains on-site and finished raising the steel poles and attaching the upper sections on the 220 kV transmission line corridor during the site visit. The crane was set on the pad prepared between the middle and southern lattice towers and was able to reach the steel pole foundations south of the substation site. The crews worked in both a basket held by the Hill Crane and mobile man-lifts to connect the insulators and cables on the steel pole portion of the transmission work (see Figure 4). The Bronto man-lift slid off the supports on the small, sloped pad and was moved inside the fence of the substation site to a level area. The SCE biologist help the crew set up the Bronto in the non-native vegetation (see Figure 5). No clearing or grading was required to set up the man-lift.

Figure 5 – The Bronto man-lift was moved into the non-native vegetation under the supervision of the SCE biologist.
