PROJECT MEMORANDUM SCE – VIEJO SYSTEM PROJECT

To: Jensen Uchida, CPUC
From: Vida Strong, Aspen Project Manager
Date: December 30, 2004
Subject: Weekly Report #21: December 19, 2004 – December 25, 2004
CPUC Environmental Monitor (EM): Christopher Meyer

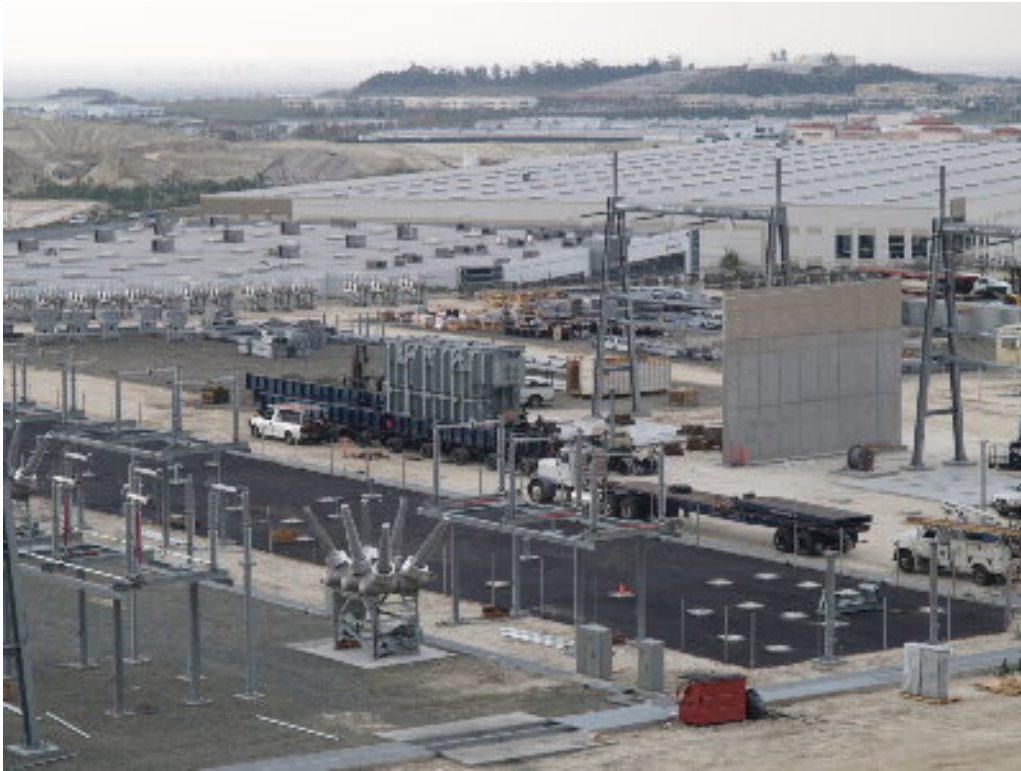
The two A transformers have been delivered to the substation site and a crew prepared the first transformer for lifting onto the pad (see Figure 1). Sandbags on sections of the access road were removed to provide room for the larger truck trailer used to move the transformers into the substation site and will be replaced before any predicted rain. The larger trailer has rear-wheel steering to maneuver within the confines of the substation (see Figure 2). Another crew worked to unload cable reels at the substation site. Much of the substation equipment has been delivered and placed on the poured foundations (see Figure 3).

Figure 1 – Crews prepared the pad and the first A transformer for the lift onto the pad.

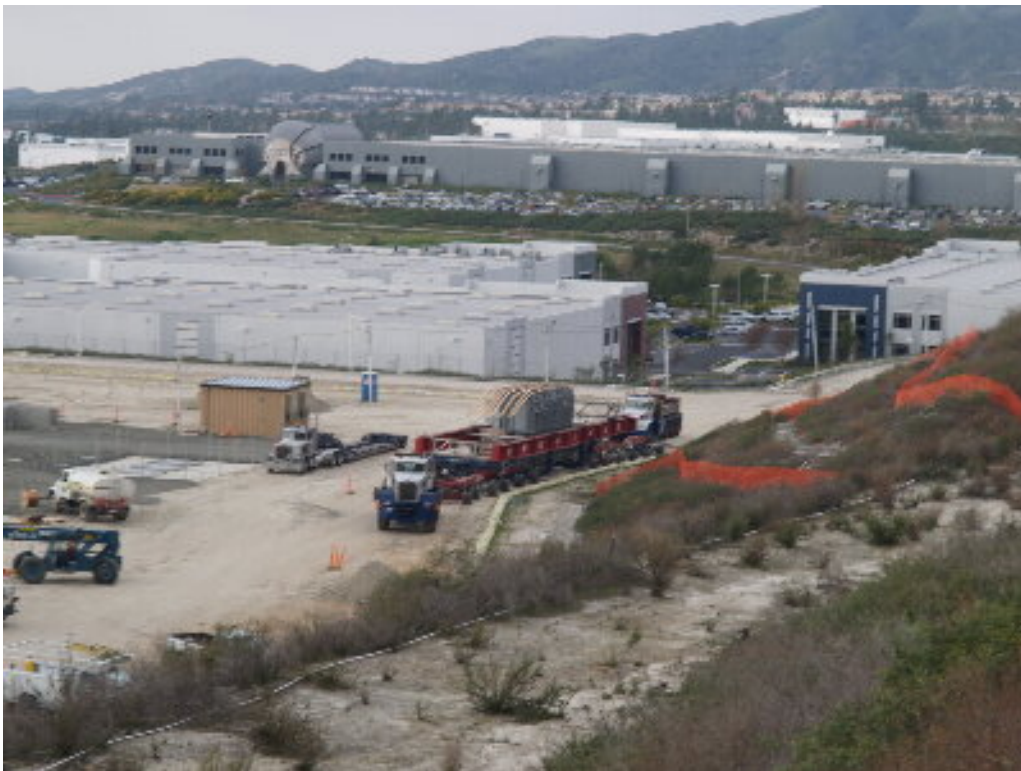
Figure 2 – A special truck was used to move the transformers within the substation site. Note the size difference against the normal tractor-trailer to the left.

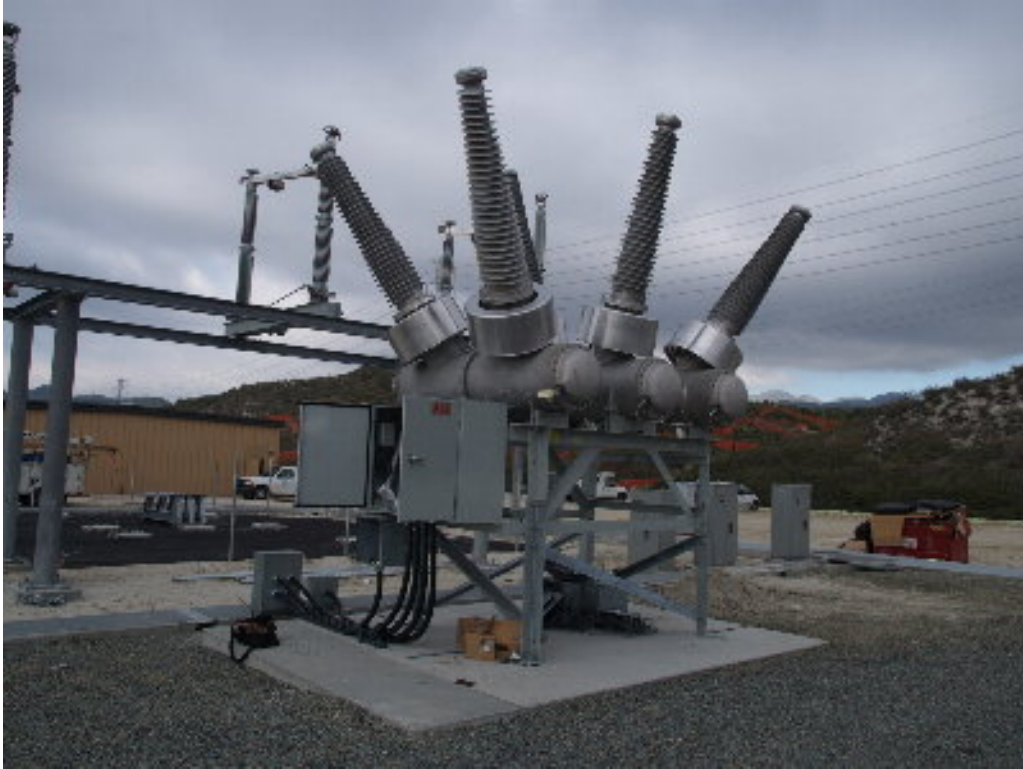
Figure 3 – Most of the equipment has been delivered to the substation site and set on completed foundations.

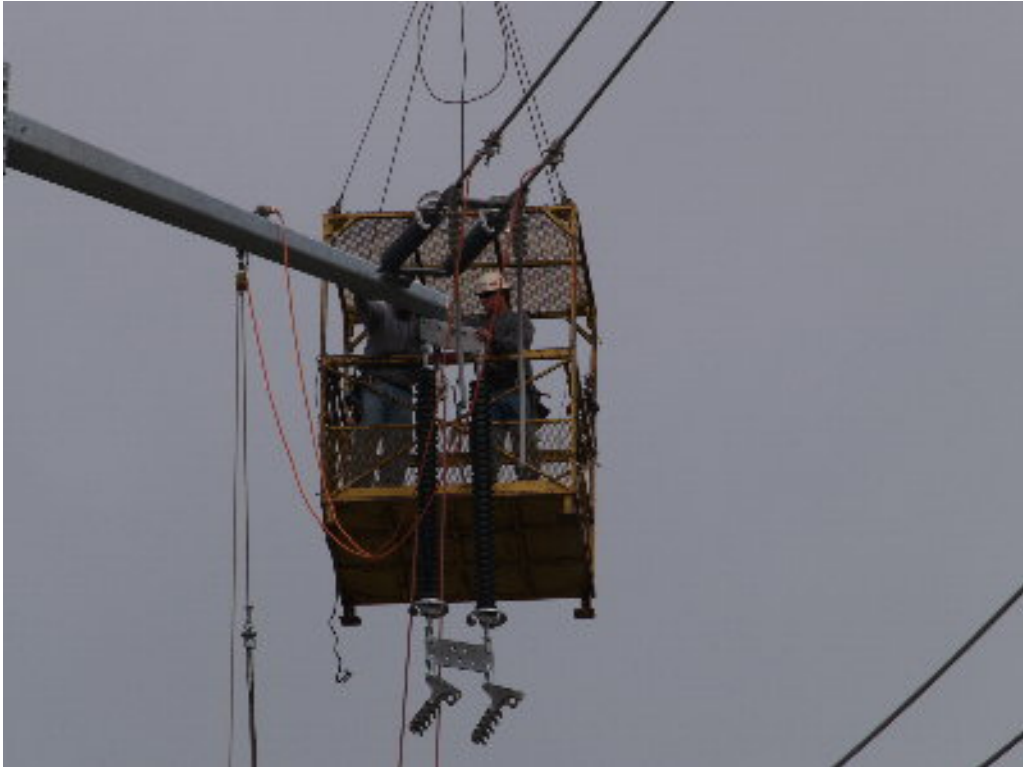
The large mobile Hill Crane remains on-site and was used in stringing cable between the substation site and the 220 kV transmission line corridor. The crews worked in both a basket held by the Hill Crane and mobile man-lifts to connect the insulators and cables on the steel pole portion of the transmission work (see Figure 4). The Bronto man-lift remained on the level area between the southern staging area

Figure 4 – The Hill Crane held a basket to allow workers to connect cables and insulators to the steel pole arms.

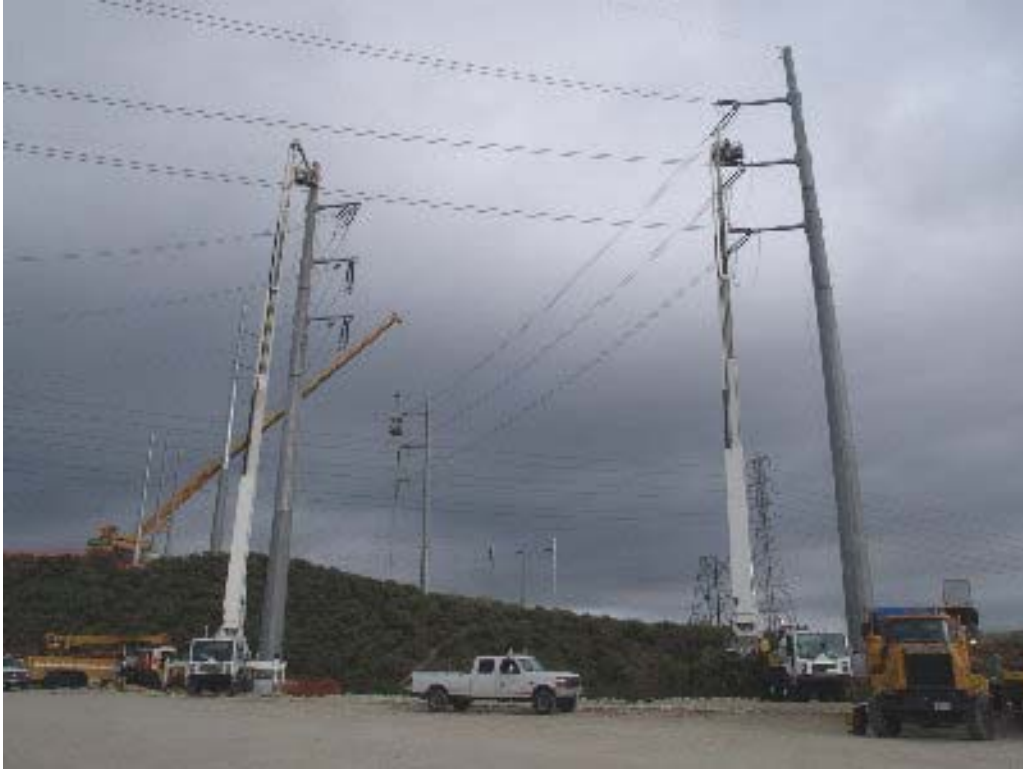
and the transmission line right-of-way. The SCE biologist helped the crew set up the Bronto in the non-native vegetation. No clearing or grading was required to set up the man-lift. The two man-lifts worked on the south side of the substation staging area to lift workers to the poles (see Figure 5).

Figure 5 – Two man-lifts were used to string cable between the transmission line corridor and the substation. Cables are now connected to the large A-frame supports within the substation site.
