PROJECT MEMORANDUM SCE – VIEJO SYSTEM PROJECT

To: Jensen Uchida, CPUC
From: Vida Strong, Aspen Project Manager
Date: January 27, 2005
Subject: Weekly Report #25: January 16, 2005 – January 22, 2005
CPUC Environmental Monitor (EM): Christopher Meyer

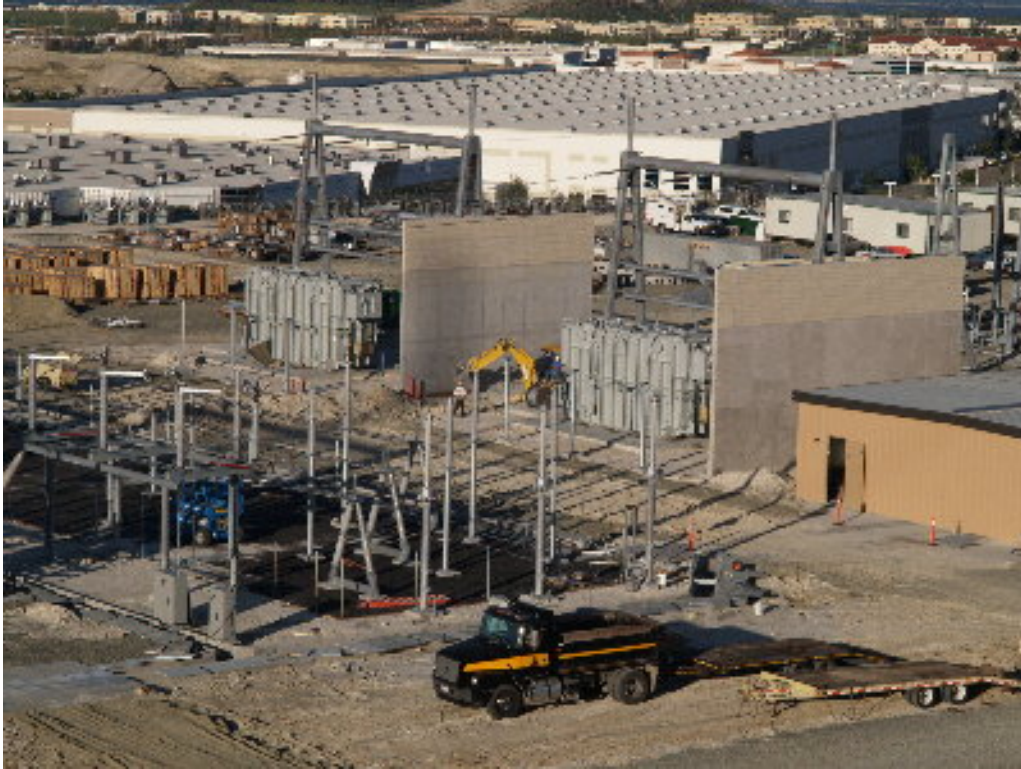
The two A transformers have been delivered to the substation site and set onto the pads west of the Mechanical Electrical Engineer Structure #1 (see Figure 1). A crew worked to prepare the set transformers. Another crew worked on the 66 kV support system within the substation site (see Figure 2). An operator worked on a Bobcat with an auger attachment to clean out the holes for the 12 kV foundations to prepare for a concrete pour next week (see Figure 3).

Figure 1 – Crews prepared A transformers once they were set onto the pads.

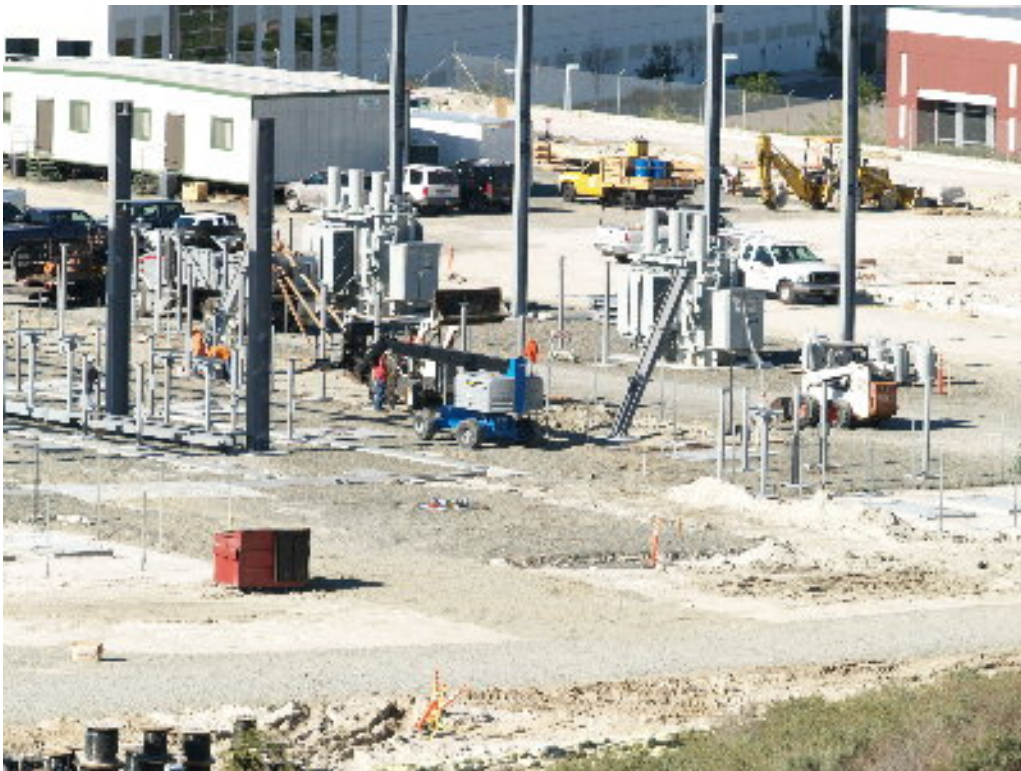
Figure 2 – A crew worked with small lifts to prepare the 66 kV support structures.

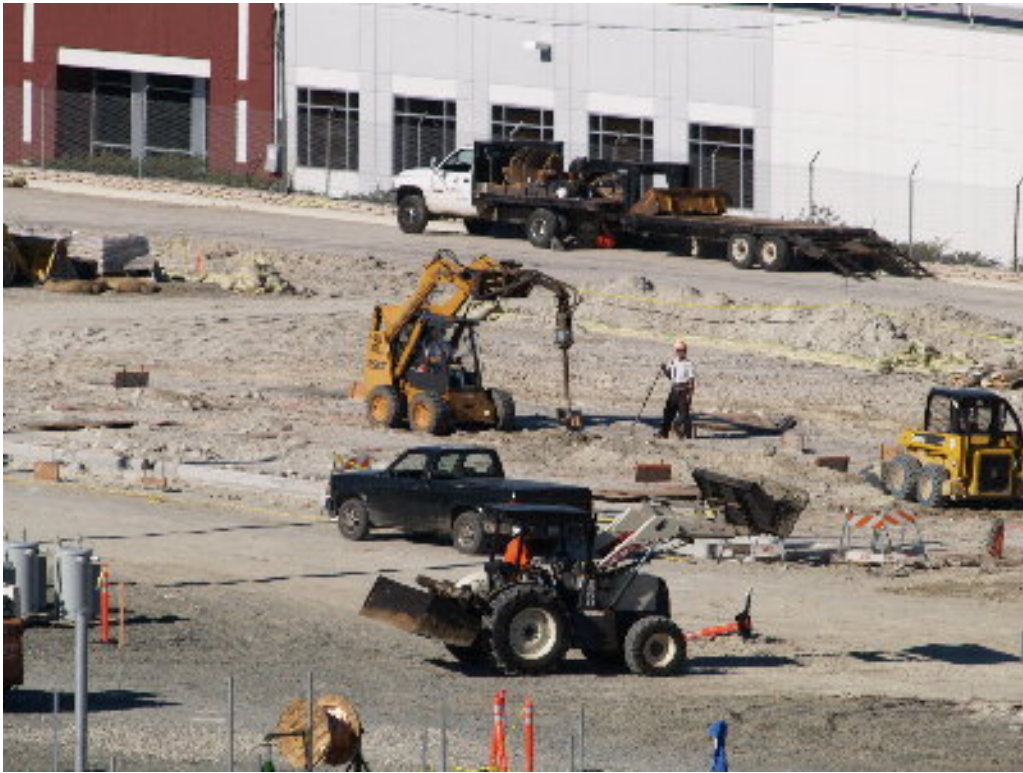
Figure 3 – An operator worked with a Bobcat and small auger attachment to clean out the foundations for the 12 kV structures.

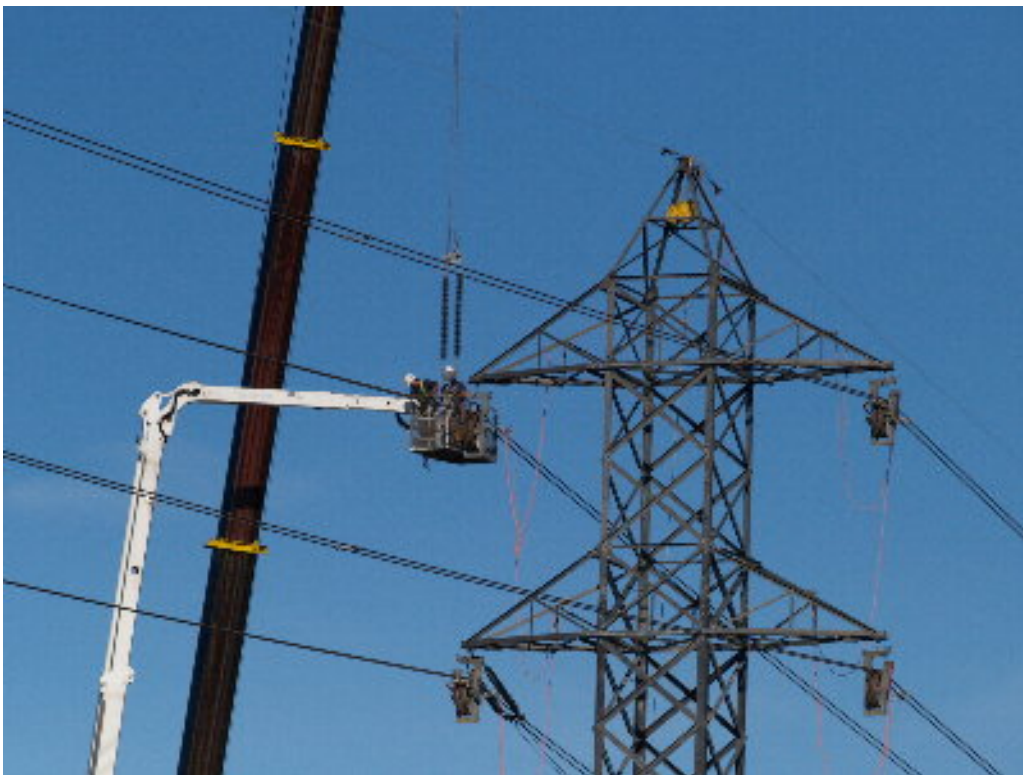
Only one crew was working on the 220 kV transmission line right-of-way during the CPUC EM site visit. The crew worked in a man-lift to attach insulators on the center lattice tower (see Figure 4). No other work occurred on the transmission line segment during the site visit. The upper sections of the old lattice towers were removed during the outage and set onto trucks for removal from the substation site.

Figure 4 – The transmission line crew worked in a man-lift with the help of the crane to attach insulators to the new lattice towers.

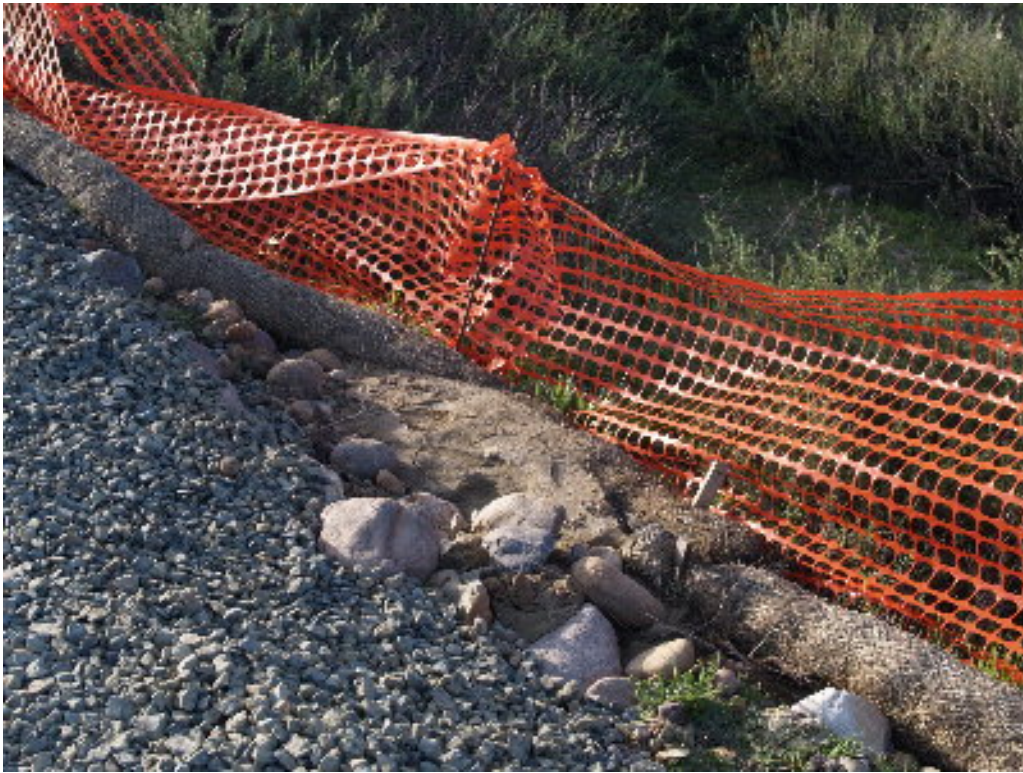
Many of the straw wattles had been moved to the side on the access roads to allow access during construction. The materials were on-site and the contractor was putting them back in place when no work was occurring to prepare for predicted rains. Several areas on the transmission line corridor show signs of significant erosion or sediment issues (see Figure 5). The BMPs along the edge of the right-of-way require maintenance and should be improved in places to address the type of erosion or sediment concerns. The CPUC EM reviewed the possibility of replacing the straw wattles with silt fencing where appropriate with SCE.

Figure 5 – Several areas on the 220 kV transmission line corridor need BMP maintenance and/or improvement.
