## **PROJECT MEMORANDUM SCE – VIEJO SYSTEM PROJECT**

**To:** Jensen Uchida, CPUC  
**From:** Vida Strong, Aspen Project Manager  
**Date:** March 2, 2005  
**Subject:** Weekly Report #30: February 20 – February 26, 2005.  
**CPUC Environmental Monitor (EM):** Christopher Meyer

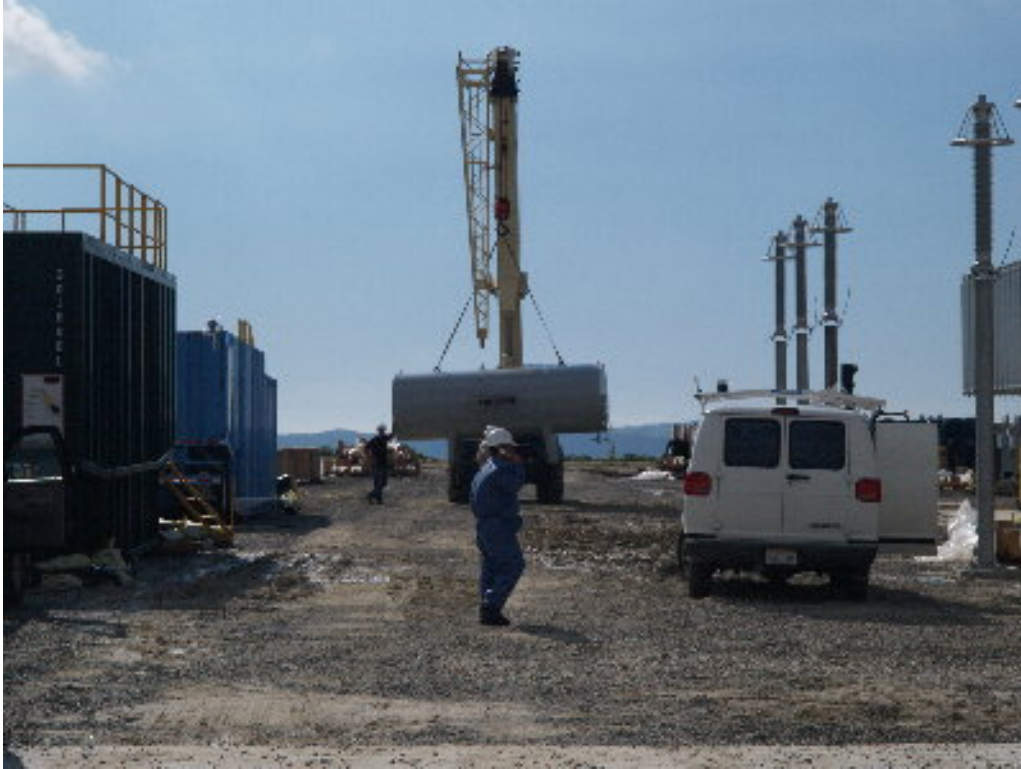
1. SCE continued working on the A-bank transformers during the site visit. The crew worked on the installation of external covers and fittings for the oil tank on the A-bank transformers during the site visit. The oil tank for the A-bank transformers was being prepared for installation (see Figure 1).

**Figure 1** – A SCE crew prepared to install the oil tank on the A-bank transformers.

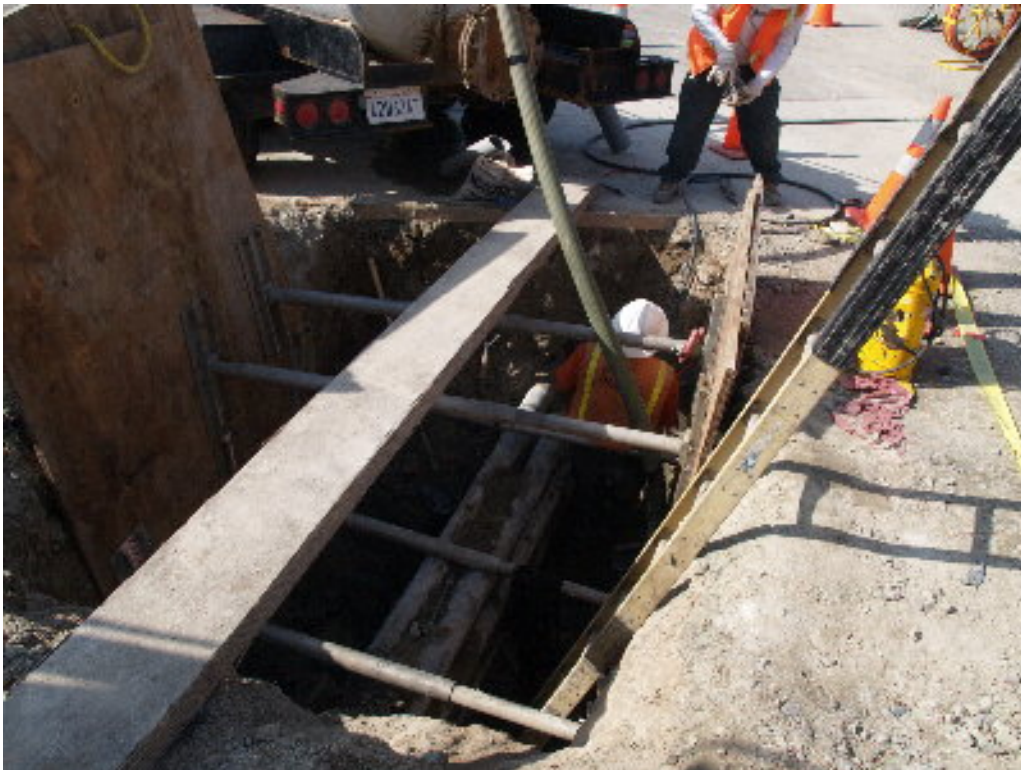
4. A crew from PAR worked to repair the conduit running from the public right-of-way to the substation under the access road (see Figure 2). The conduit allowed passage of the mandrel, but the 12 kV cable for housekeeping power at the substation site would not pull, possibly due to friction on the long and curved pull. The problem was corrected and the cable was successfully installed to the substation site.

**Figure 2** – The PAR crew worked to repair the conduit for the 12 kV power to the substation.

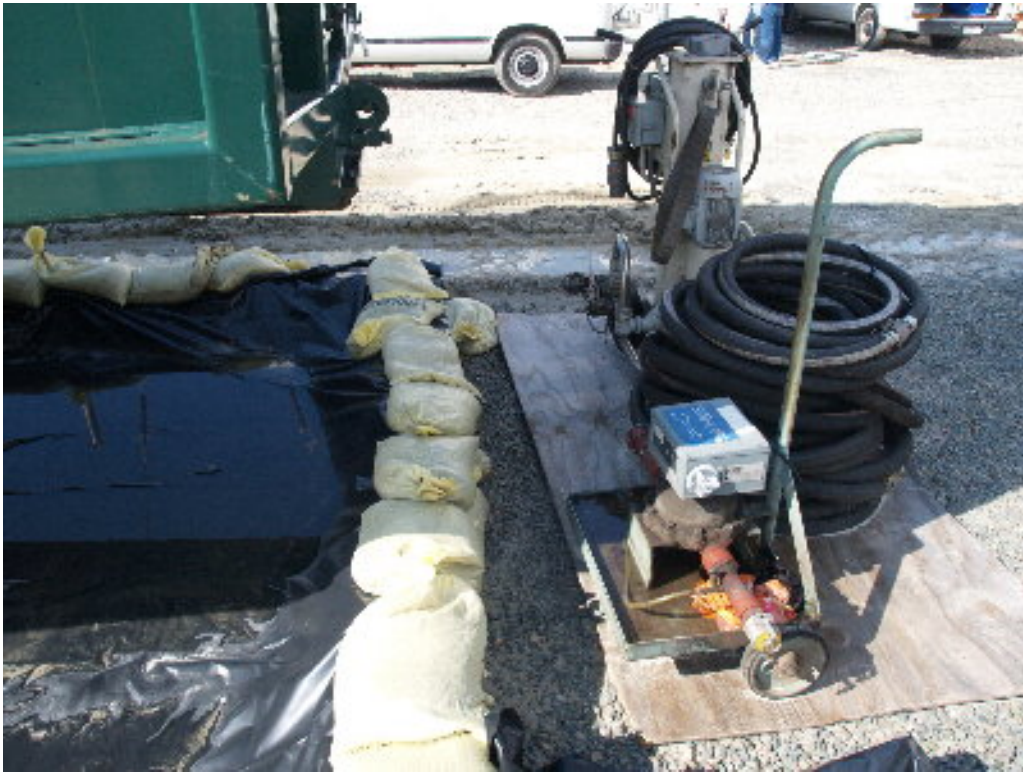
Some of the primary and secondary containment structures within the substation site have rainwater from the recent storms (see Figure 3). Any petroleum-laden water in these containment structures needs to be properly disposed of and the structures readied for any future rain events.

**Figure 3** – Containment structures need rainwater or any contaminated water removed and properly disposed.

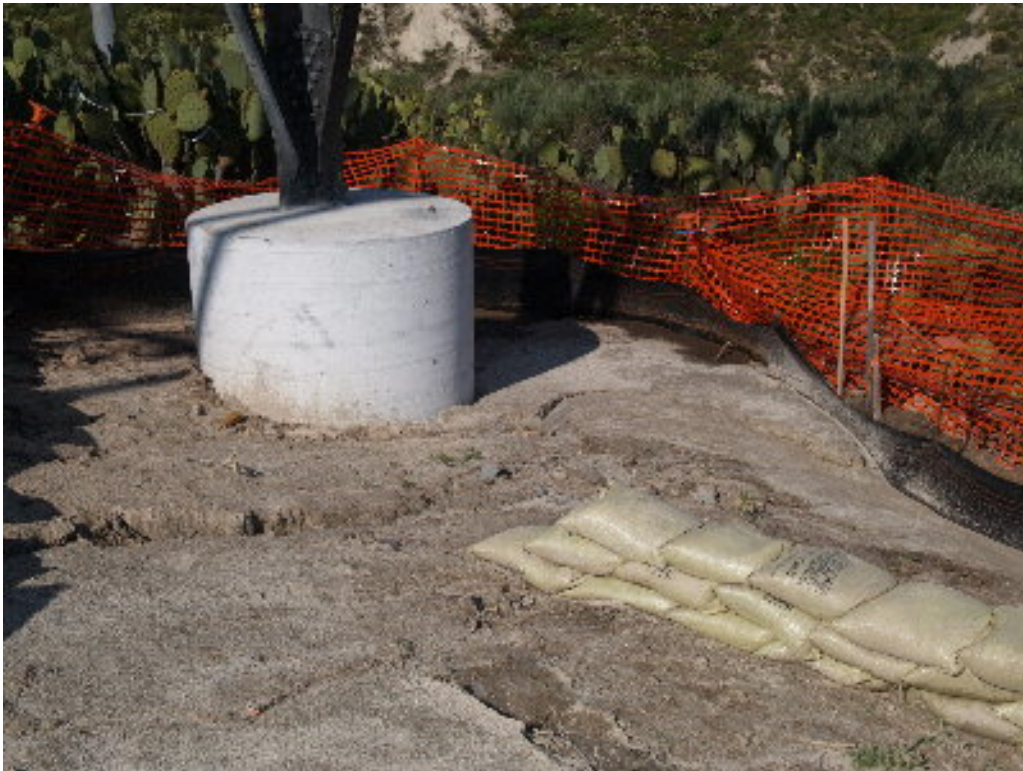
Although additional BMPs have been installed and some maintenance occurred on the 220 kV transmission line right-of-way, additional maintenance needs to be completed at several locations. The silt fencing that has been installed around the northern structure still has excess sediment (see Figure 4). The sandbags from the southeastern portion of the access road were moved to the northern structure and the sediment now outlets directly into the habitat (see Figure 5). SCE was notified of the remaining concerns with the BMPs and the CPUC EM will review the repairs during the next site visit. SCE will use additional outside resources to inspect and make recommendation for improvements to the BMPs on the project to address the current concerns.

**Figure 4** – The silt fencing on the 220 kV transmission line corridor was overwhelmed in several places and still requires maintenance.

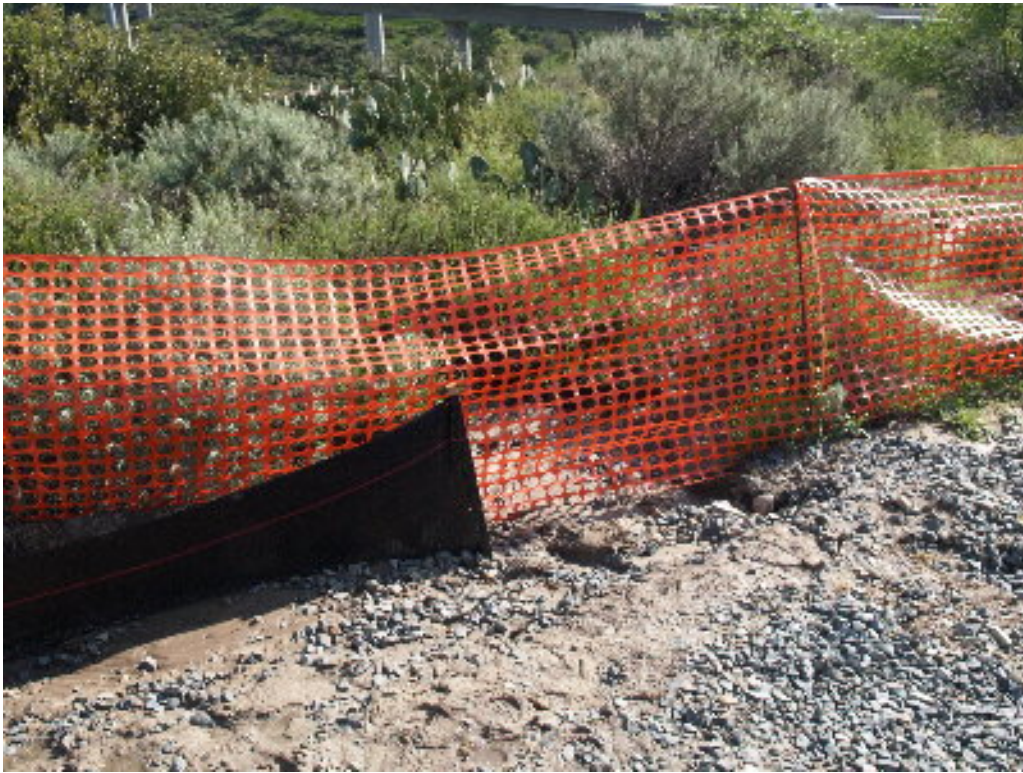
**Figure 5** – The silt fencing on the southeastern access road on the 220 kV segment outlets directly to the protected habitat.

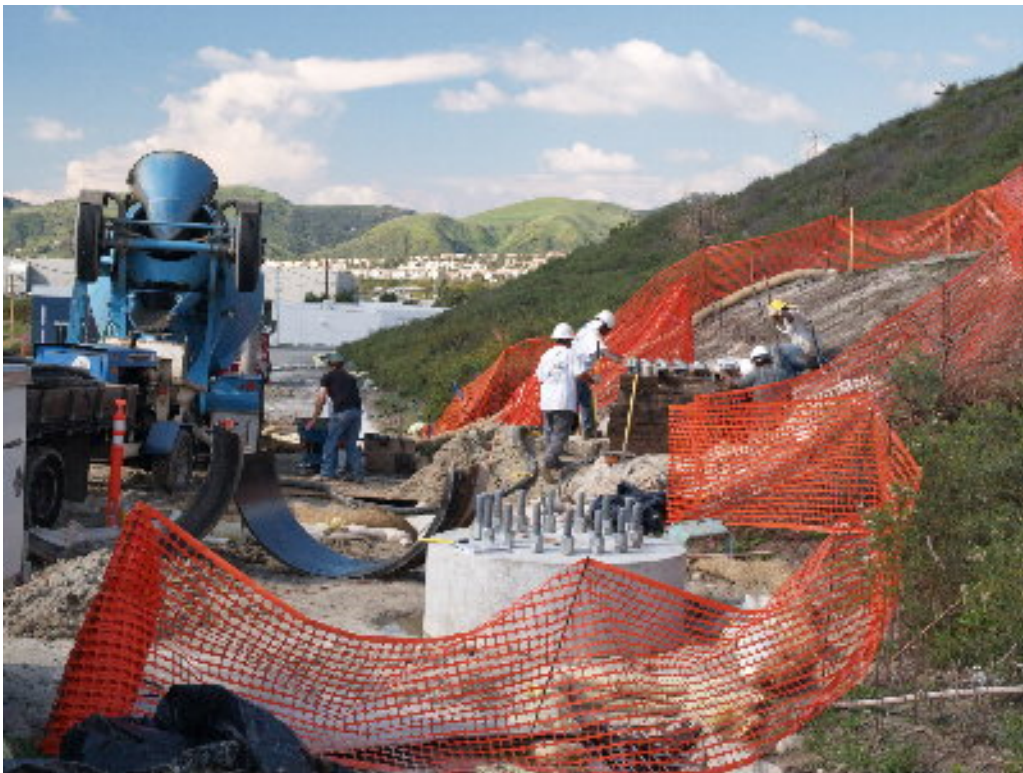
1. Inland Valley Construction poured the foundation for the 66 kV steel pole on the edge of the substation site (see Figure 6). The v-ditch was protected during the operation and the crews were cleaning any concrete from the steel plates over the v-ditch.

**Figure 6** – Inland Valley Construction poured the foundation for the 66 kV steel pole on the edge of the substation site.

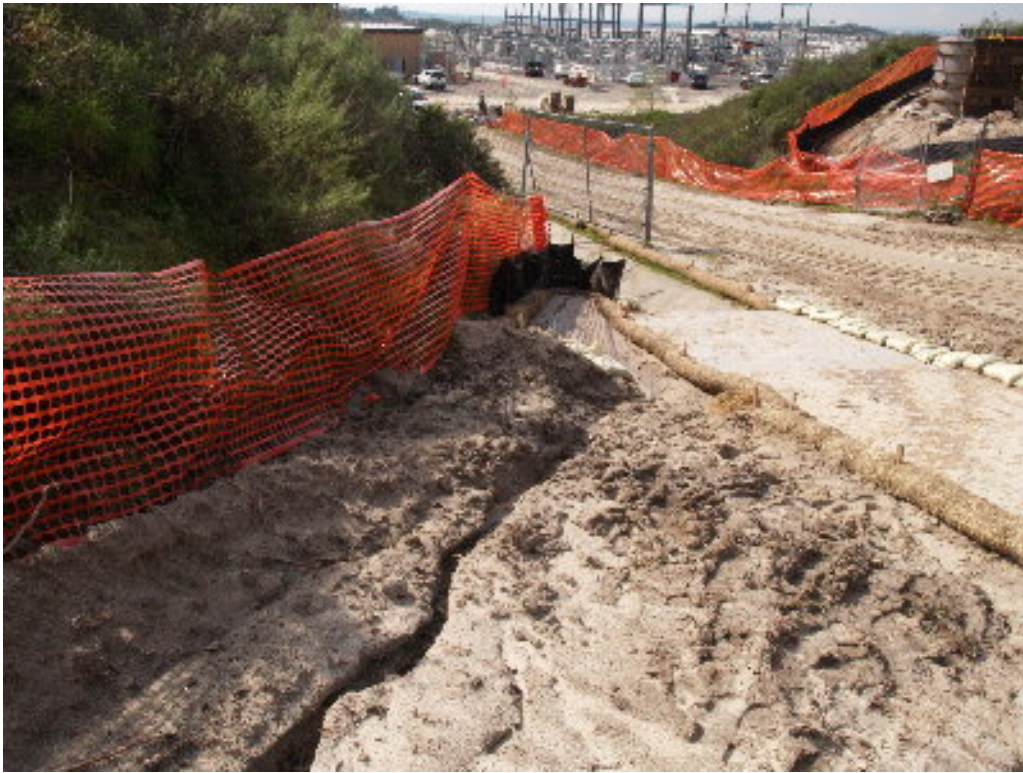
Many of the BMPs stopped sediment from leaving the construction area; however, some need maintenance (see Figure 7).

**Figure 7** – The BMPs on the 66 kV right-of-way require maintenance before any additional rain events.
