PROJECT MEMORANDUM SCE – VIEJO SYSTEM PROJECT

To: Jensen Uchida, CPUC
From: Vida Strong, Aspen Project Manager
Date: March 8, 2005
Subject: Weekly Report #31: February 27 – March 5, 2005.
CPUC Environmental Monitor (EM): Christopher Meyer

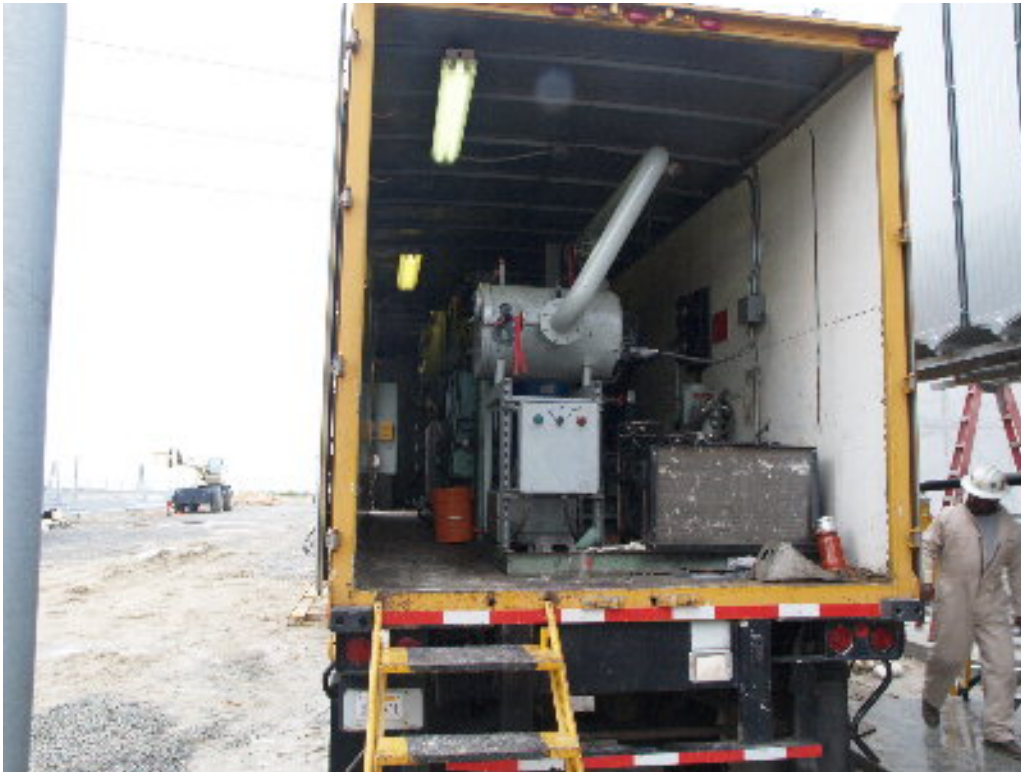
1. SCE continued working on the A-bank transformers during the site visit. The crew used a special vacuum truck to pull the moisture from the A-bank transformers during the site visit (see Figure 1). The oil tanks for the A-bank transformers have been installed.

Figure 1 – A SCE crew used a special vacuum to pull the moisture from the A-bank transformers.

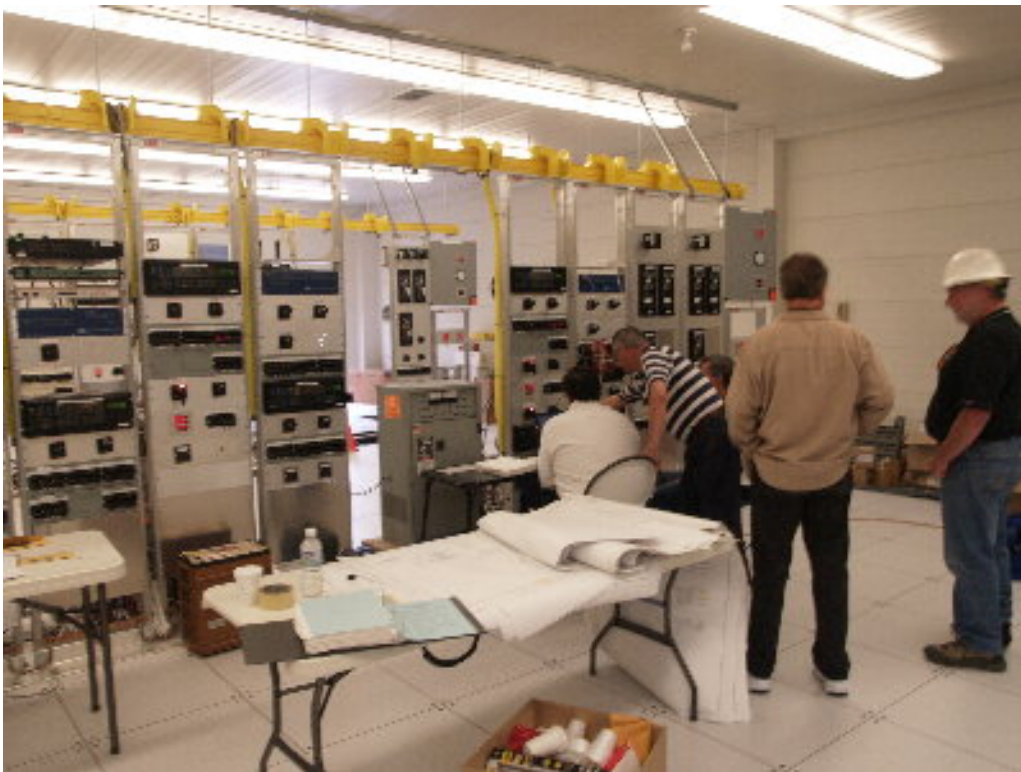
2. SCE engineers worked to test the panels inside the Mechanical Electrical Engineering Room (MEER) #1 (see Figure 2).
3. A small crew with Kindness worked to install conduit for the 12 kV housekeeping power for the substation site (see Figure 3).

Figure 2 – The control panels in the MEER #1 were tested during the site visit.

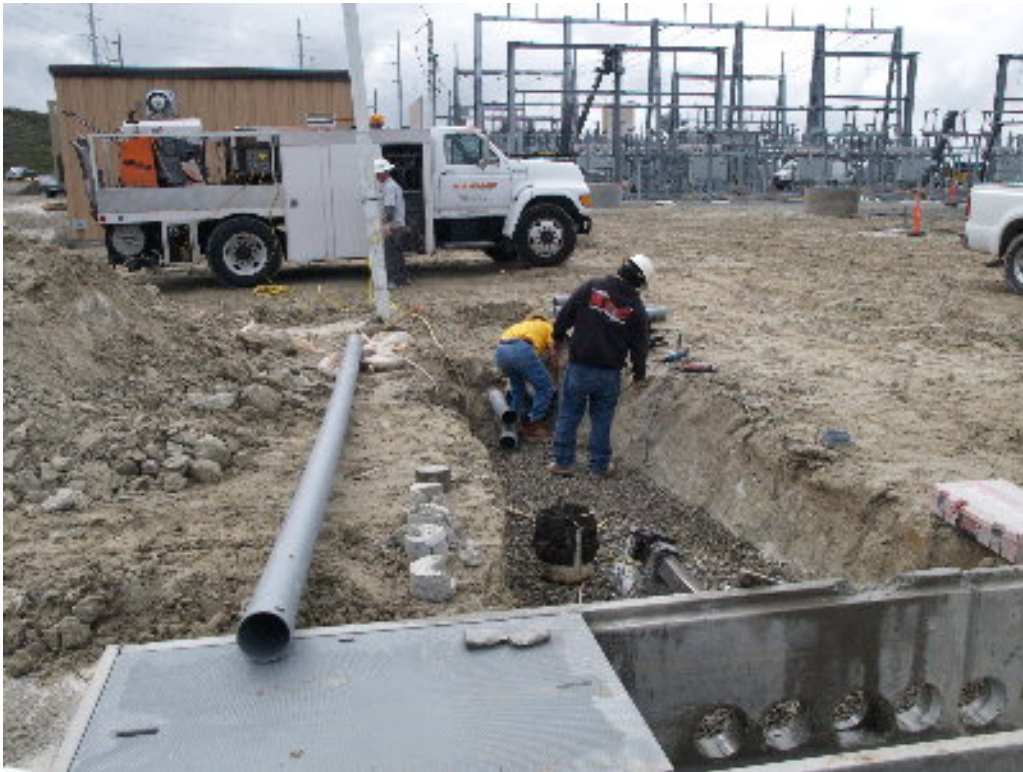
Figure 3 – A crew worked to place conduit for the 12 kV housekeeping power in the prepared trench and into the vault.

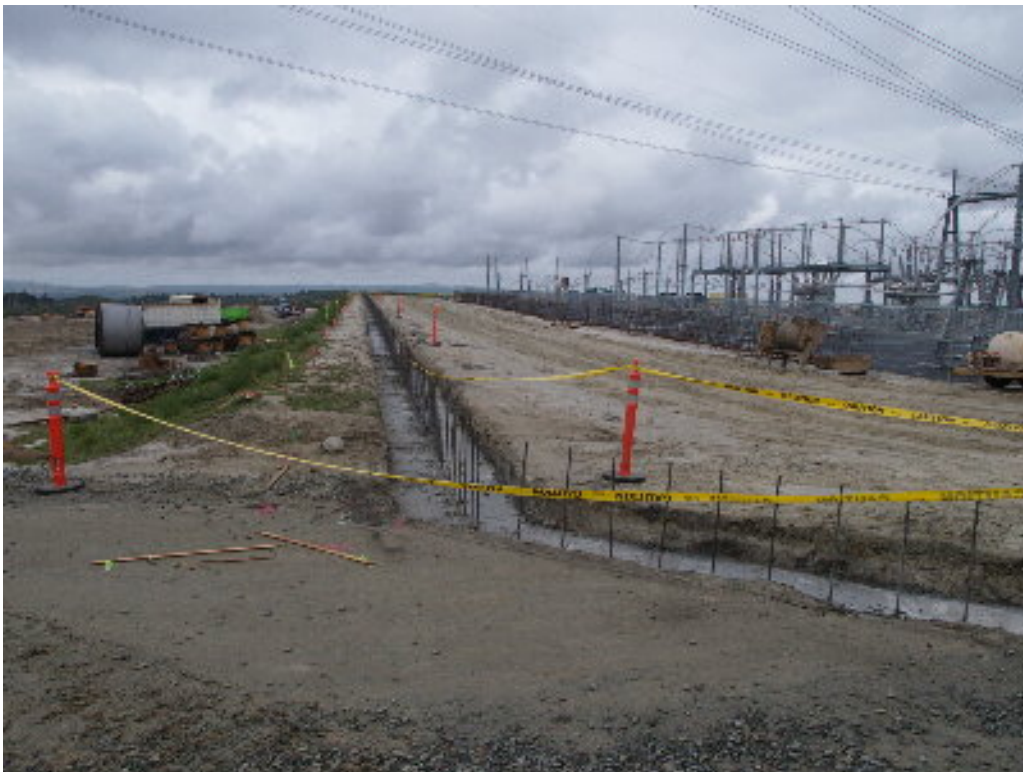
4. A crew from Union has excavated and poured the southern portion of the foundation for the block wall that will eventually surround the substation site (see Figure 4).

Figure 4 – A Union Construction crew excavated and poured the foundation for the southern portion of the block wall that will surround the substation site.

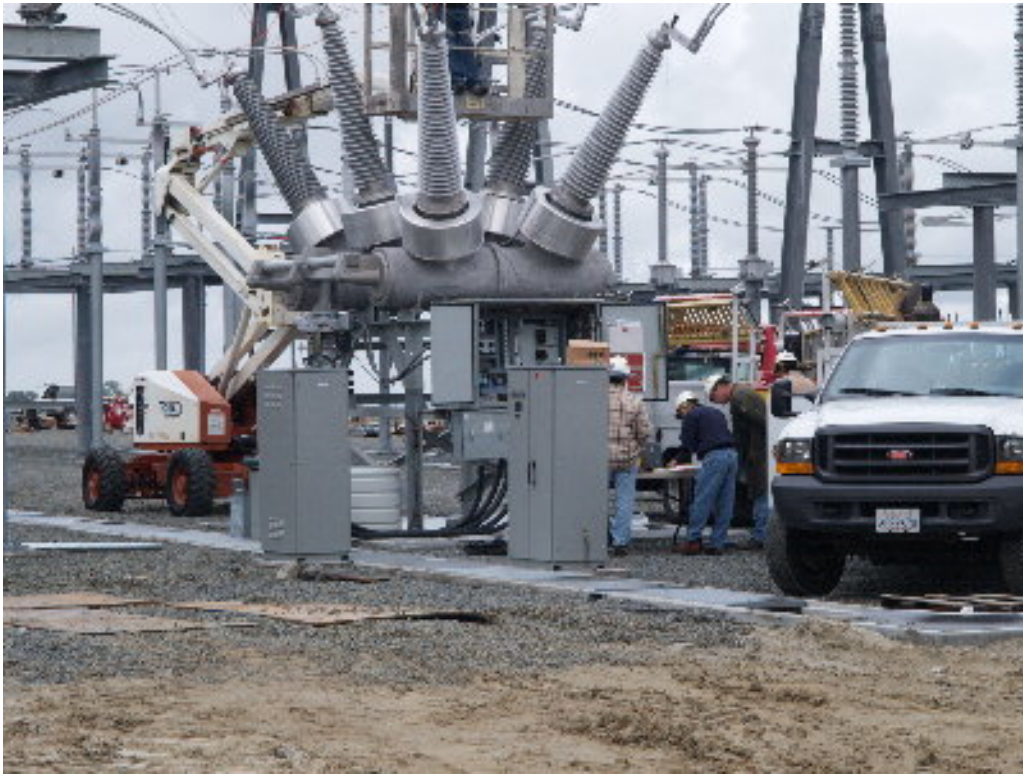
5. SCE crews worked to test the panels throughout the substation site after installation (see Figure 5). The technicians tested each connection on the panels to verify the panels were correctly fabricated at the factory prior to energizing.

Figure 5 – Crews tested all the panels throughout the substation prior to energizing.

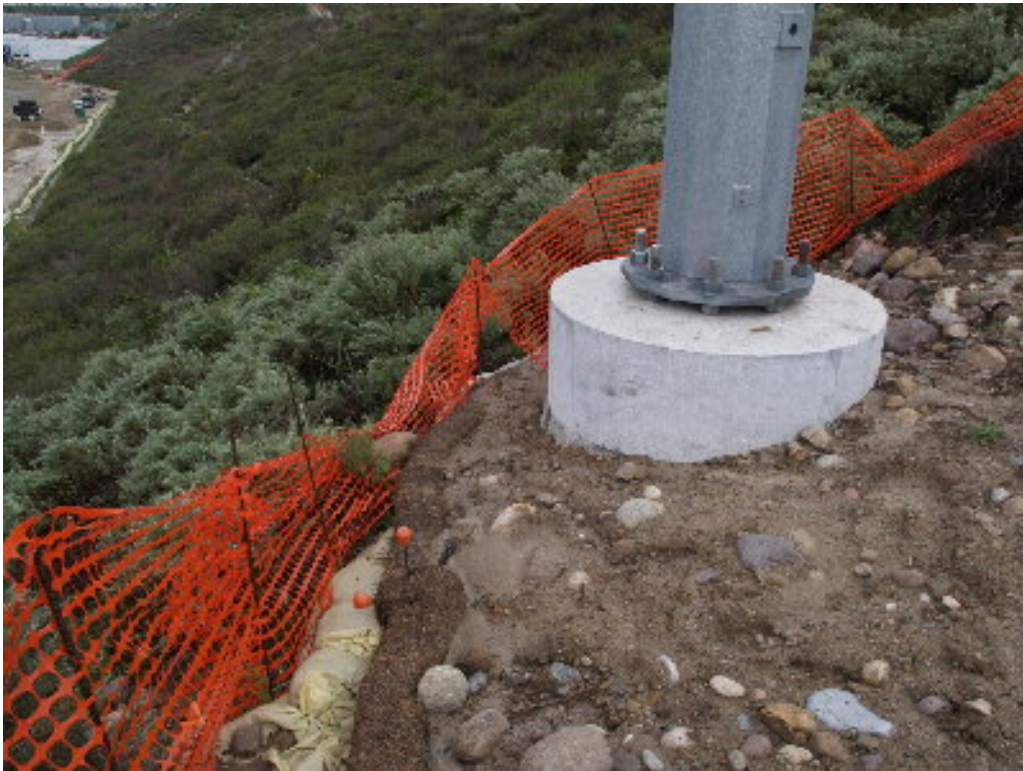
Although additional BMPs have been installed and extensive maintenance occurred on the 220 kV transmission line right-of-way, additional maintenance needs to be completed at the upper steel pole pads (see Figure 6). The straw waddle still has excess sediment and has failed to keep sediment from entering the habitat. SCE was notified of the remaining concerns with the BMPs and the CPUC EM will review the repairs during the next site visit. SCE has stated that they will use additional outside resources to inspect and make recommendation for improvements to the BMPs on the project to address the current concerns.

Figure 6 – The BMPs on the pads for the steel poles on the 220 kV section of the project have been overwhelmed and silt has entered the habitat.

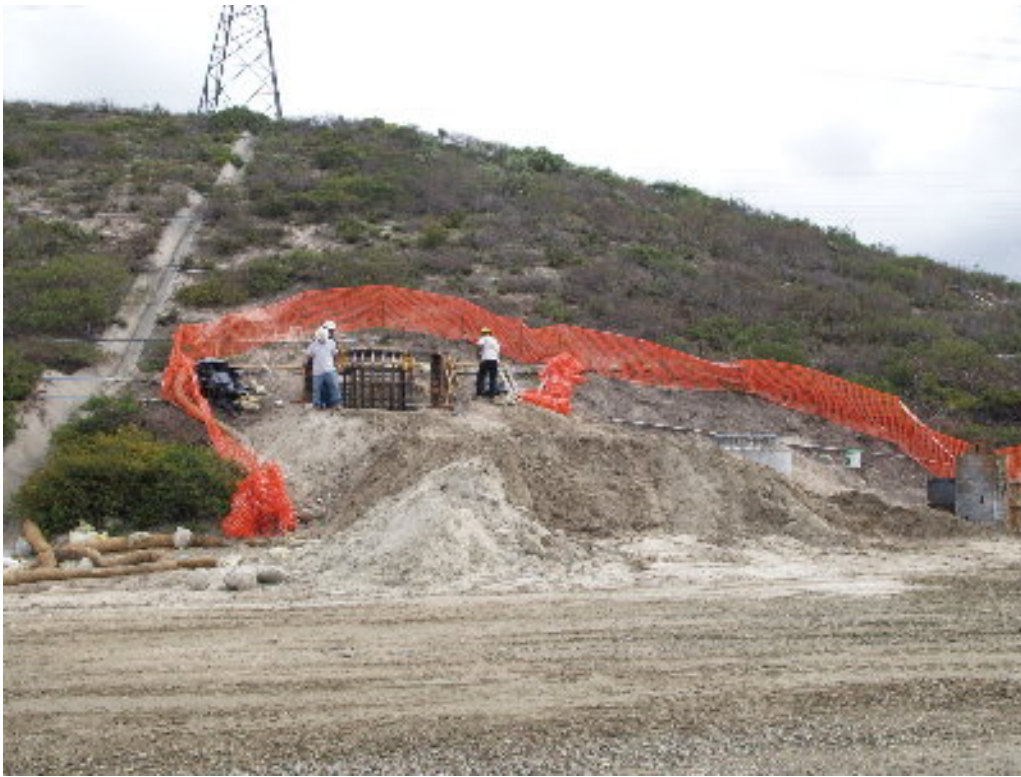
1. Inland Valley Construction prepared the anchor bolts and forms to pour the second to last foundation for the 66 kV steel poles (see Figure 7). The crew worked to move spoils back from the v-ditch and away from the habitat.
2. The drilling machine worked on the final foundation for the 66 kV poles adjacent to the substation site (see Figure 8). The spoils from drilling have overwhelmed the silt fencing and were also entering the v-ditch while the operator works on the drilling head.

Figure 7 – The Inland crew worked to prepare the second to last foundation for pouring on the 66 kV right-of-way.

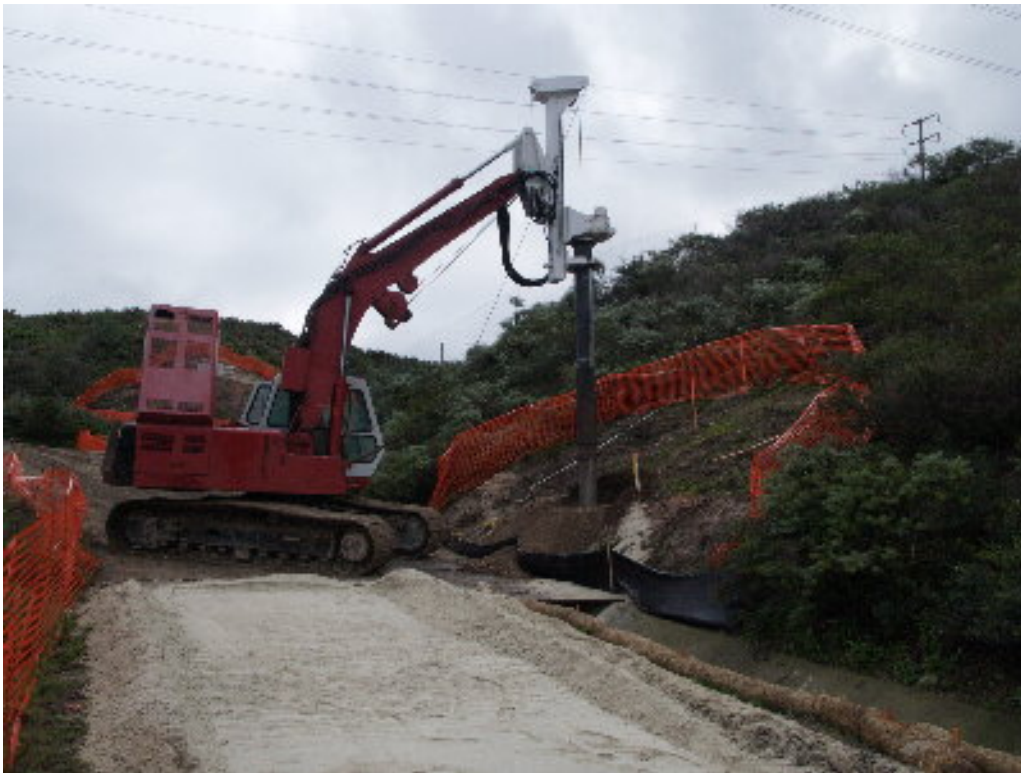
Figure 8 – A Low-Drill was used to work on the final foundation for the 66 kV poles adjacent to the substation site. Drilling spoils will have to be cleaned from the v-ditch.

Many of the BMPs stopped sediment from leaving the construction area; however, some continue to need maintenance. The v-ditch will need to be cleaned of sediment prior to any predicted rain events.
