PROJECT MEMORANDUM SCE – VIEJO SYSTEM PROJECT

To: Jensen Uchida, CPUC
From: Vida Strong, Aspen Project Manager
Date: March 30, 2005
Subject: Weekly Report #34: March 20 – March 26, 2005.
CPUC Environmental Monitor (EM): Christopher Meyer

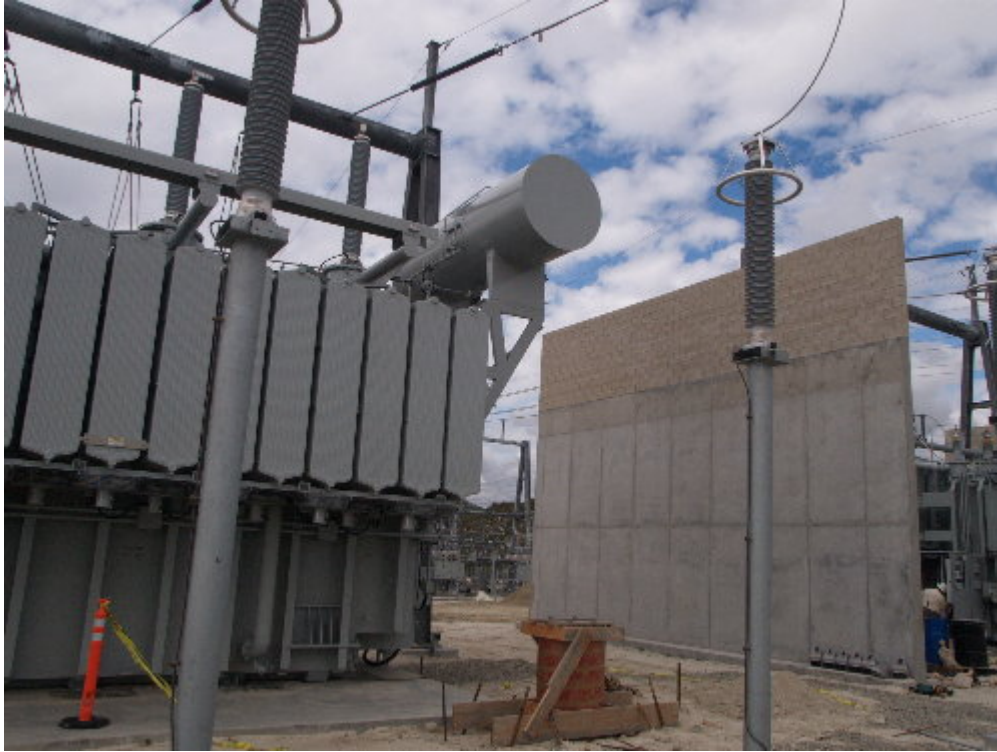
1. Two new foundations were being set during the site visit to set an additional set of poles at the A-transformer banks to gain the required off-set between the wires and the oil tank on the top of the transformer (see Figure 1). The configuration of the transformer was slightly different than anticipated by the engineers and the field change was required to provide the proper off-set.

Figure 1 – New poles will be placed to gain the proper off-set between the circuits and the oil tank on the A-bank transformers.

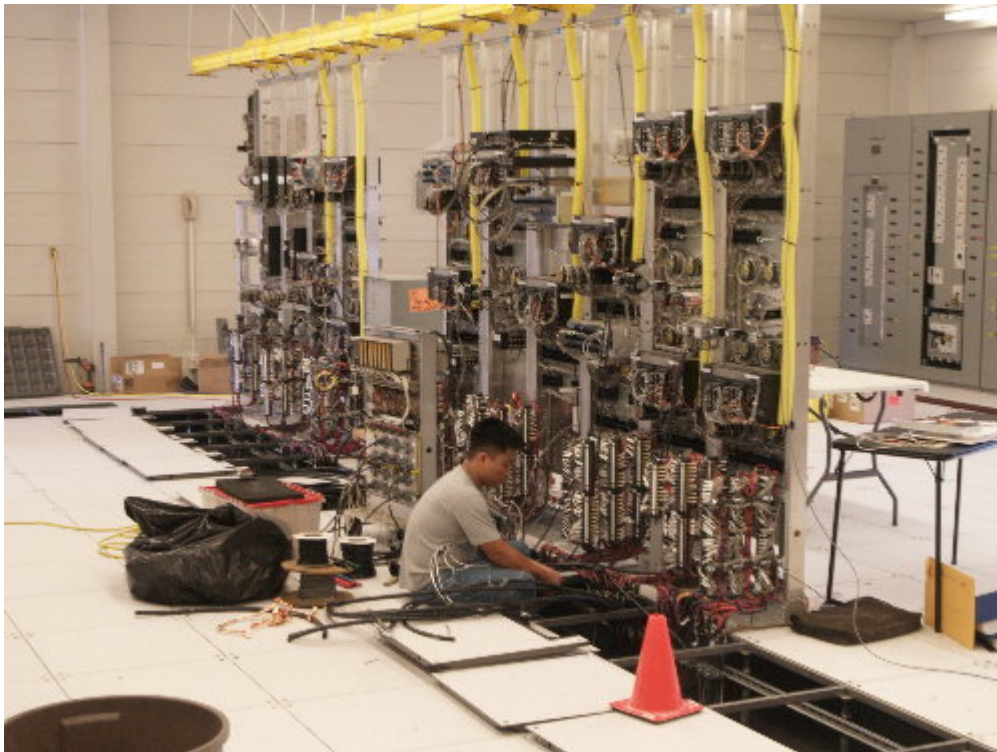
2. Testing crews worked inside MEER #1 to test the circuit breakers and associated computer systems (see Figure 2).
3. Reycon continued working on the western side of the block wall during the site visit. The wall will have several step-downs along the western side to address the gentle slope. Reycon also worked to set the blocks for the spill wall on the north side of the substation site (see Figure 3). The spill wall will be coated and will block any spilled petroleum from reaching the drainage system.

Figure 2 – Testing crews worked to check the circuit breakers and associated computer systems within MEER #1.

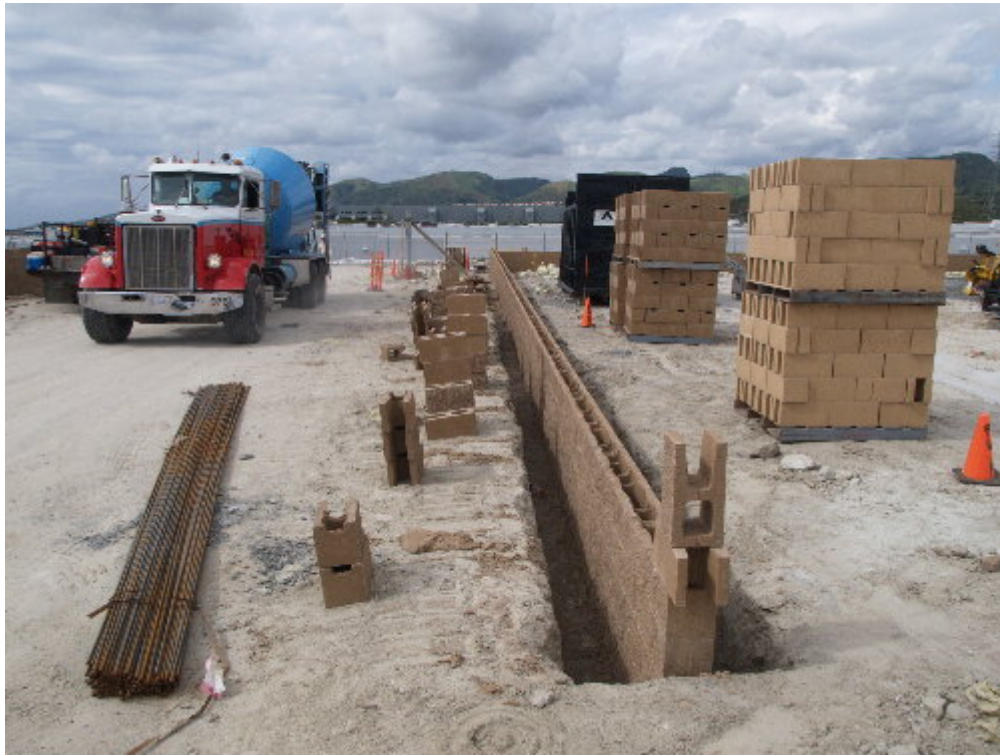
Figure 3 – Reycon started setting the concrete blocks for the spill wall on the north side of the substation site.

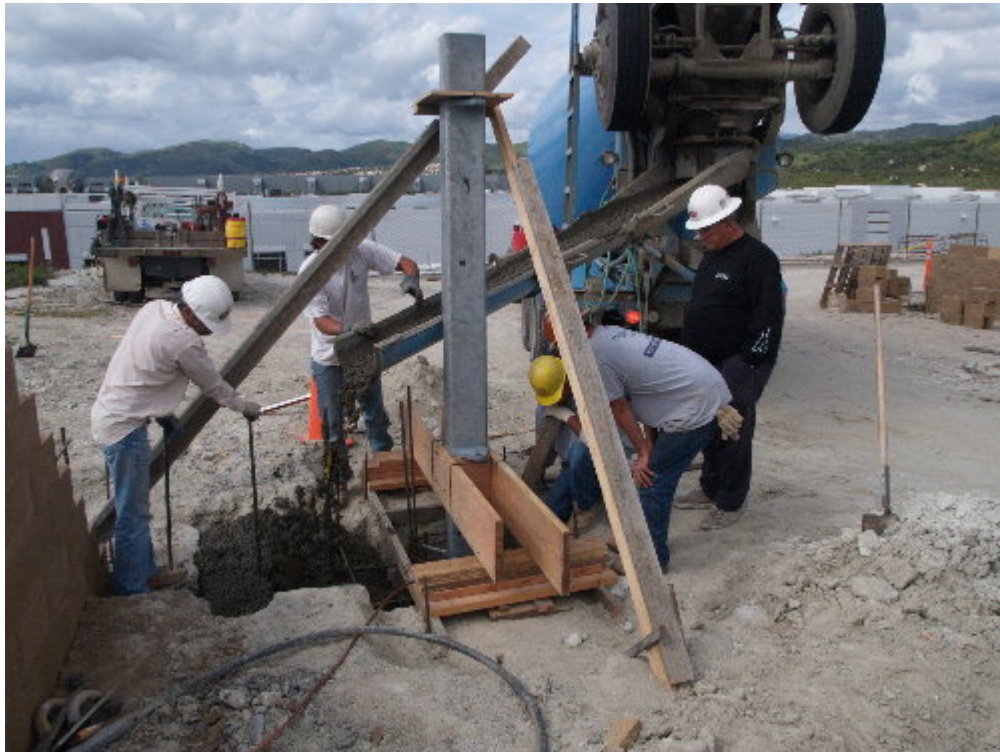
4. The Union crew worked to build the forms and pour the foundation for the main gate during the site visit (see Figure 4). The gate will consist of two 12-foot swinging gates, set low to prevent passage underneath.

Figure 4 – Union poured the foundations for the main gate posts for the substation site.

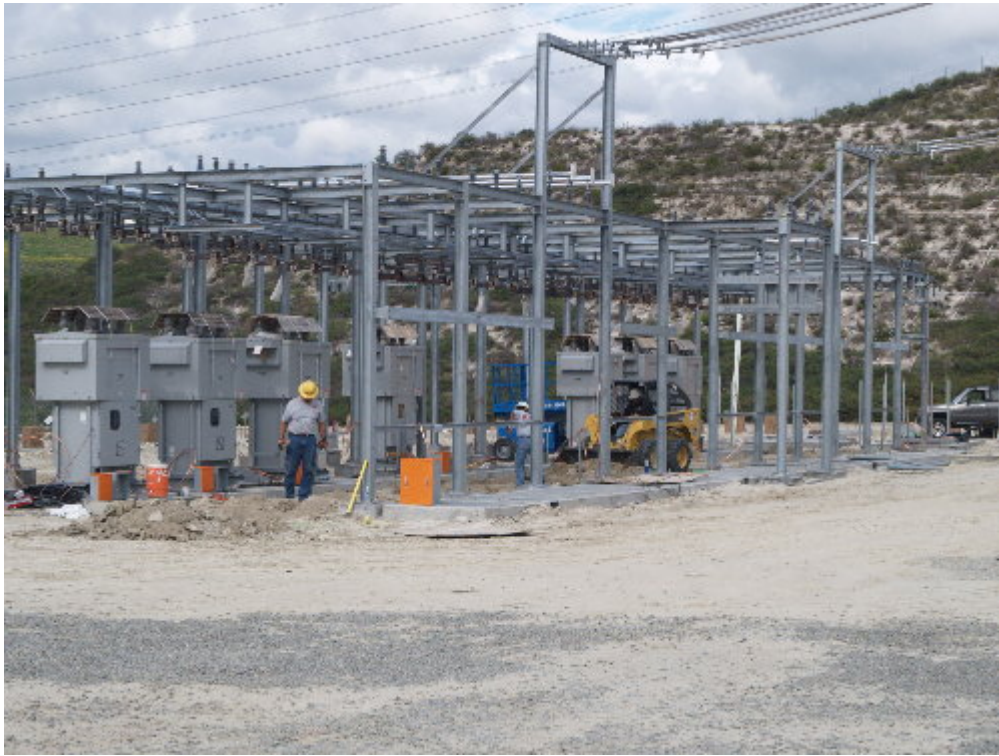
5. Several small crews with NRG continued working to connect the various conductors on the 66 kV section of the substation site. NRG crews also worked on connecting the foundations and equipment on the 12 kV portion of the site to the grounding grid (see Figure 5).

Figure 5 – NRG worked to connect the 12 kV structures to the grounding grid.

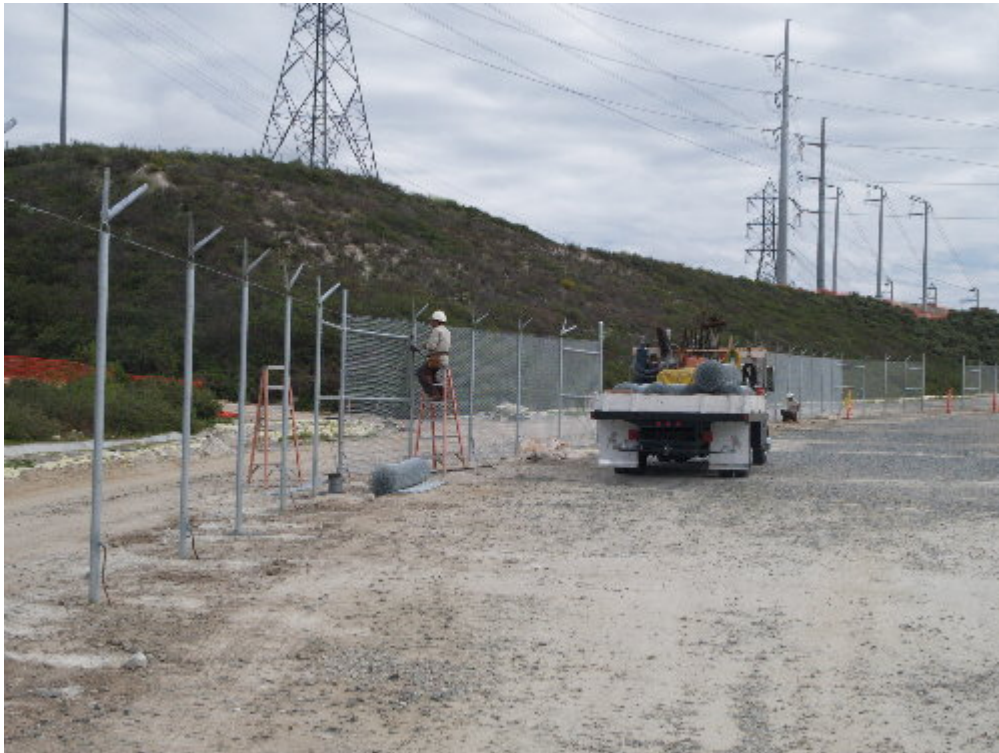
6. The fencing was installed on the poles for the cyclone fencing that will be on the eastern side of the substation site during the site visit (see Figure 6).

Figure 6 – The fencing was placed on the poles for the cyclone fence during the site visit. The cyclone fencing will only be on the eastern portion of the substation site and will not be visible from the public right-of-way.
