PROJECT MEMORANDUM SCE – VIEJO SYSTEM PROJECT

To: Jensen Uchida, CPUC
From: Vida Strong, Aspen Project Manager
Date: May 4, 2005
Subject: Weekly Report #39, April 24 – April 30, 2005.
CPUC Environmental Monitor (EM): Christopher Meyer

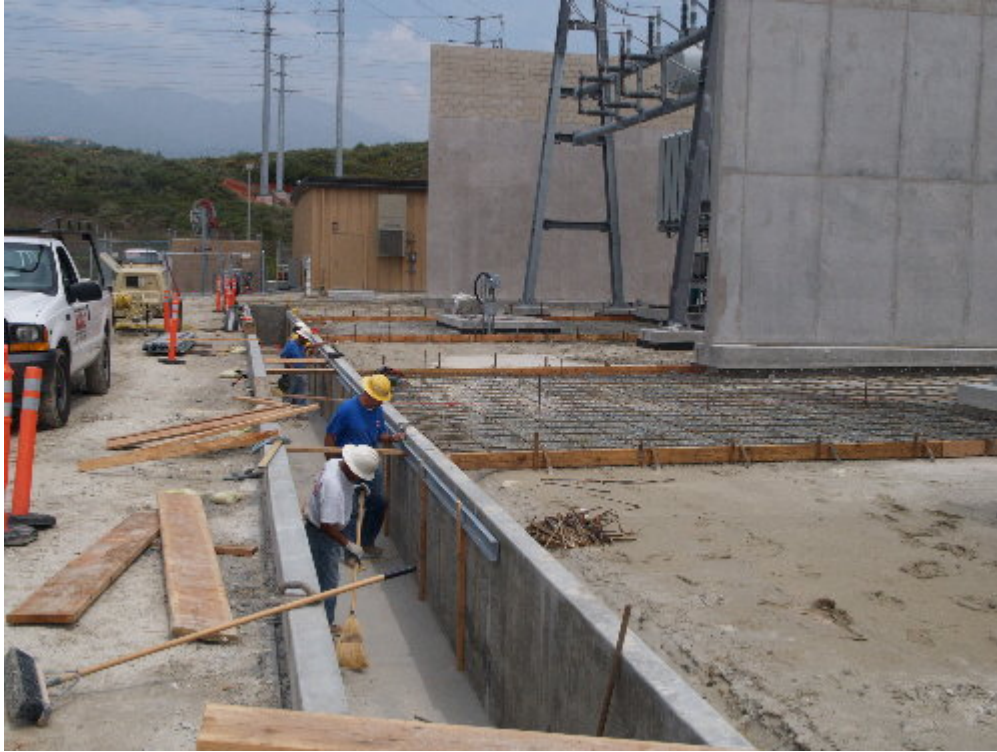
1. Work continued on the main trench running east-west, dividing the 220 kV and 66 kV sections of the substation site. The concrete has been poured and the forms removed from the trench. Crews drilled holes in the concrete trench and placed anchor bolts to attach the steel ledge that will support the trench cover (see Figure 1).

Figure 1 – Crews worked to attach the steel rail that will support the trench covers.

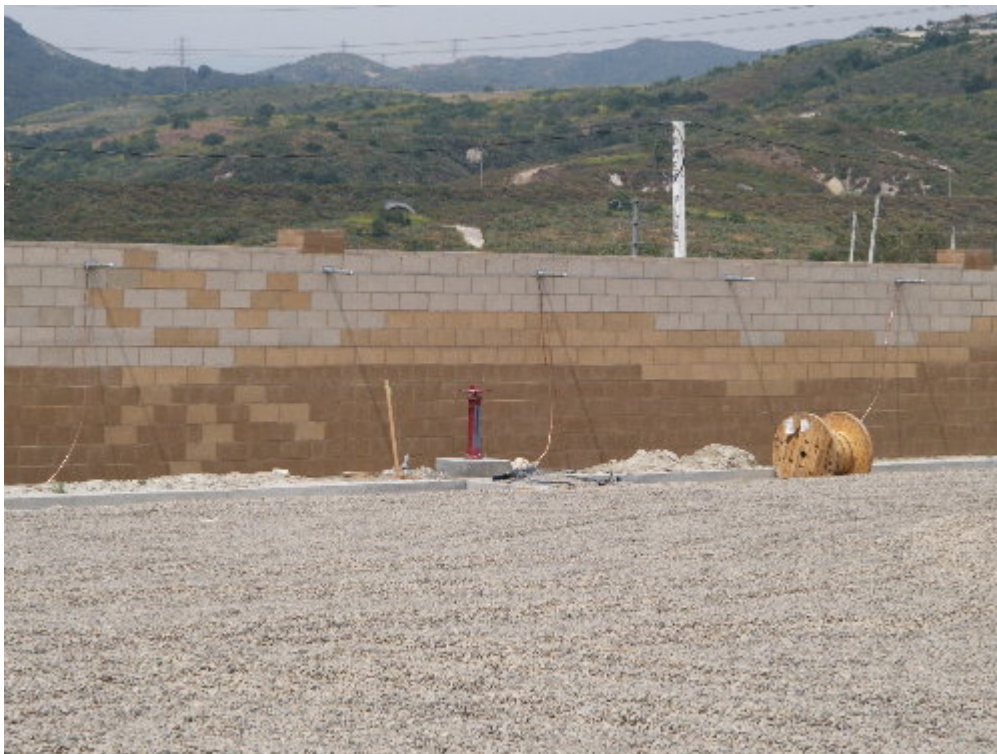
3. Reycon continued working on the block wall around the substation during the site visit. The gateposts and block columns for the gate at the public right-of-way have been placed, but no additional work was observed during the site visit. The braces for the barbed-wire have been placed on the inside of the wall and the crew has grounded the wire at intervals along the wall (see Figure 2). Foam blocks have been placed in spaces in the wall to be replaced with glass block details.

Figure 2 – Reycon worked to ground the barbed wire that runs along the inside of the block wall.

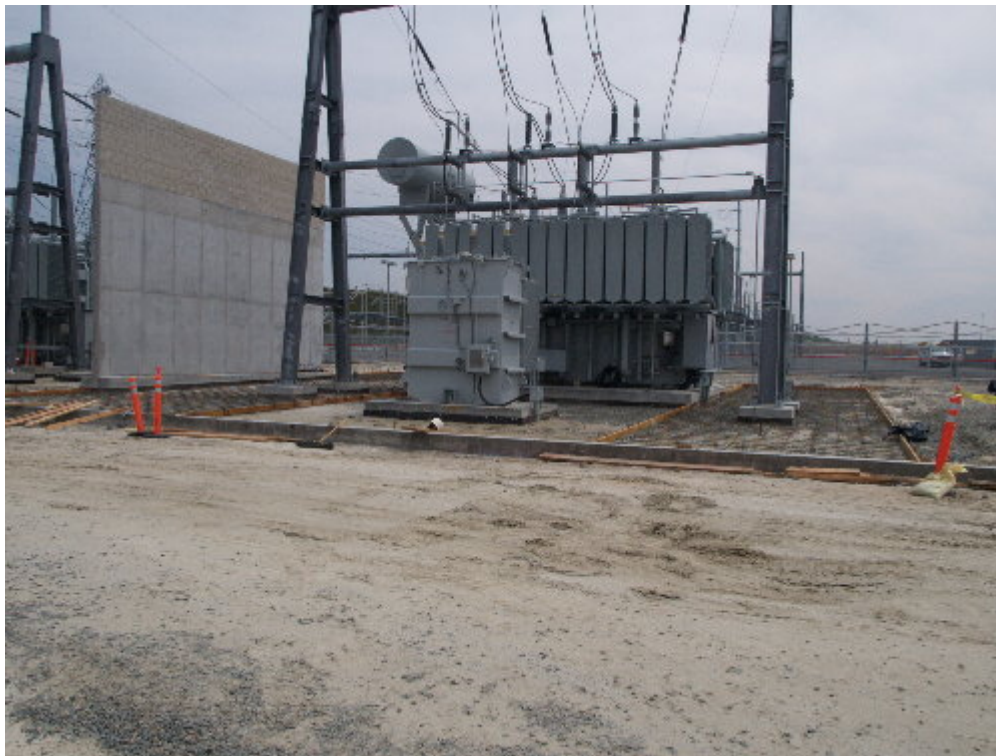
4. A small crew worked to test the 66 kV transformers and associated equipment in preparation for energizing that section of the substation site.
5. The 12 kV area of the substation site has been rocked and forms have been placed around the A-bank transformers in preparation for pouring the concrete pads that will connect the various foundations (see Figure 3). The pouring of the pads was delayed by the rainfall over the previous weekend and the crews will need to perform minor clean-up of the forms before pouring can resume. An asphalt berm will be placed around the perimeter of the pad to contain the oil from the transformers in case of an accident.

Figure 3 – The forms were set for the concrete pads that will be poured between the various foundations.

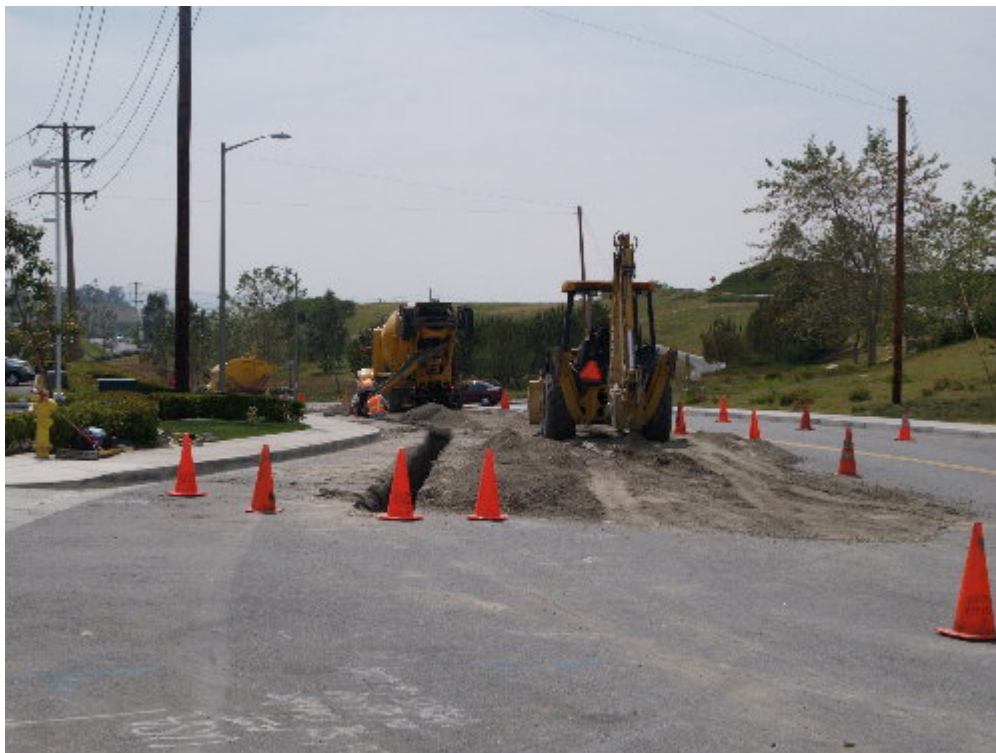
6. A crew with Arizona Pipeline worked on Definition Road outside the substation site on the 12 kV buried cables connecting the substation to the distribution network (see Figure 4). The crews have been trenching, placing conduit and backfilling with a slurry mix. The CPUC EM noted traffic control issues resulting in wrong-way traffic within the work area and notified both SCE and the Arizona Pipeline superintendent. The superintendent addressed the problem immediately and stated that all workers will be reminded to follow approved traffic control practices.

Figure 4 – Arizona Pipeline worked on trenching, laying conduit for the 12 kV distribution conductor, and backfilling with slurry.

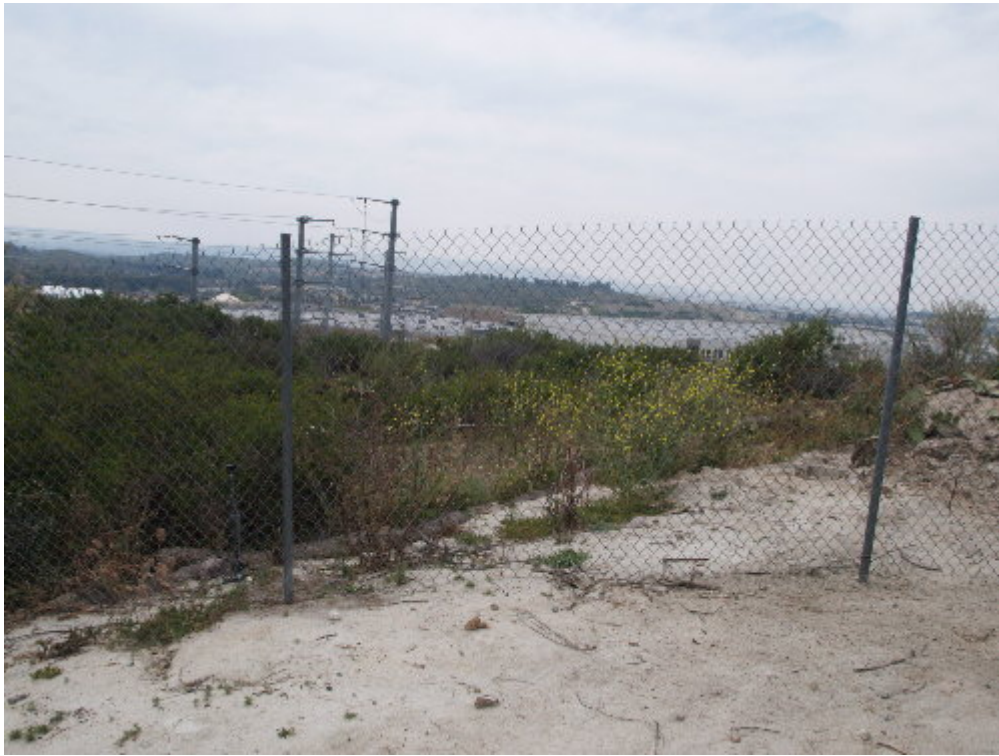
The CPUC EM informed the SCE biologist that the invasive plant species in the recontoured area of the 220 kV right-of-way need to be removed due to the proximity of the native plant communities (see Figure 5). The area adjacent to the project is dominated by native species and is part of a habitat conservation area.

Figure 5 – The CPUC EM reminded SCE to remove invasive non-native plants from the 220 kV right-of-way, adjacent to the native habitat.

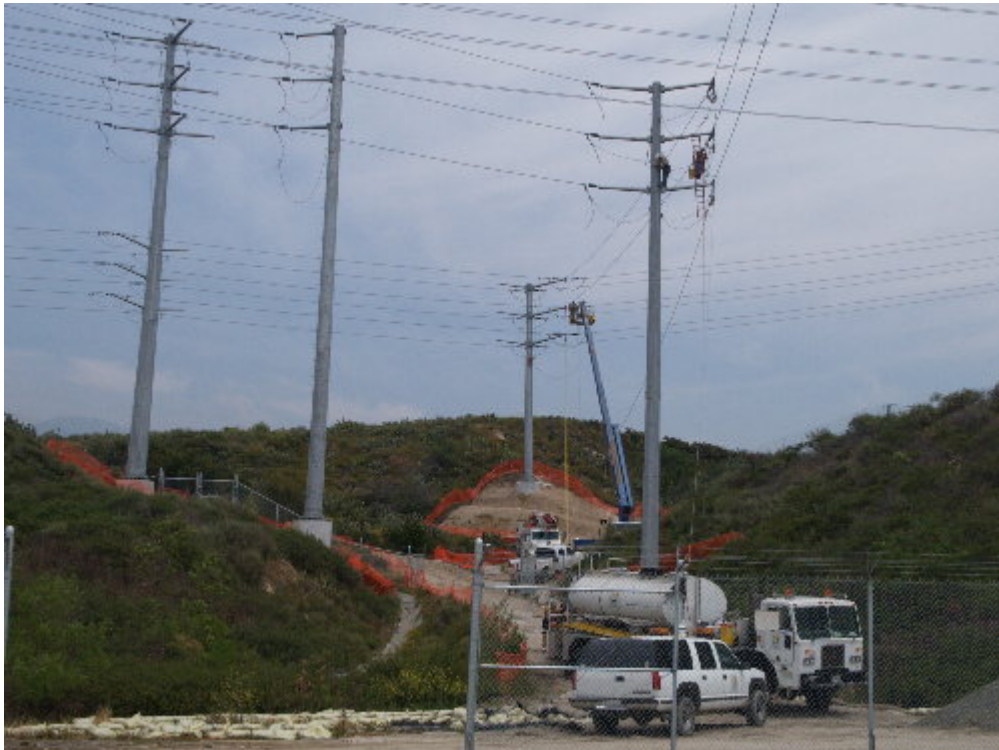
NTP #3, for the 66 kV work within the City of Lake Forest was issued on February 1, 2005 and NTP #4 was issued on April 19, 2005 for the remaining 66 kV H-structures. The transmission line crew worked on stringing conductor between the 66 kV section of the substation site and the 66 kV structures immediately above the substation site (see Figure 6). The conductor temporarily bypassing the substation is still in place and will be removed after the 66 kV section is ready for energization.

Figure 6 – Crews worked on stringing conductor between the 66 kV line and the substation during the site visit.
