## **PROJECT MEMORANDUM SCE – VIEJO SYSTEM PROJECT**

**To:** Jensen Uchida, CPUC  
**From:** Vida Strong, Aspen Project Manager  
**Date:** September 2, 2005  
**Subject:** Weekly Report #57, September 4 – September 10, 2005.  
**CPUC Environmental Monitor (EM):** Christopher Meyer

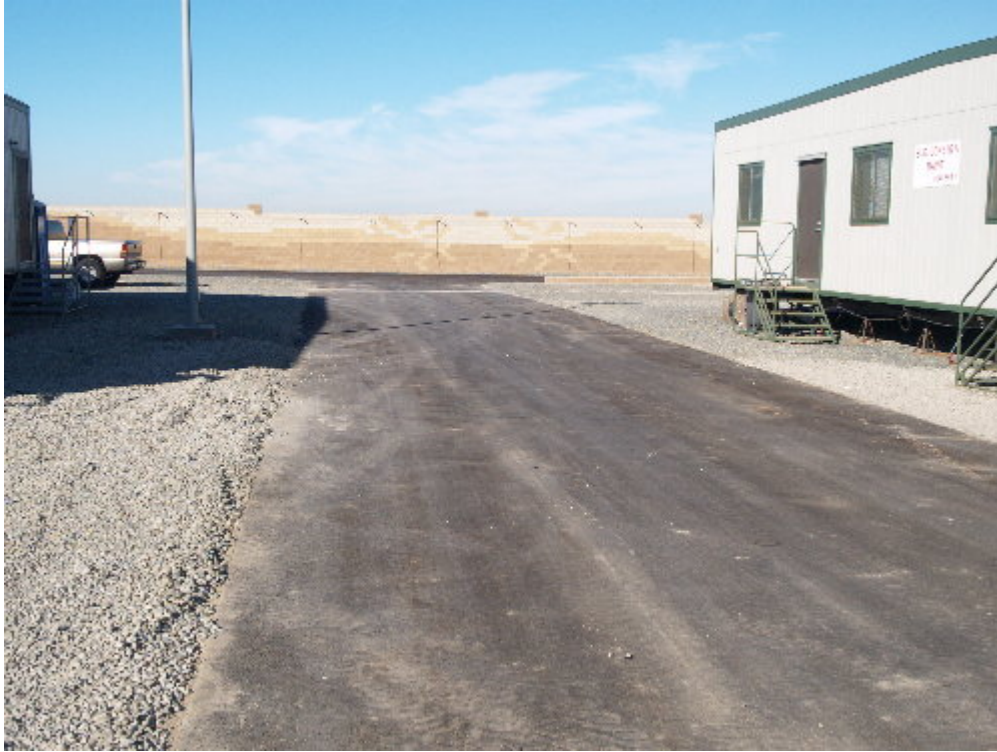
1. No construction activities were observed during the site visit. Gravel has been placed on the apron of the new asphalt road throughout the substation site (see Figure 1).

**Figure 1** – The gravel has been laid on the apron of the new roads within the substation site.

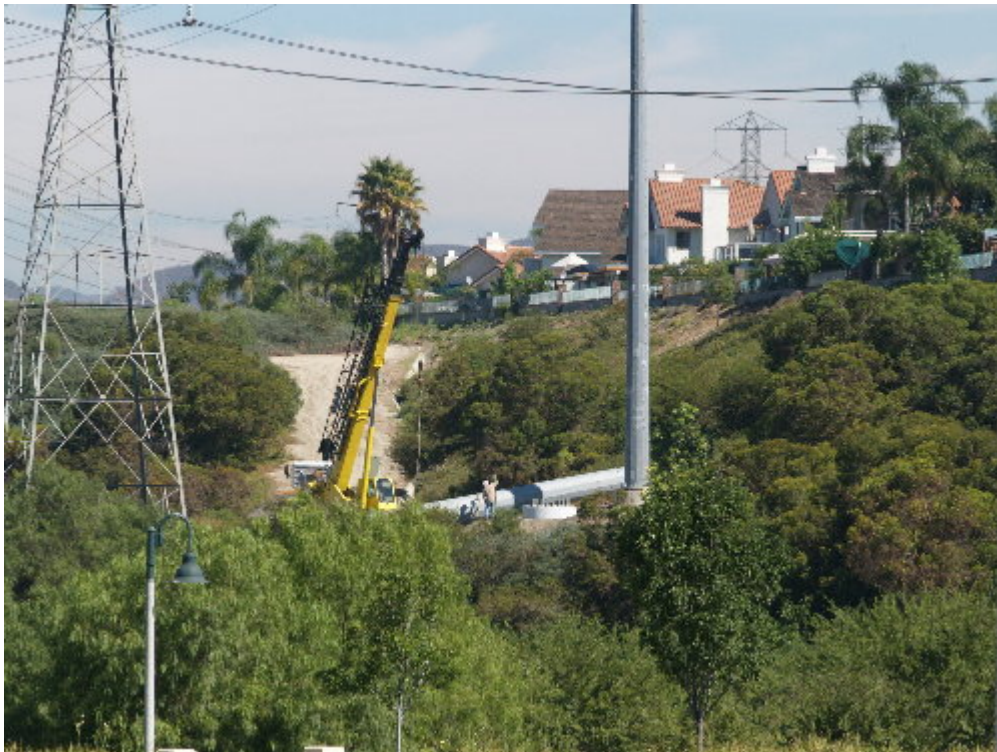
**Figure 2** – The crane was set up at H-Structure 4 and the crew prepared to raise the steel pole sections.

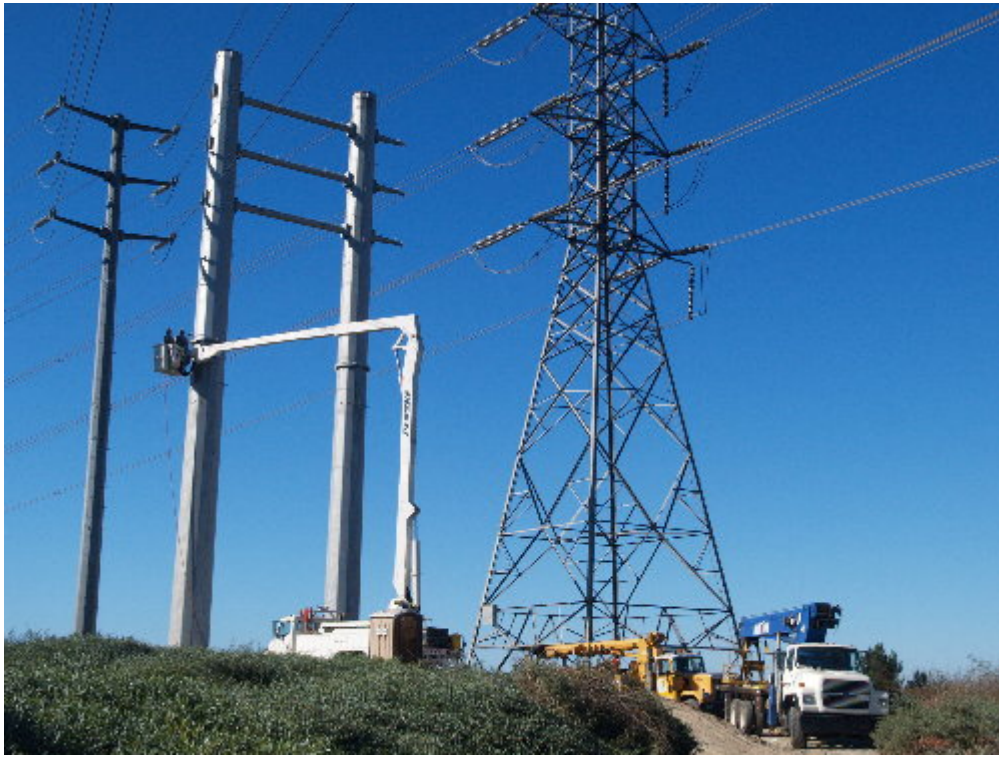
**Figure 3** – The crew at H-Structure 5 worked to tighten the bolts on the arms.

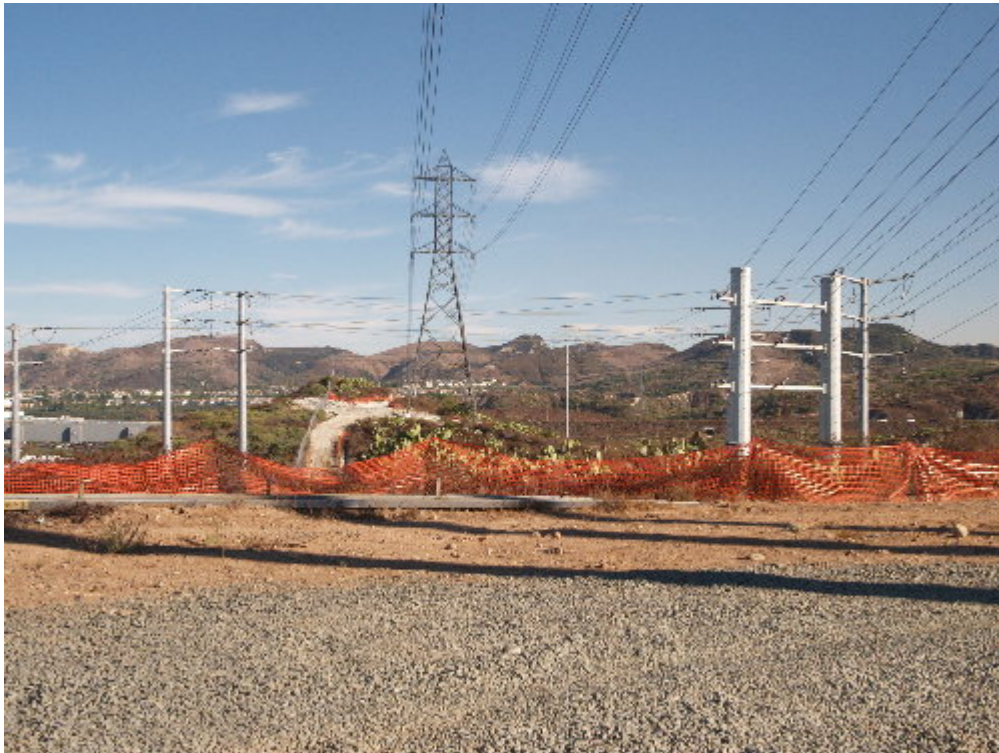
**Figure 4** – Conductor has been pulled between the substation and H-structure 10.

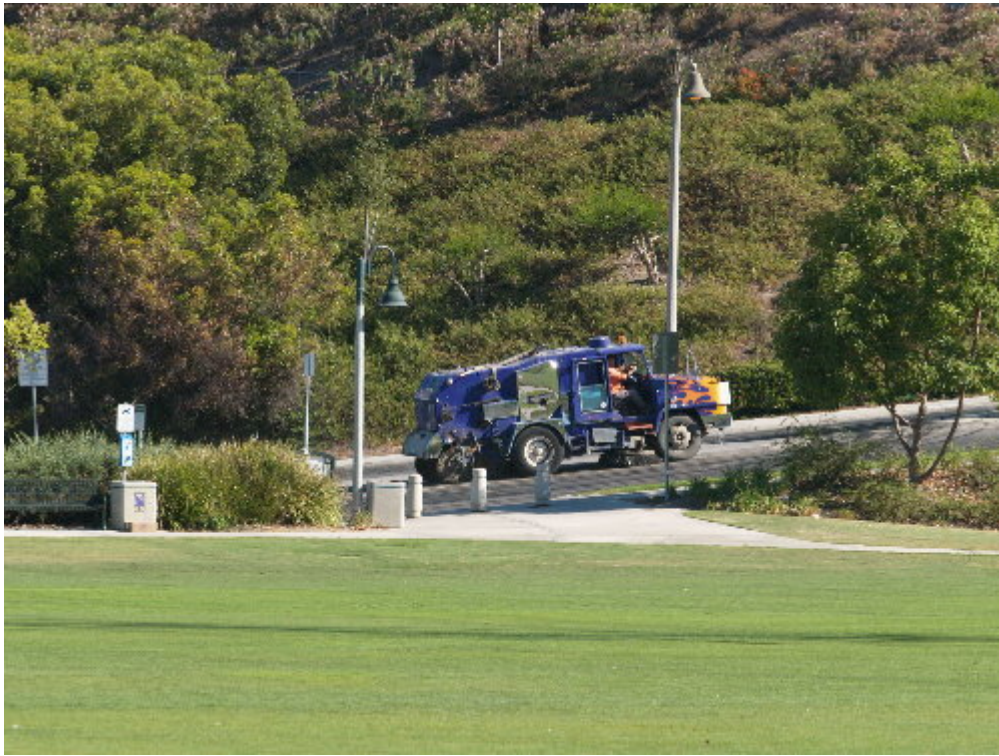
The CPUC EM noted that the access road and pads north of Olympiad Park were very dry and needed water. Due to the Mission Viejo permit conditions, the water truck did not arrive until 9 A.M., after crews had been working at the site. Dirt tracked from the right-of-way on to the public street was cleaned with a sweeper truck (see Figure 5).

**Figure 5** – A sweeper truck was used to clean the public right-of-way at the entrance to the access road.
