## **PROJECT MEMORANDUM SCE – VIEJO SYSTEM PROJECT**

**To:** Jensen Uchida, CPUC  
**From:** Vida Strong, Aspen Project Manager  
**Date:** September 21, 2005  
**Subject:** Weekly Report #58, September 11 – September 17, 2005.  
**CPUC Environmental Monitor (EM):** Christopher Meyer

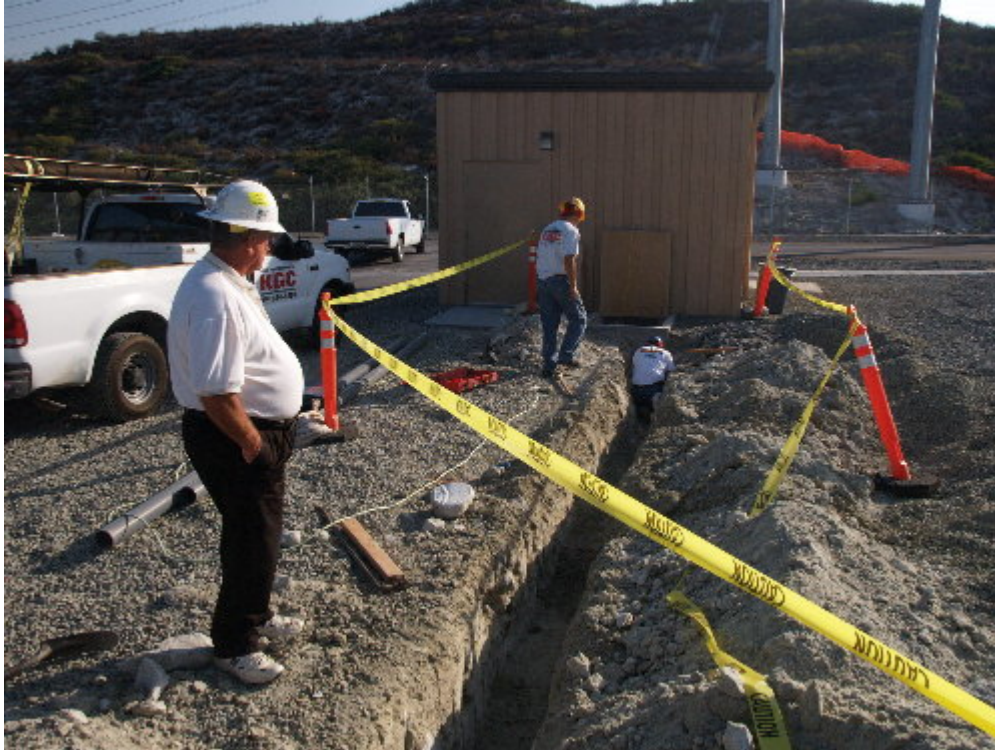
1. A small crew with KGC worked to install a portion of the fiber optic system that will monitor the temperature of the underground conduit leading from the substation site (see Figure 1). The crew used a small combination machine to excavate the trench west from MEER #2.

**Figure 1** – KGC trenched west from MEER #2 to install fiber optic cable that will monitor the temperature of the underground conduit.

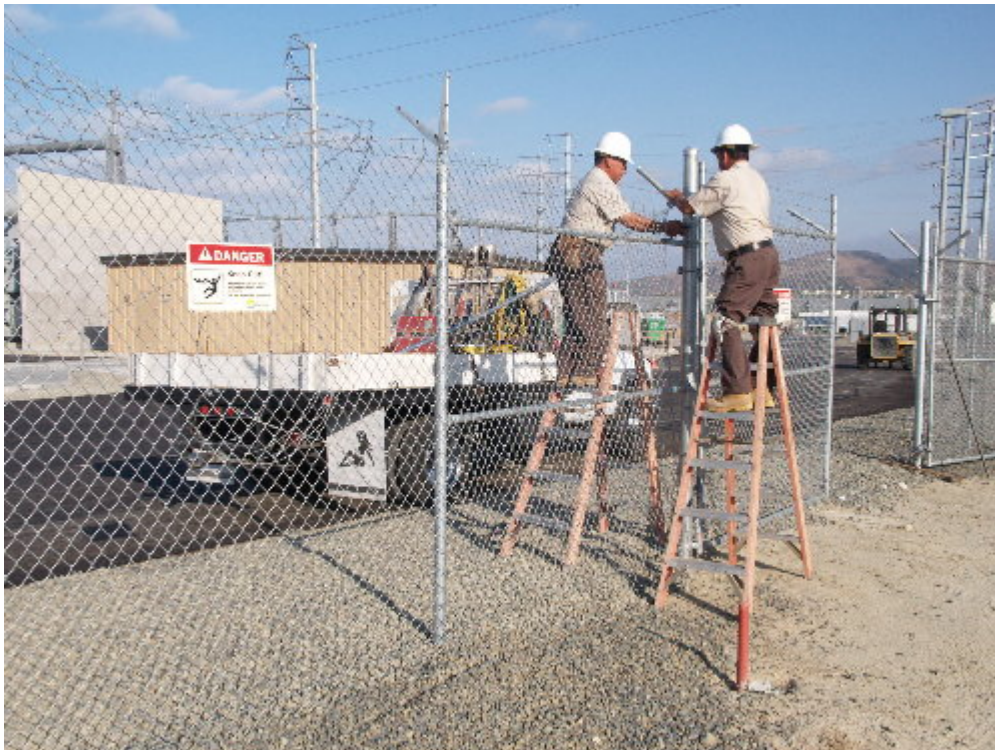
2. Two workers from the fencing subcontractor repaired a section of the fence on the east side of the substation site damaged during construction (see Figure 2).

**Figure 2** – The fencing subcontractor repaired damage to the eastern fence during the site visit.

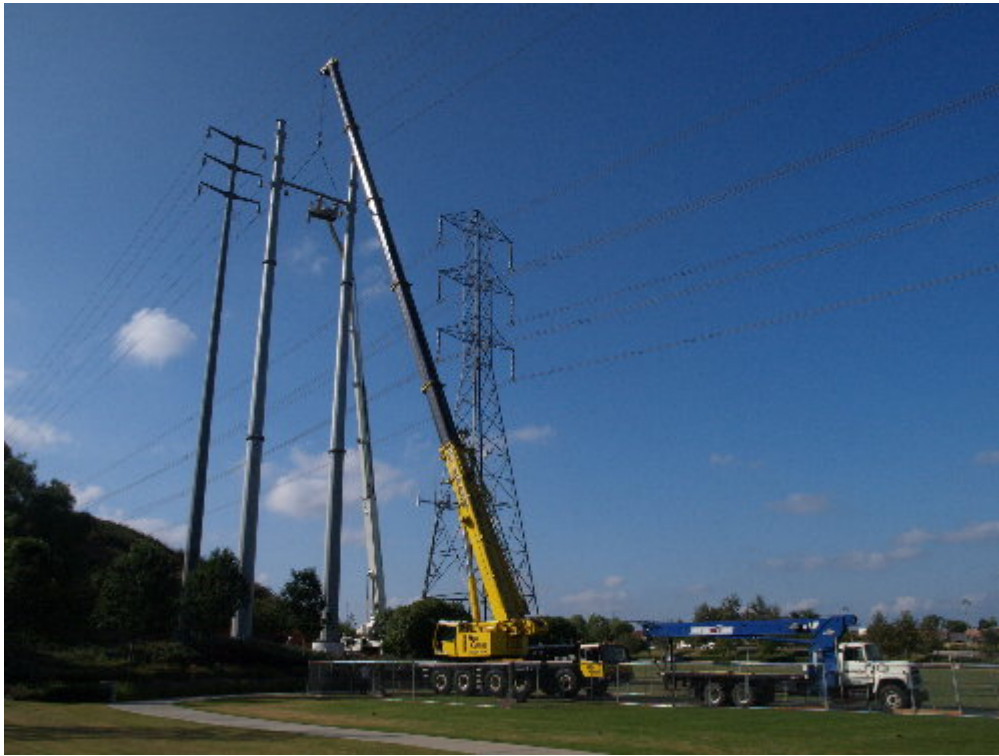
1. An SCE transmission line crew worked in Olympiad Park with a man-lift and a large crane to attach the cross-members to connect the two steel poles that make up the H-Structure (see Figure 3). A section of the park was fenced off during the operation and plates were placed to distribute the weight of the crane on the grass.

**Figure 3** – The SCE transmission line crew worked to attach the cross-members to the H-Structure in Olympiad Park.

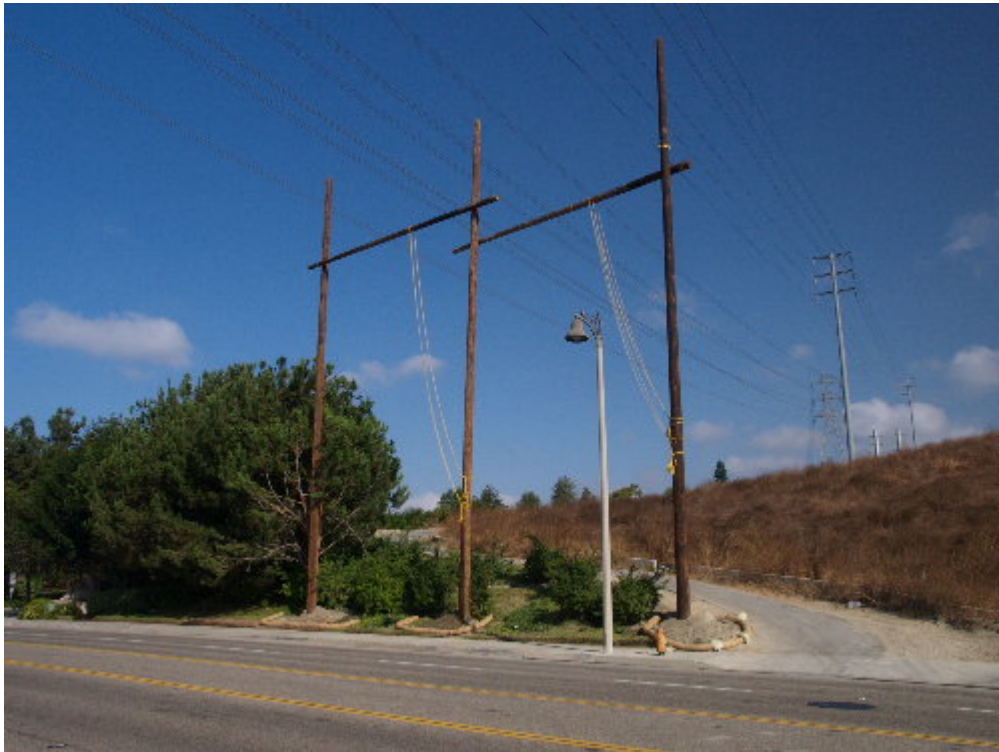
BMPs have been placed at the base of the guard structures to prevent the loose material from being transported onto the public right-of-way (see Figure 4).

**Figure 4** – BMPs have been placed at the base of the guard structures.
