PROJECT MEMORANDUM SCE – VIEJO SYSTEM PROJECT

To: Jensen Uchida, CPUC
From: Vida Strong, Aspen Project Manager
Date: October 31, 2005
Subject: Weekly Report #64, October 23 – October 29, 2005.
CPUC Environmental Monitor (EM): Christopher Meyer

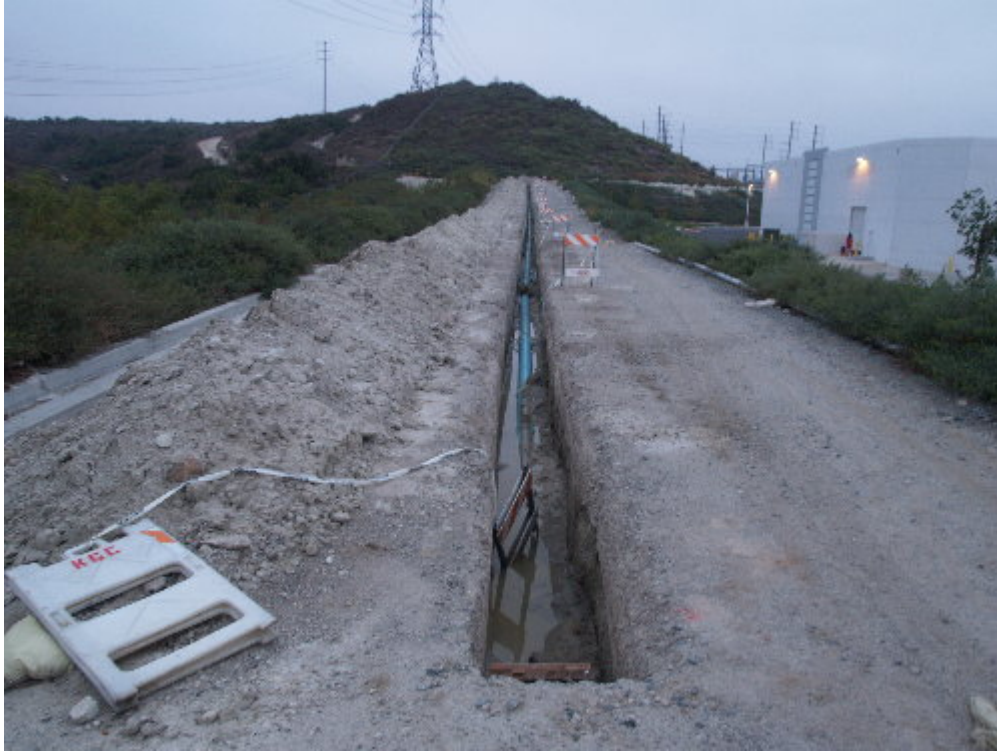
1. No progress was observed on the water line leading into the substation site during the subject week. Sections of the open trench on the south end of the access road have been covered with steel plates for safety and to provide access. SCE engineers are working to make the second set of revisions required by the Water Department and resubmit the permit application so that the water line work can resume. The CPUC EM informed SCE that the trench and pipe will need to be examined by a biologist prior to work resuming. Animals may have taken up residence in the trench or pipe since work was suspended. With the recent rains, SCE will have to address dewatering and sediment control now that water has entered the trench. The dirt road has dried out since the rain during the previous week; however, there is still some water in the trench (see Figure 1).

Figure 1 – The open trench on the main entrance to the Viejo Substation has partially drained, but water remains. Some of the pipe is now covered with silt.

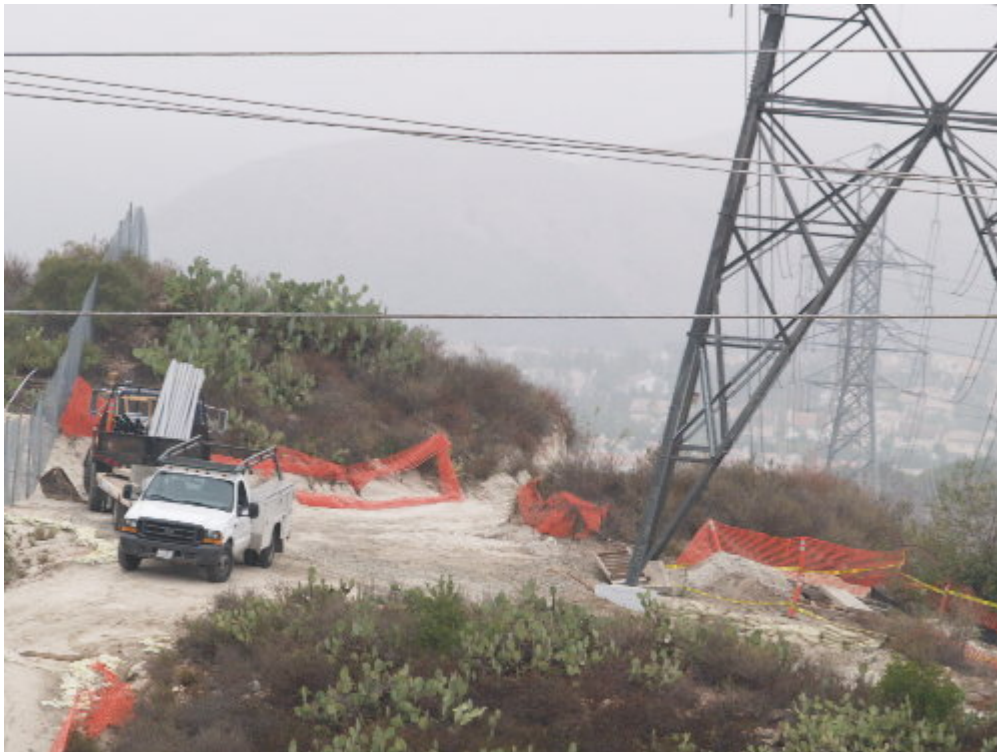
1. The invasive plant species in the recontoured area of the 220 kV right-of-way, adjacent to the native plant communities, have been removed by SCE without disturbing the native species. However, some of this area was disturbed during the site visit by a crew placing communication conduit along the SCE right-of-way (see Figure 2). This crew is not part of the Viejo System Project. The area adjacent to the project is dominated by native species and is part of a habitat conservation area. Parts of the 220 kV right-of-way that have not recently been disturbed are showing natural revegetation by native species (see Figure 3).

Figure 2 – A crew unrelated to the Viejo System Project installed communication conduit in the SCE right-of-way above the Viejo Substation.

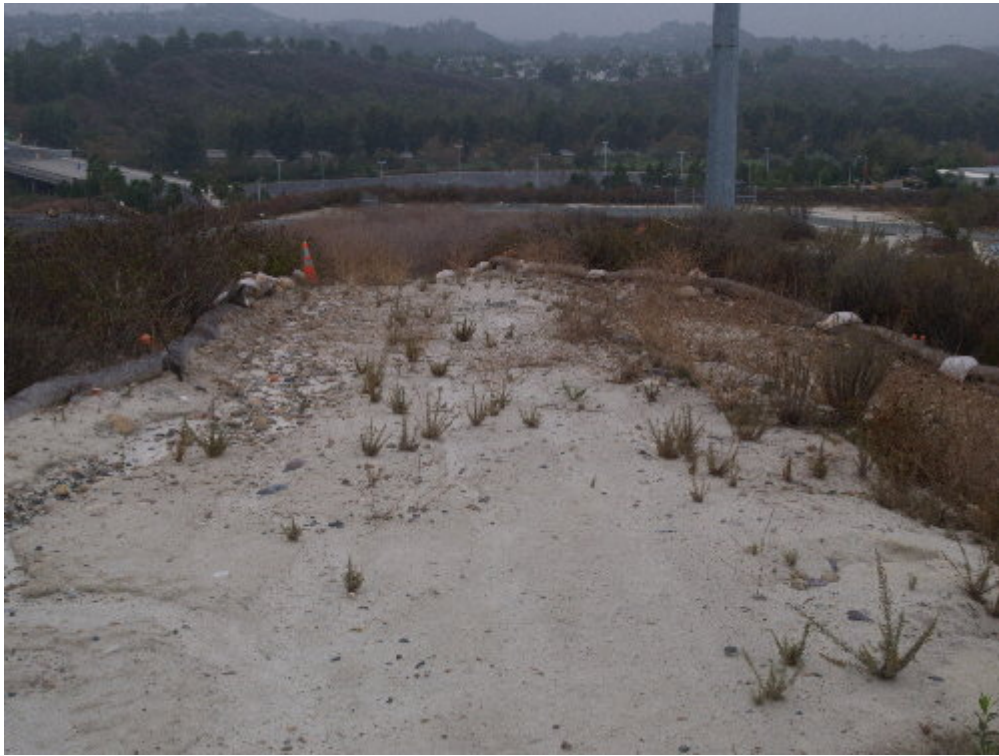
Figure 3 – Native vegetation is naturally returning to sections of the 220 kV right-of-way that have been undisturbed for several months.

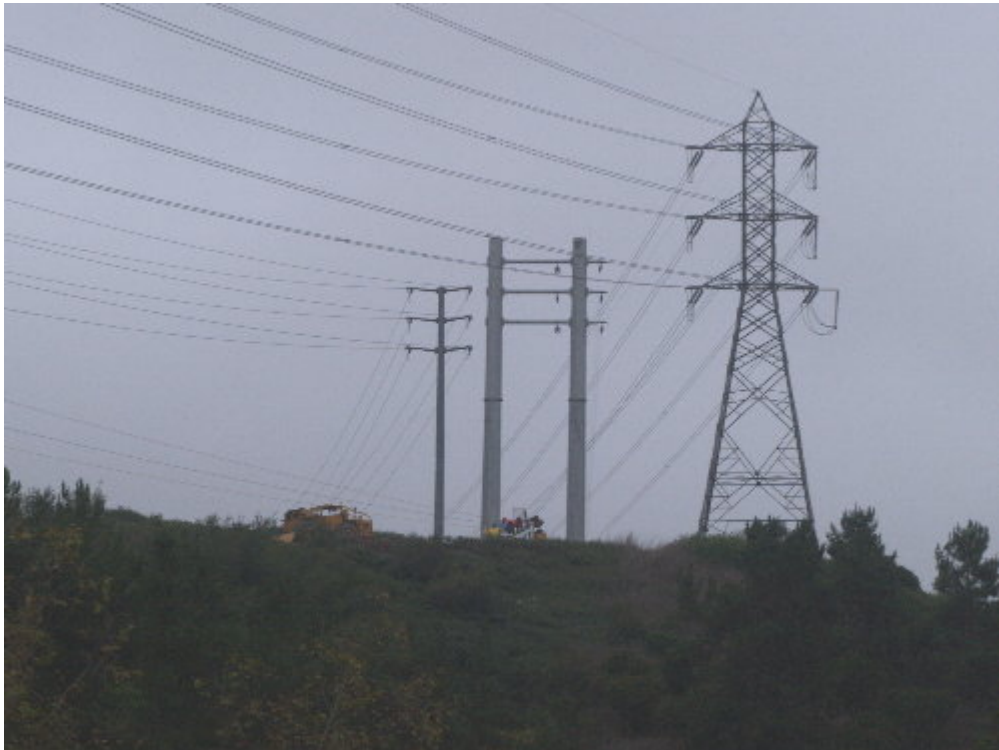
1. SCE transmission line crews were set up above Birchwood Park to pull conductor from Structure 5 to Structure 7 (see Figure 4). Crews were working at both Structure 5 and Structure 7 during the site visit, with additional workers checking the right-of-way between the pulling stations. No other work was noted during the site visit.

Figure 4 – SCE crews worked to pull conductor between Structures 7 and 5 during the site visit.
