## **PROJECT MEMORANDUM SCE – VIEJO SYSTEM PROJECT**

**To:** Jensen Uchida, CPUC  
**From:** Vida Strong, Aspen Project Manager  
**Date:** November 22, 2005  
**Subject:** Weekly Report #67, November 13 – November 19, 2005.  
**CPUC Environmental Monitor (EM):** Christopher Meyer

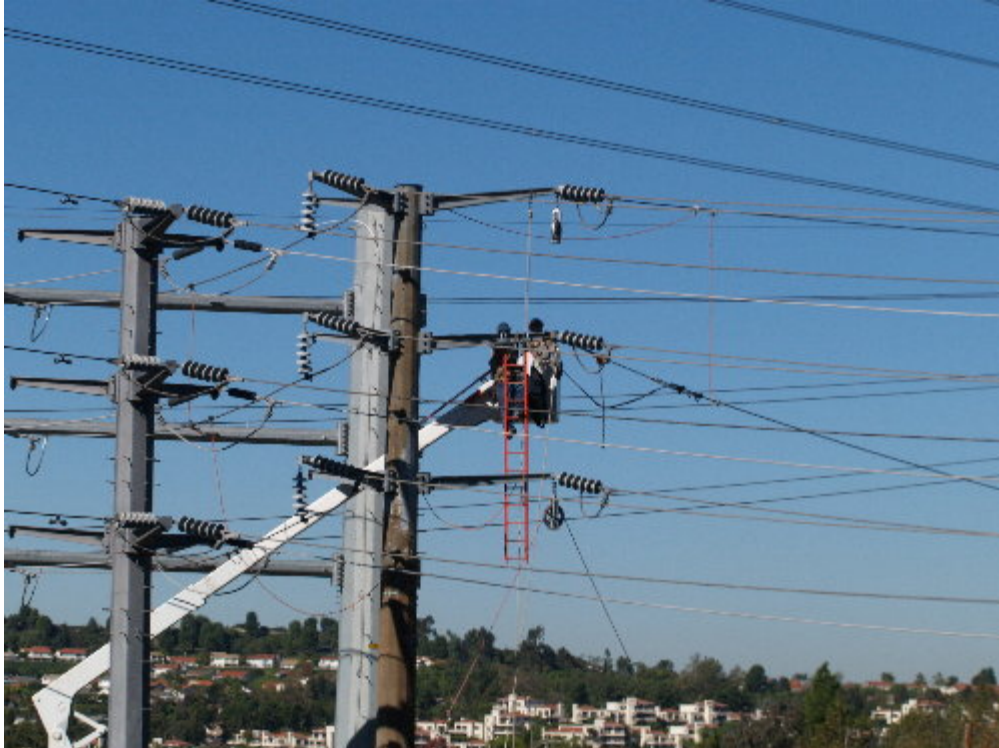
1. Two SCE transmission line crews were set during the site visit to wreck out the old 66 kV conductor on the adjacent towers between the new H-Structure 5 and the Chiquita Substation (see Figure 1). One crew worked adjacent to the Chiquita Substation disconnecting the old conductor and splicing rope to reel out the old conductor (see Figure 2). The other crew, working adjacent to Structure 5, used a reel truck to bring in the old conductor. Crews watched the two roads crossed by the operation to ensure the safety of passing motorists. No other work was noted during the site visit.
2. Crews have completed repairs to the asphalt transitions damaged during construction at several locations. The road at La Barca was repaired in several places (see Figure 3).

**Figure 1** – A crew set up adjacent to H-Structure 1 with a boom truck to support the crew wrecking out the old conductor on the 66 kV steel pole.

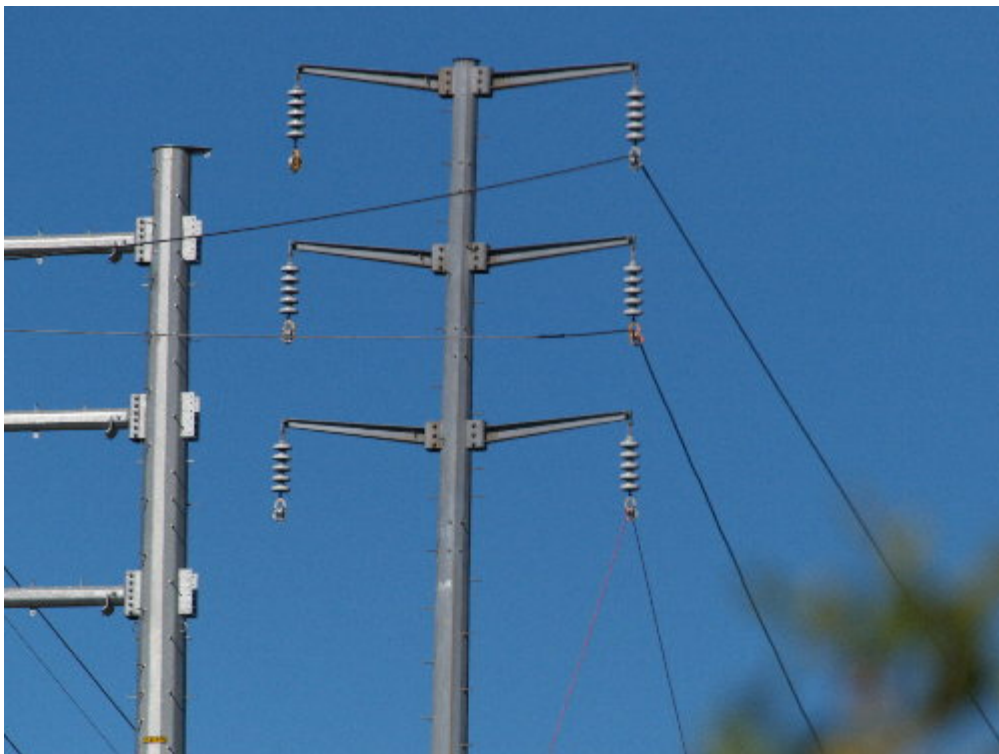
**Figure 2** – The center conductor on the old 66 kV steel poles has been spliced with rope for wrecking out. The bottom conductor has already been removed.

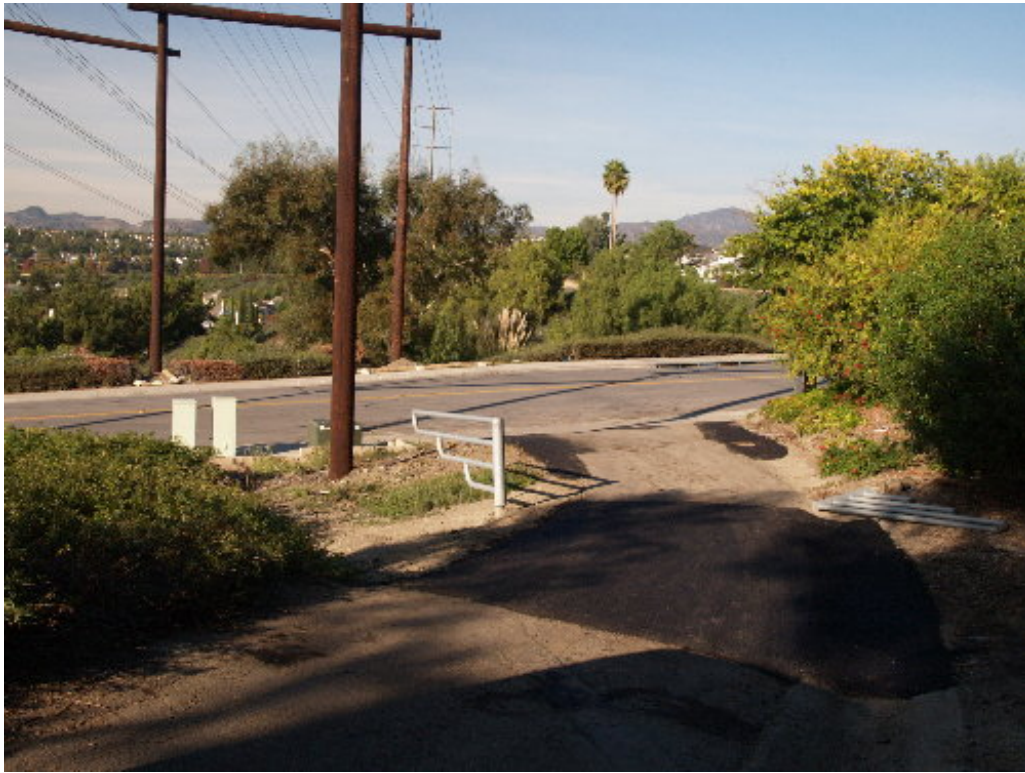
**Figure 3** – The damage to the access road off La Barca done during construction has been repaired.
