PROJECT MEMORANDUM
PG&E WINDSOR SUBSTATION PROJECT

To: Eric Chiang, Project Manager, CPUC
From: Vida Strong, Aspen Project Manager
Date: January 18, 2017
Subject: Monitoring Report #5 – January 2, 2017 to January 15, 2017

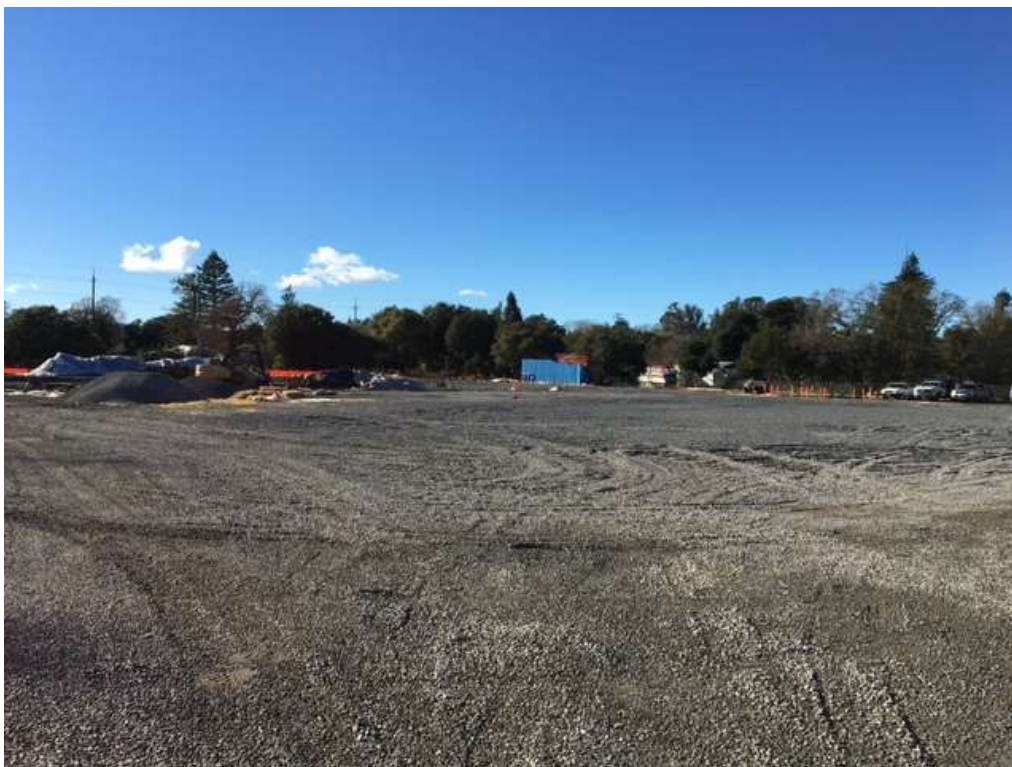
Limited construction activities occurred during the week due to wet weather conditions. Approximately 70 percent of the site is stabilized with rock fill (see Figure 1). Construction activities only occurred on January 5th and 6th due to wet weather conditions, during which time spoils were off-hauled.

Figure 1 – Base rock compacted at substation site – view west-northwest, January 5, 2017.

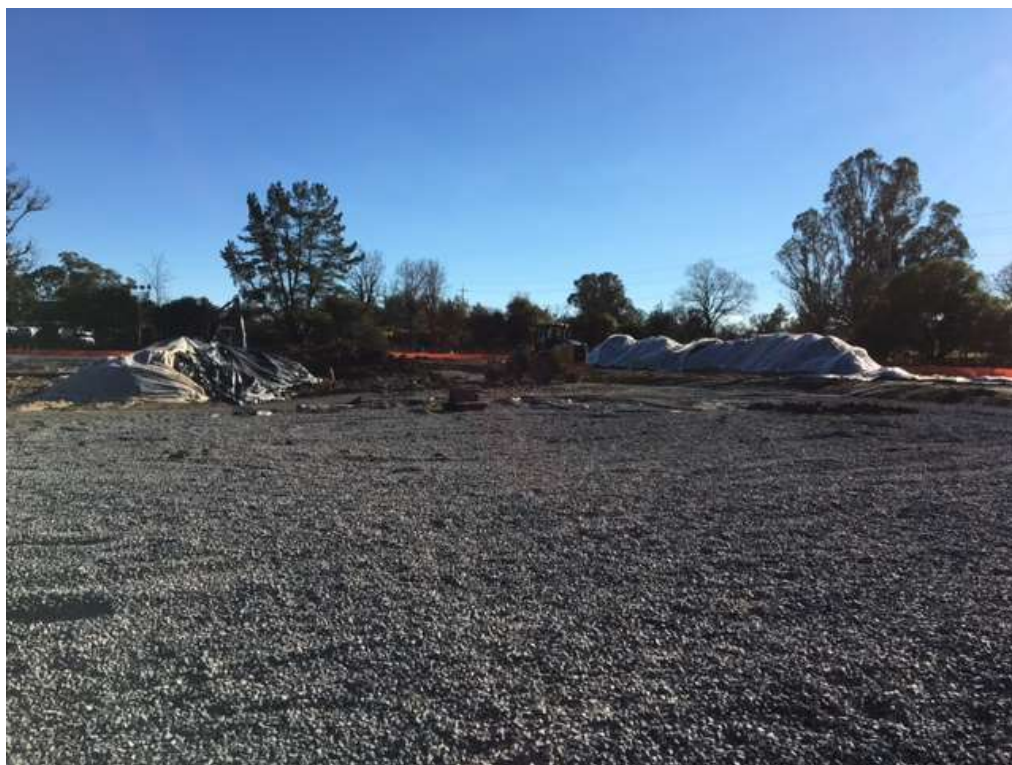
At the time of the CPUC EM's site visit on Thursday, January 5th, crews were preparing the site for upcoming storm events by covering spoil piles with plastic surrounded by fiber rolls, maintaining BMPs, and cleaning up trash (see Figure 2). The CPUC EM walked around the site and inspected BMPs, which were noted to be functional.

Figure 2 – Soil piles covered with plastic at the substation site – view south, January 5, 2017.

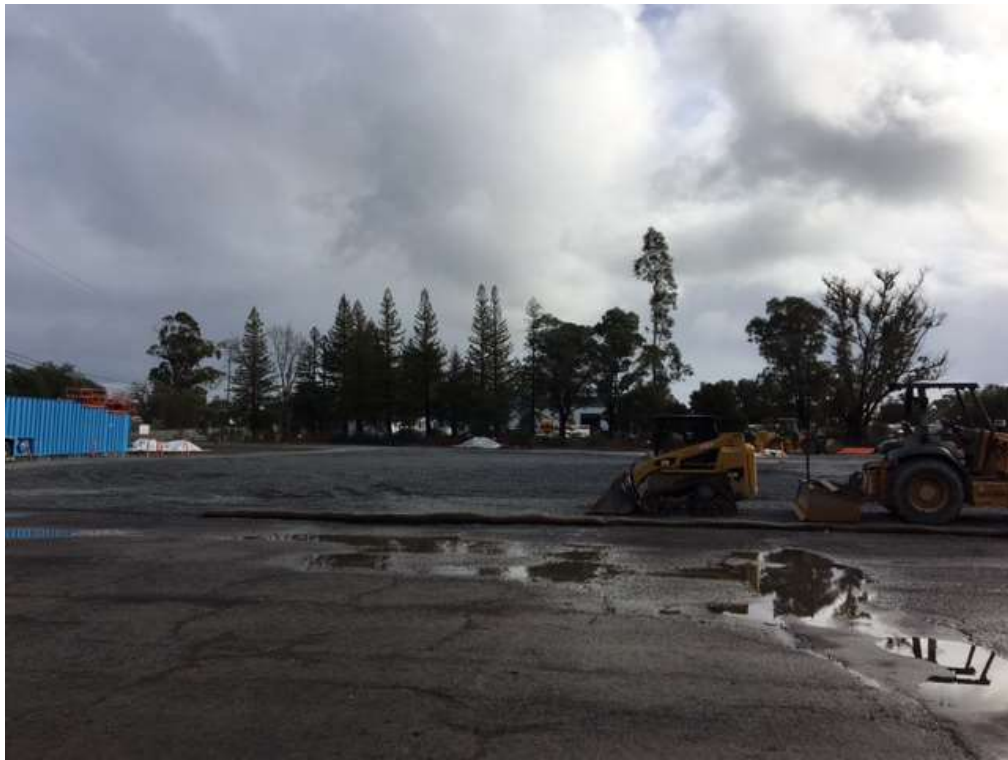
At the time of the CPUC EM site visit on January 11th, no crews were working at the site and it was lightly raining. The CPUC EM walked along the perimeter of the substation site on the north side along Herb Road (see Figure 3). No water was observed flowing off-site, except what was flowing through the drainage inlets, which were surrounded with BMPs (see Figure 4). The unnamed ephemeral creek was running fairly clear (see Figure 5).

Figure 3 – Substation site after storm event – view south, January 11, 2017.

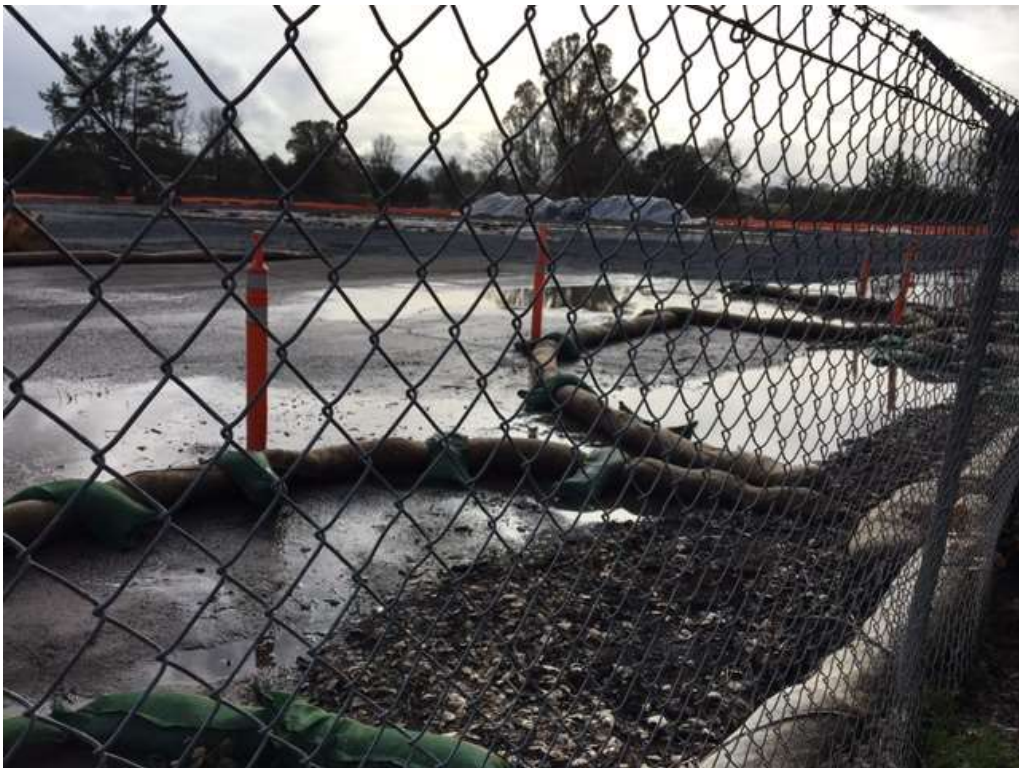
Figure 4 – Drainage inlets on the northern side of the substation site, January 11, 2017.

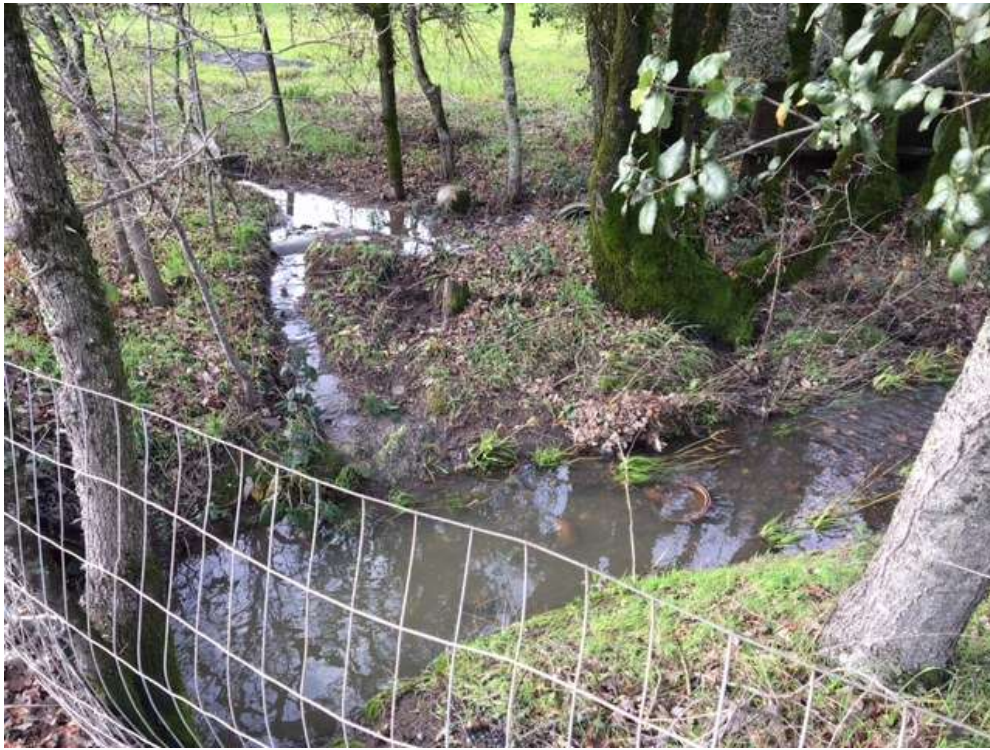
Figure 5 – Unnamed ephemeral creek north of substation, January 11, 2017.
