<b>California Public Utilities Commission</b> <b><i>Mitigation Monitoring, Compliance, and Reporting Program</i></b>
	<b>Cleveland National Forest Power Line Replacement Projects</b>  <b>Compliance Status Report: 011</b>  <b>February 19, 2017</b>

This compliance status report covers construction activities from February 6 through February 19, 2017.

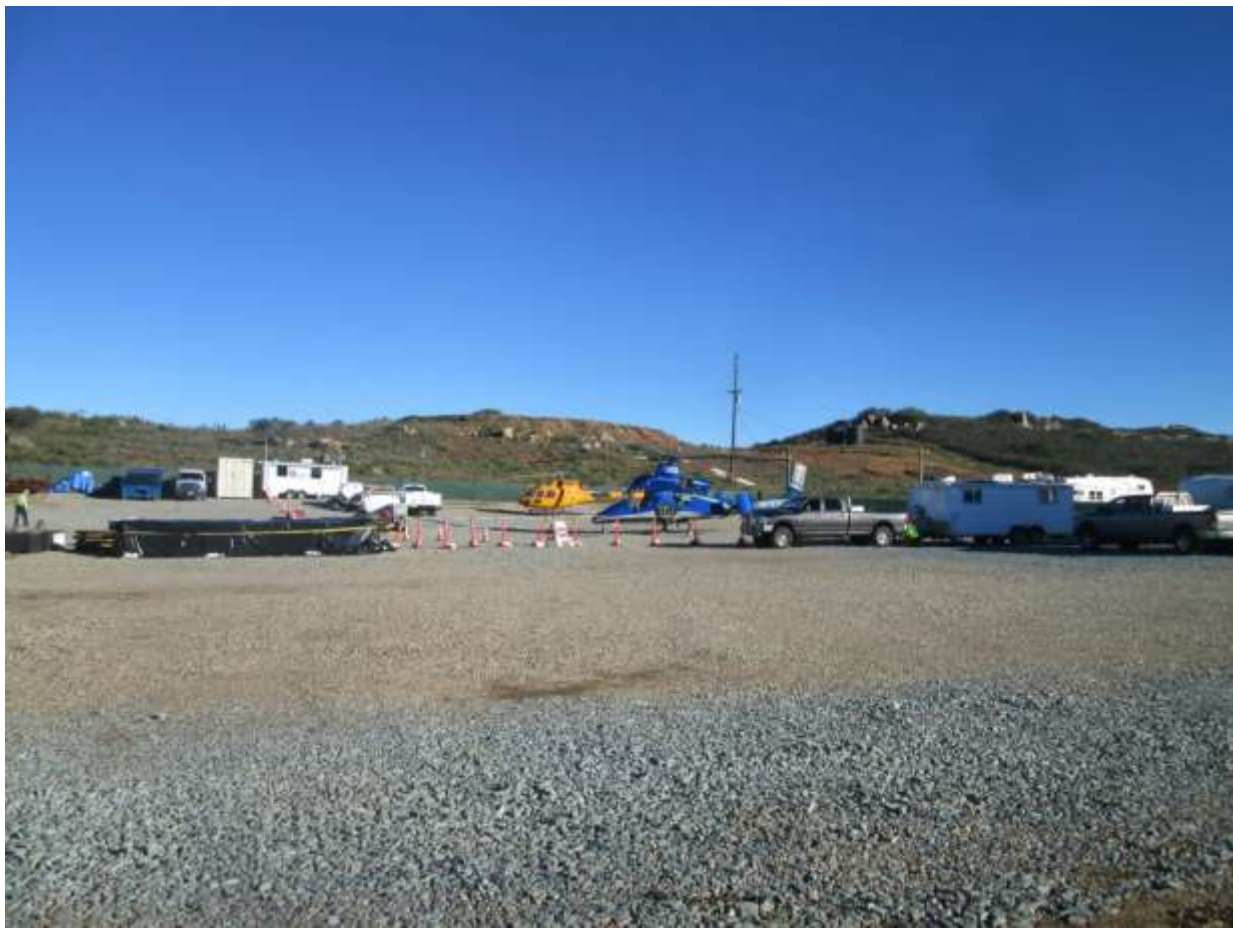
Helicopters were utilized to transport equipment and materials to project components not accessible by vehicle. Helicopter staging and fueling occurred in a designated landing area in Japatul Spur Staging Yard, and external load operations were conducted in accordance with the Aviation Safety Plan (MM PHS-05) (See Photo 1—Attachment A).

**Photo 1:** In accordance with the Aviation Safety Plan (MM PHS-05), helicopter staging and fueling was observed in a designated landing area set-up in the northeastern corner of Japatul Spur Staging Yard (TL 625B).

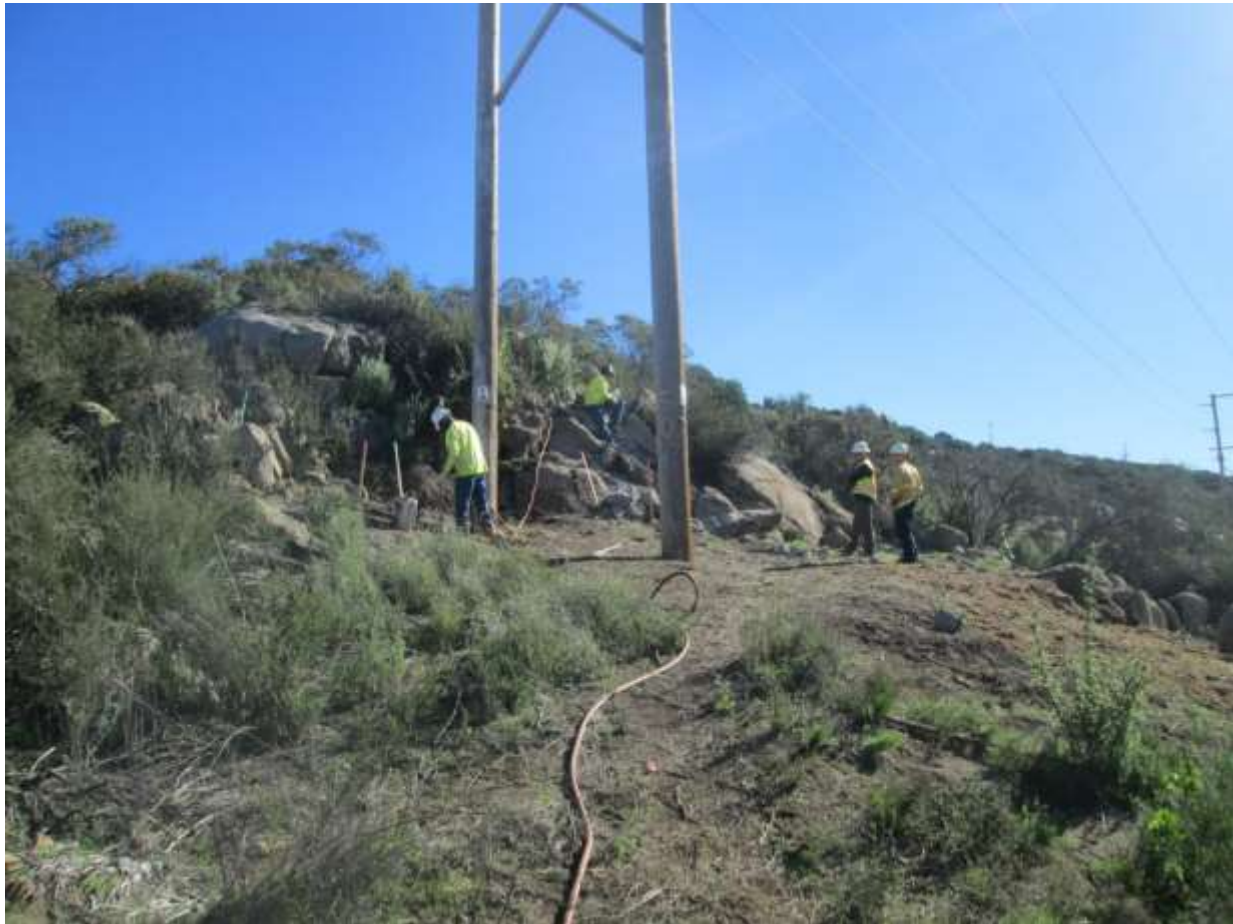
During construction activities, crews were observed working within the delineated workspace in accordance with MM BIO-1. Biological monitors were observed surveying along the project alignment and surrounding areas to ensure compliance with environmental specifications in accordance with MM BIO-3 and MM BIO-22 (See Photo 2—Attachment A). Environmentally Sensitive Area (ESA) signs were posted along the limits of construction to prevent impacts to special status and butterfly host plants in accordance with MM BIO-13, MM BIO-14, and MM BIO-16.

**Photo 2:** During site clearing at Pole Z272898 (TL 625B), a biological monitor was observed inspecting the site to ensure compliance with environmental measures in accordance with MM BIO-3 and MM BIO-22, while a fire patrol was observed monitoring the work activity to ensure compliance with the Construction Fire Prevention/Protection Plan (MM FF-1), MM BIO-6, APM HAZ-01, and APM HAZ-04.

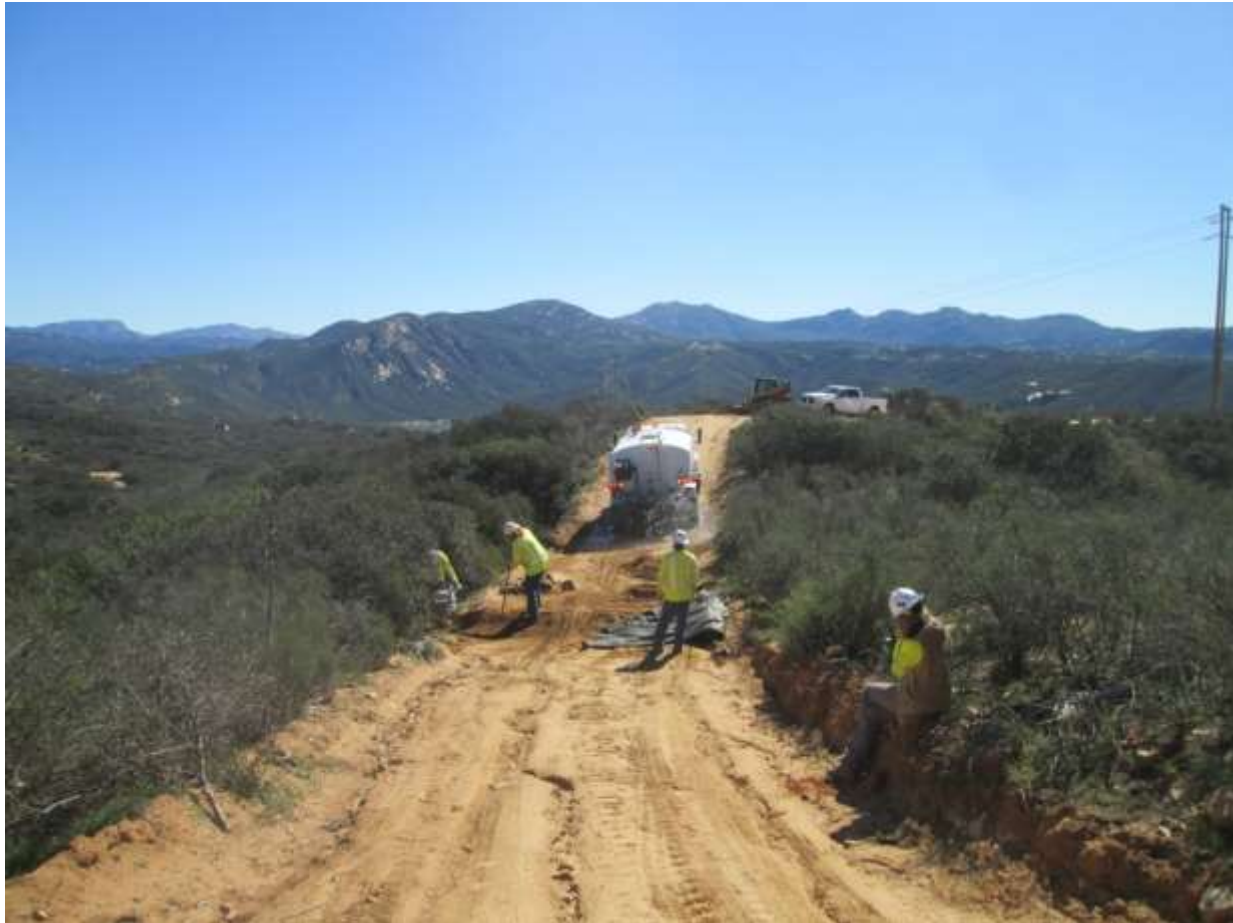
In accordance with the Construction Fire Prevention Protection/Protection Plan (CFPPP) (MM FF-1) and MM BIO-6, APM HAZ-01, APM HAZ-04, construction crews were observed carrying the activity-specific fire safety equipment required by the Project Fire Prevention Matrices (Off CNF Land, and On CNF Land), and fire patrols were observed inspecting work areas to ensure compliance (See Photo 3—Attachment A). During the grading of access road water bars and maintenance of energy dissipaters, the construction crew was observed with the required 100 gallons of water, pump, and hose, in addition to the general fire safety tools of a 5 gallon backpack pump, round point shovel, Pulaski, and 2A10BC fire extinguisher. During the activity, a water truck was also observed spraying water during grading to prevent dust emissions in accordance with APM AIR-02 and APM AIR-05 (See Photo 3—Attachment A).

**Photo 3:** A construction crew was observed grading water bars and maintaining energy dissipation devices along the access road to Pole Z272840 (TL 625B) in accordance with the Erosion Control Plan (ECP) and Storm Water Pollution Prevention Plan (SWPPP) (MM HYD-1, APM HYD-05, MM BIO-7). A water truck was utilized to spray water during grading to prevent dust emissions in accordance with APM AIR-02 and APM AIR-05, and to comply with requirements of the Construction Fire Prevention/Protection Plan (MM FF-1), MM BIO-6, APM HAZ-01, and APM HAZ-04.

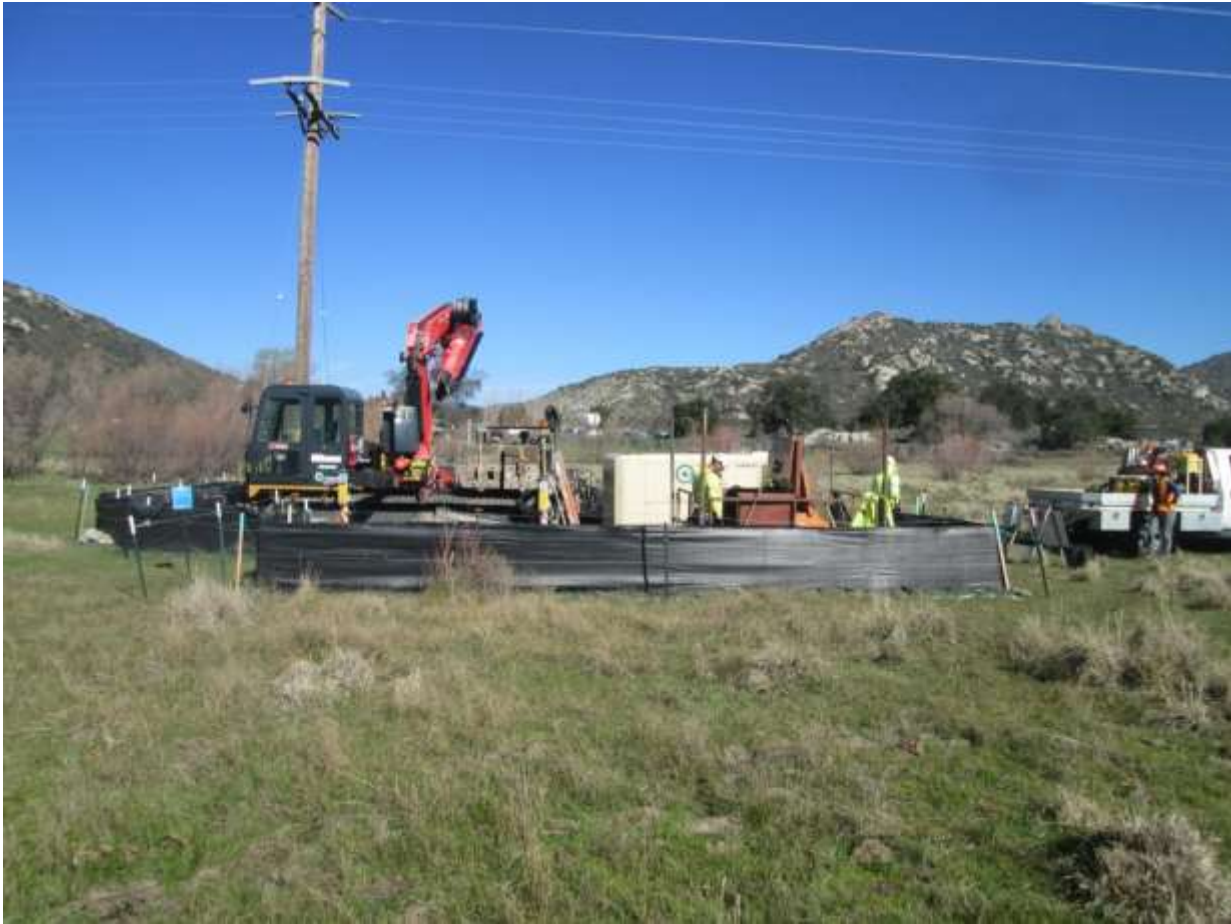
During construction activities, crews were observed using approved access roads and working within the delineated work limits in accordance with MM BIO-1. Biological monitors were observed monitoring work activities along the project alignment in accordance with MM BIO-3 and MM BIO-22. In accordance with the Streambed Alteration Agreement, measures to avoid impacts to arroyo toad were observed being implemented at Z40577, where a qualified biologist was present for all work and exclusionary fencing was observed around the workspace perimeter (See Photo 4—Attachment A). ESA signs were posted along the limits of construction to prevent impacts to special status and butterfly host plants in accordance with MM BIO-13, MM BIO-14, and MM BIO-16. In accordance with MM BIO-4 (Habitat Restoration Plan), salvaged topsoil stockpiles remained at pole locations where crane pad grading had been conducted, and the stockpiles were covered with fiber matting and surrounded by fiber rolls to prevent erosion.

**Photo 4:** During micropile drilling at Pole Z40577 (TL 629E), Arroyo Toad protection measures were observed being implemented in accordance with the Streambed Alteration Agreement, and included the use of exclusionary fencing around the workspace perimeter and the presence of a qualified biological monitor.

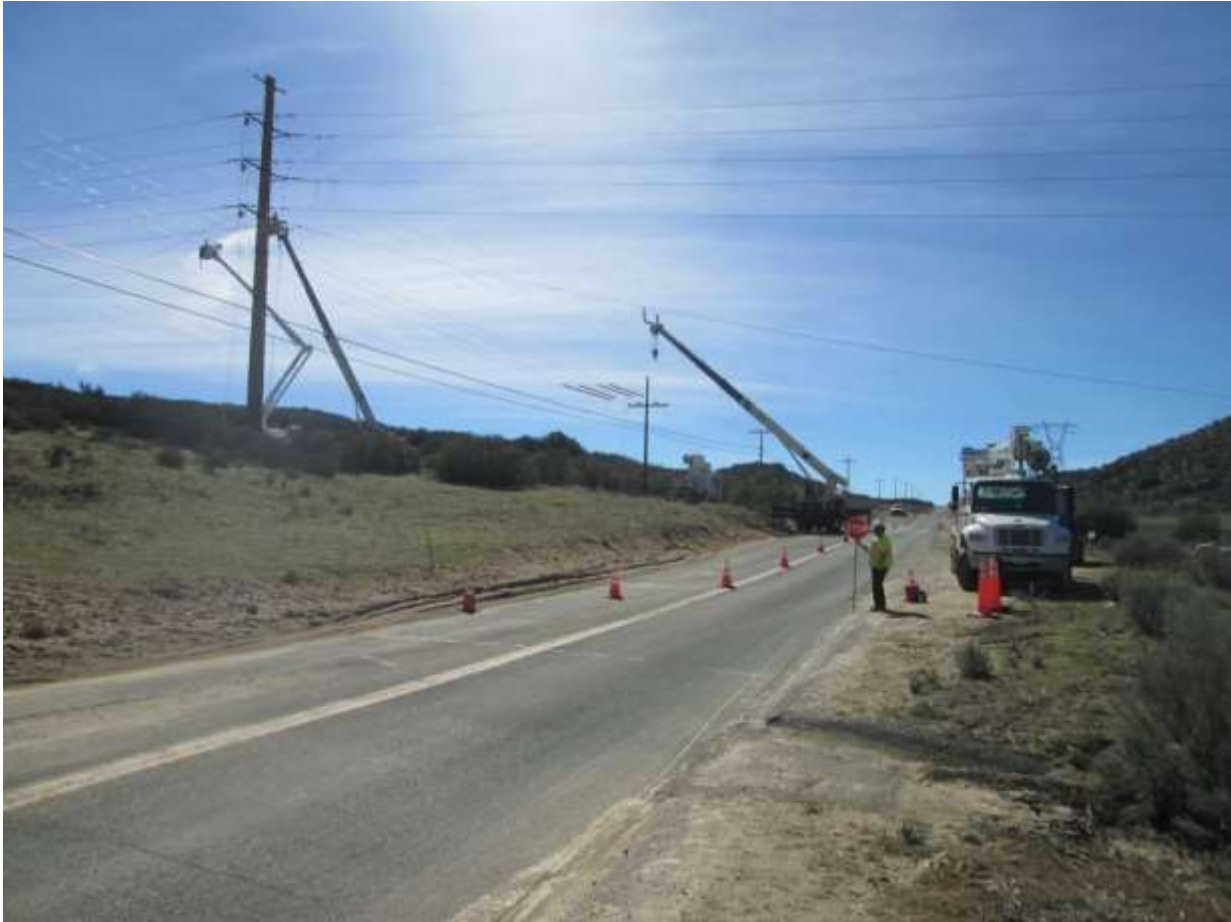
During wire stringing activities that crossed over La Posta Road, traffic control flag persons were observed being utilized to direct one-way traffic safely through the construction zone while one lane was closed for the staging of guard equipment in accordance with APM TRANS-02 (See Photo 6—Attachment A).

**Photo 6:** During wire stringing activities at Pole Z44173 and across La Posta Road (TL 629E), notification signage, cones, and flag persons were observed being utilized to direct traffic safely through the construction zone, where a lane was closed to stage a mobile guard structure unit.
