California Public Utilities Commission <i>Mitigation Monitoring, Compliance, and Reporting Program</i>
	Cleveland National Forest Power Line Replacement Projects Compliance Status Report: 013 March 19, 2017

This compliance status report covers construction activities from March 6 through March 19, 2017.

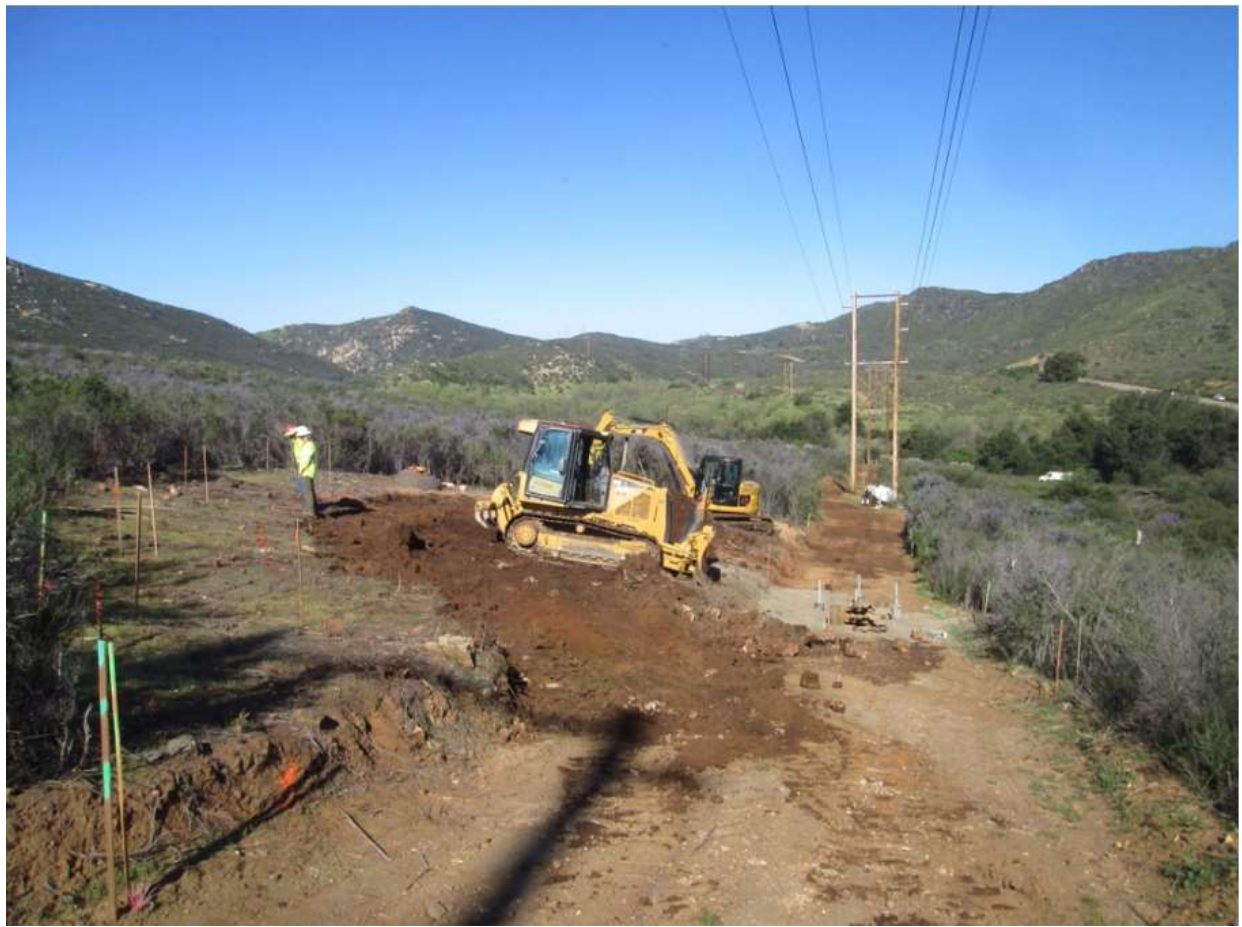
anchors; grounded and spread overhead wire; and began grading the access road re-alignment at Pole Z272867 (See Photo 1—Attachment A).

Photo 1: During access road widening at Z272867 (TL 625B), a grading crew was observed working within the delineated workspace in accordance with MM-BIO-1, and salvaging topsoil for future restoration use in accordance with MM-BIO-4.

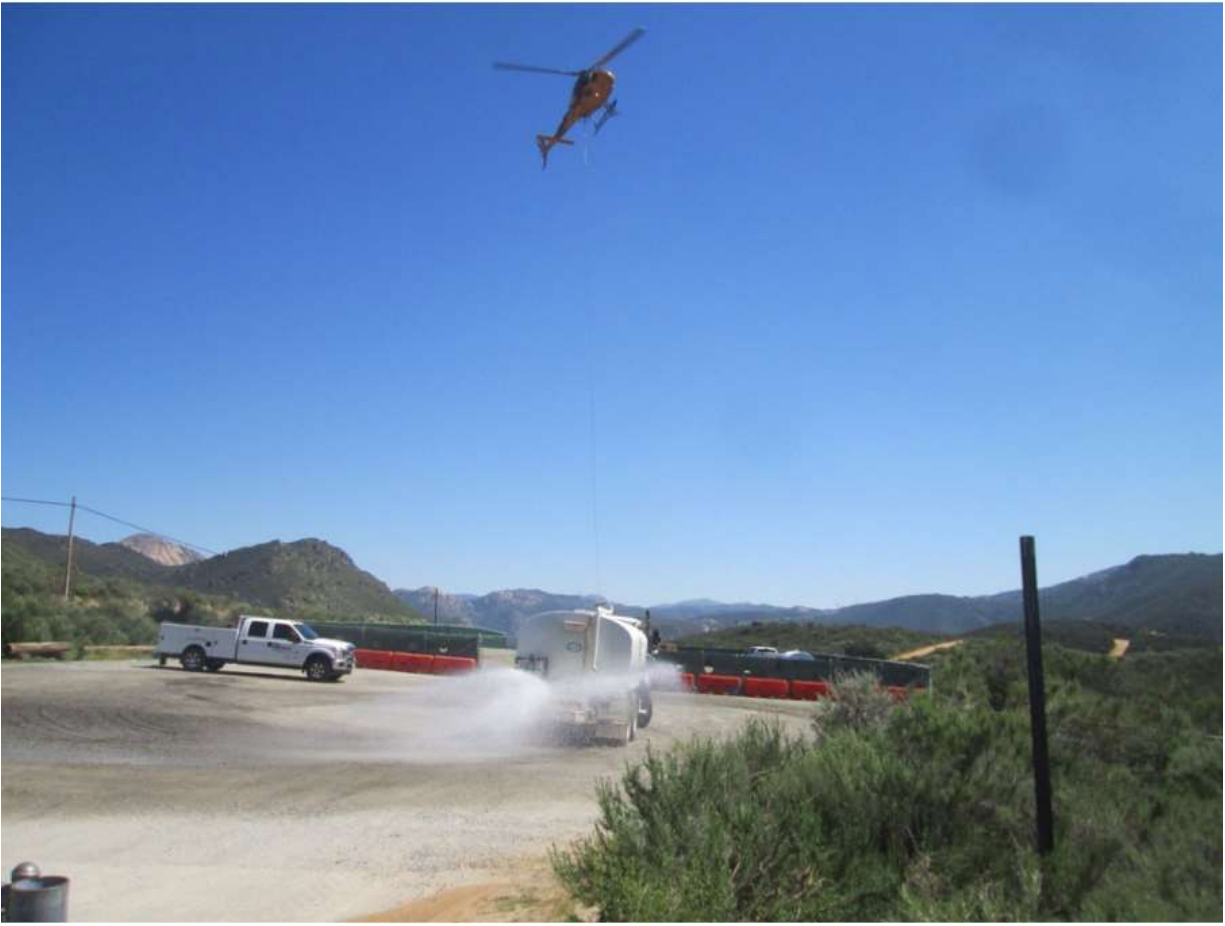
Helicopter activities supporting construction along TL 625B commenced at the Sweetwater Staging and Fly Yard. During helicopter activities, water trucks were utilized to spray water in the work area to prevent dust emissions in accordance with APM AIR-02 (See Photo 2—Attachment A). In accordance with the Aviation Safety Plan and MM PHS-5, the designated area for helicopter landing and staging in the Japatul Spur Staging Yard remains delineated, with a ground crew member on-site to ensure safety of all construction personnel in the area.

Photo 2: During helicopter staging and external load operations at Sweetwater Staging Area, a water truck was utilized to minimize dust emissions, and a ground crew member was present to ensure safety in accordance with MM-PHS-5

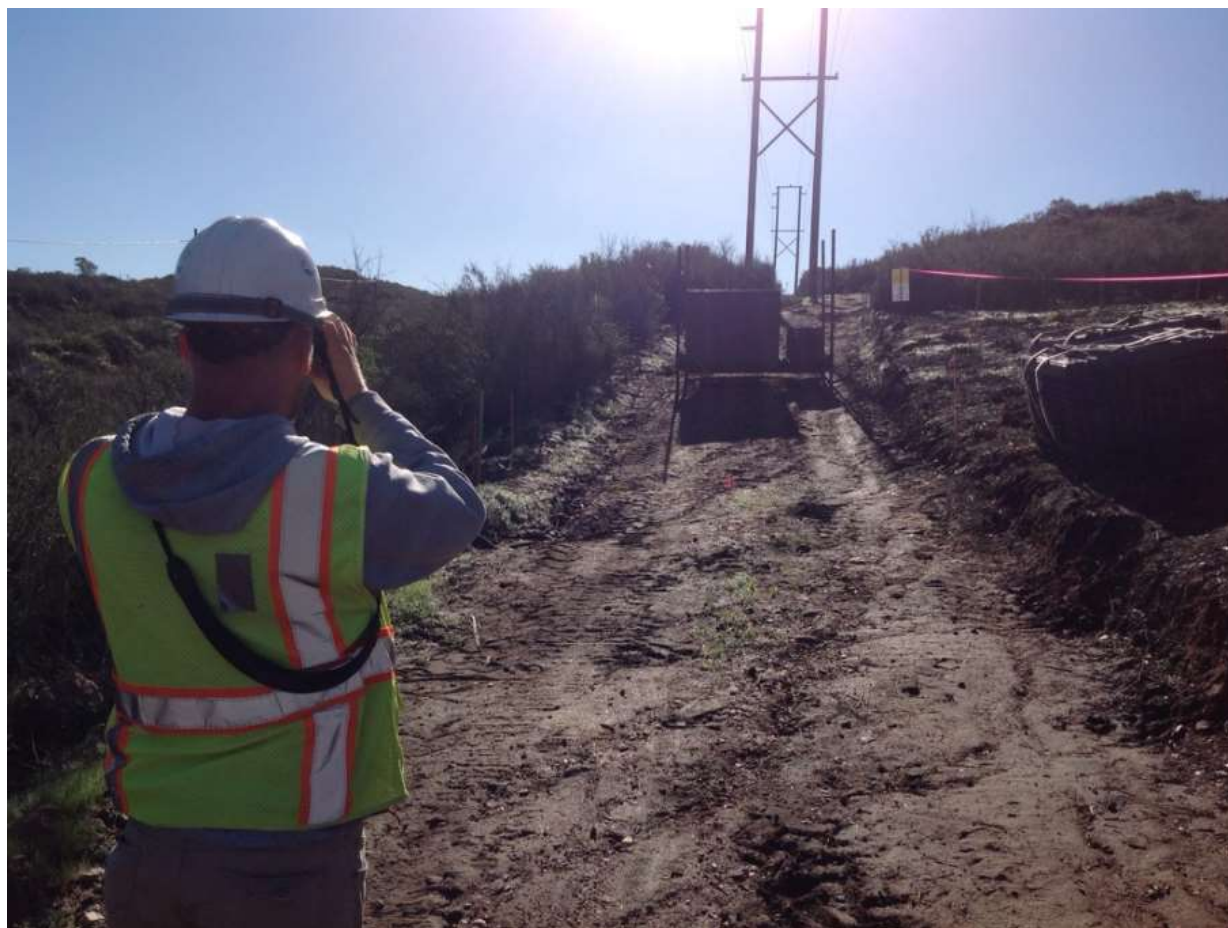
Photo 3: A qualified Avian Biologist was observed monitoring an active nest near Z272867 in accordance with MM BIO-28 and the Avian Protection Plan/Nesting Bird Management Plan.

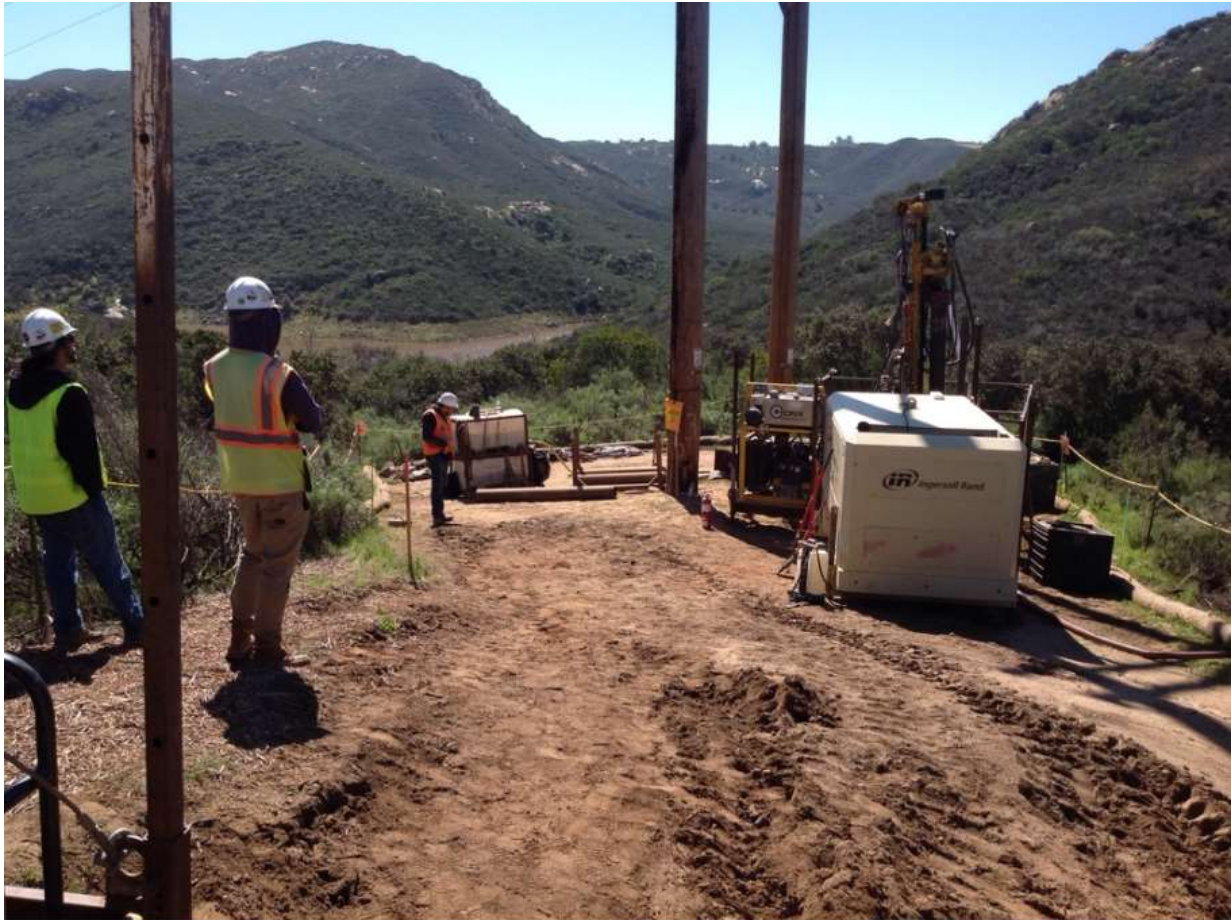
Archeological and Native American monitors were observed monitoring construction activities in work areas within the vicinity of previously recorded cultural resources and in areas identified as having a high potential to contain buried deposits in accordance with MM CUL-1, MM CUL-3, and APM CUL-04. Cultural ESA fencing was observed around the perimeter of workspaces and along the boundaries of access roads in accordance with Historic Properties Management Plan. At required pole sites, archeological and Native American monitors were observed monitoring constructing activities (See Photo 4—Attachment A).

Photo 4: In accordance with MM CUL-1, cultural monitors were observed monitoring sites near ESAs along TL 625B.

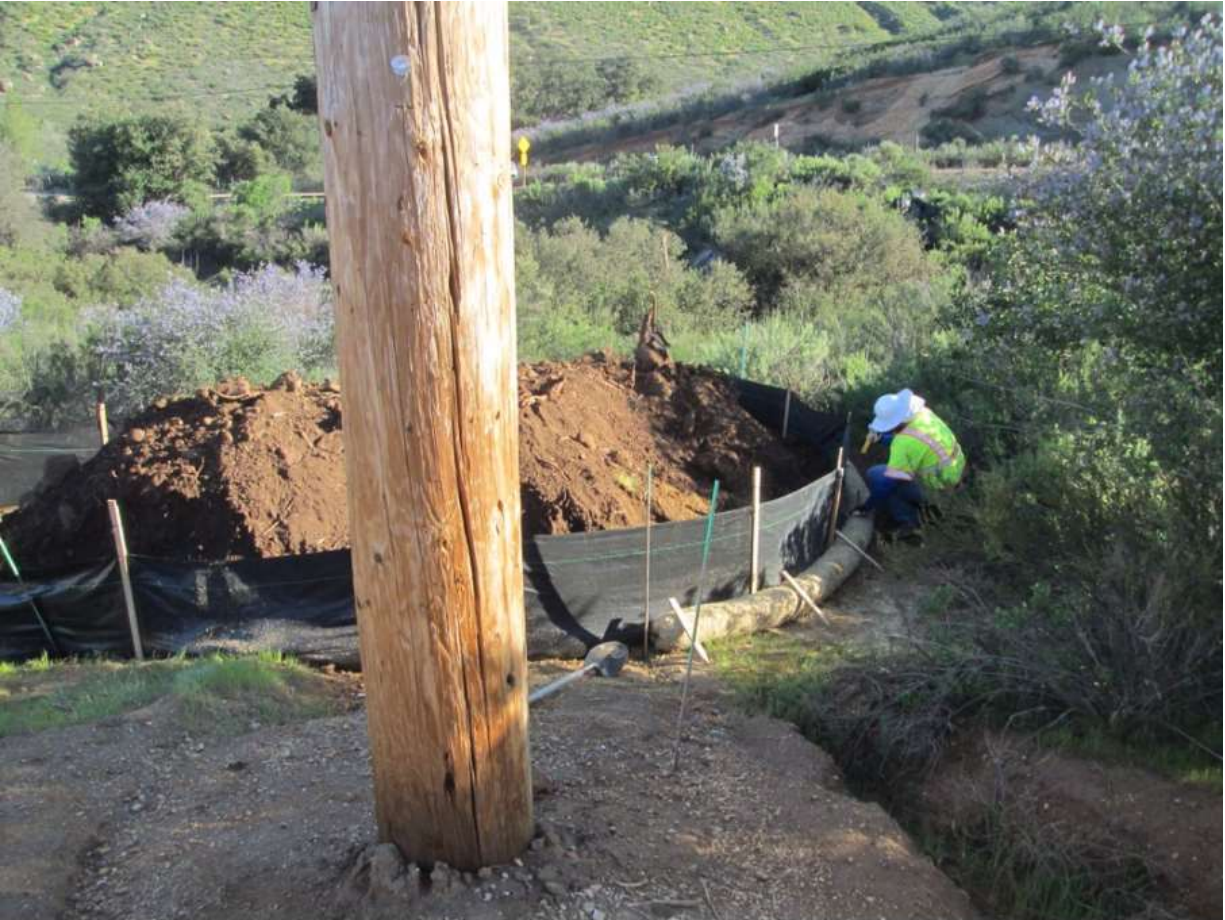
Construction crews were observed maintaining erosion control BMPs, including waterbars and energy dissipation devices, in accordance with the project Erosion Control Plan (ECP) and SWPPP (MM HYD-1, MM BIO-7, and APM HYD-09). Topsoil was observed continuing to be salvaged and secured with erosion control BMPs (See Photo 5—Attachment A).

Photo 5: A construction worker observed installing fiber rolls (in addition to silt fencing) around the perimeter of a topsoil stockpile at Z272867 (TL 625B) in accordance with MM HYD-1 and MM BIO-4).

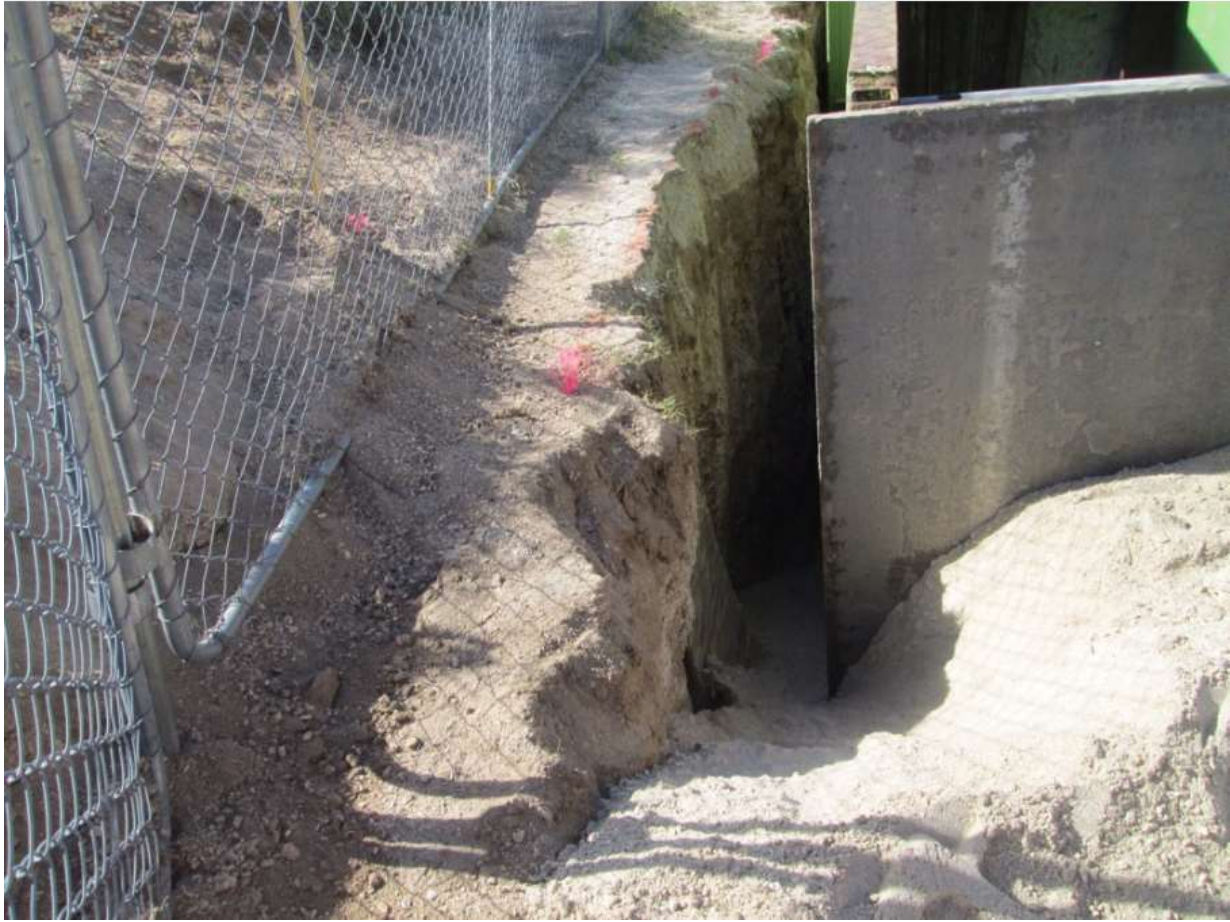
Biological monitors were observed monitoring construction activities along the project alignment in accordance with MM BIO-3 and MM BIO-22. During the bore pit operations, ramping was observed installed and inspected to prevent wildlife entrapment in accordance with MM BIO-23 (See Photo 6— Attachment A). Staged equipment along the right-of-way and at staging yards was observed to have bird deterrent devices, such as netting, to deter nesting in these areas. The CPUC environmental compliance monitor observed some reflective tape being used on equipment as a deterrent, but because the NBMP (MM BIO-28) does not specifically allow for this kind of deterrent material, upon discussion with the SDG&E LEI, the reflective tape was removed from equipment.

Photo 6: The bore pit (Crestwood Substation to Z100035, underground) had an earthen ramp constructed to prevent wildlife entrapment in accordance with MM BIO-23.
