<b>California Public Utilities Commission</b> <b><i>Mitigation Monitoring, Compliance, and Reporting</i></b> <b><i>Program</i></b>
	<b>Cleveland National Forest Power Line Replacement</b> <b>Projects</b>  <b>Compliance Status Report: 014</b>  <b>April 2, 2017</b>

This compliance status report covers construction activities from March 20 through April 2, 2017.

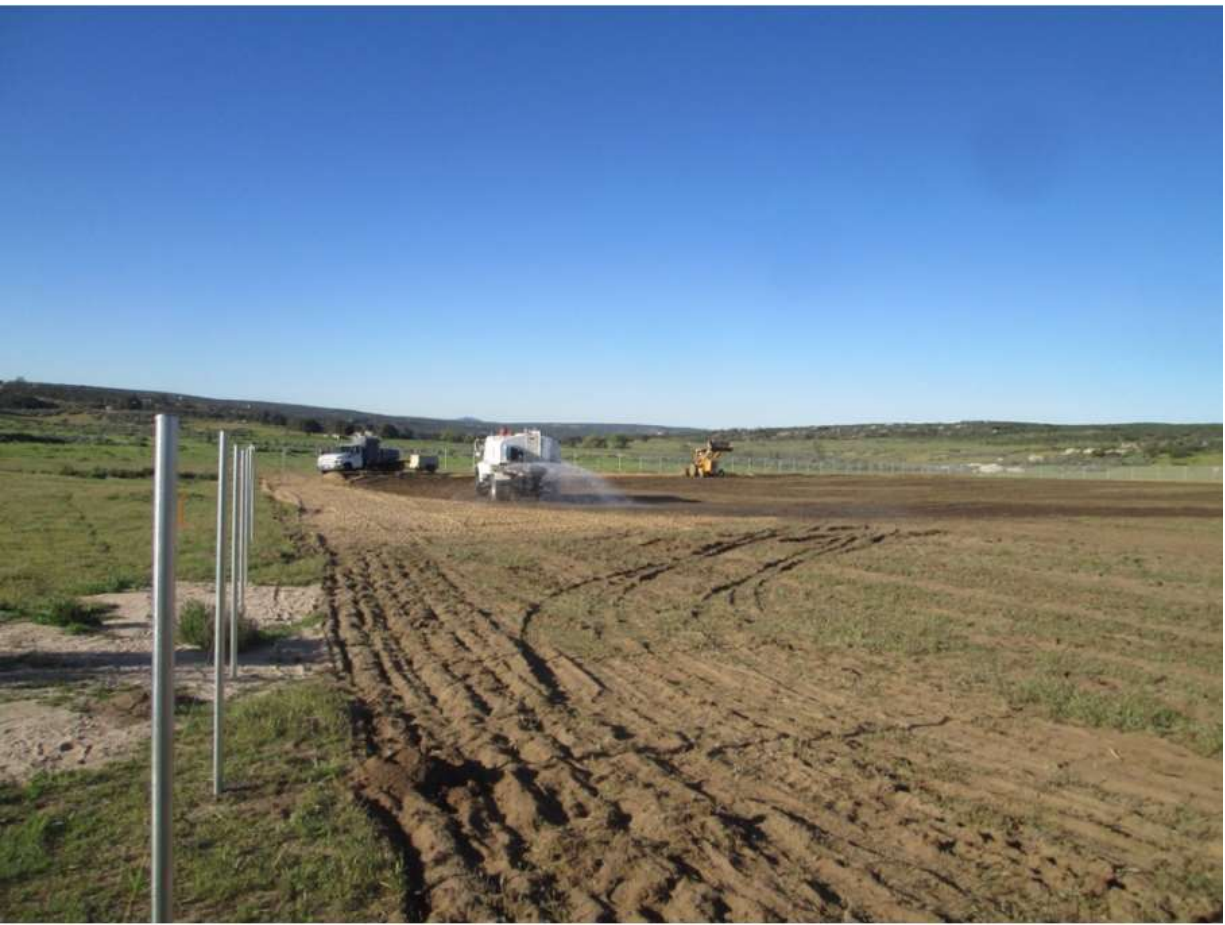
During this reporting period, CPUC ECMs observed continued implementation of dust control measures, including use of water trucks to control dust along access roads, workspaces, and development of new staging yards (See Photo 1—Attachment A) (APM AIR-02). Crews were observed sweeping sediment off

**Photo 1:** In accordance with APM-AIR-02, a water truck was observed being utilized to apply water in Live Oak Springs Staging Yard to prevent dust emissions.

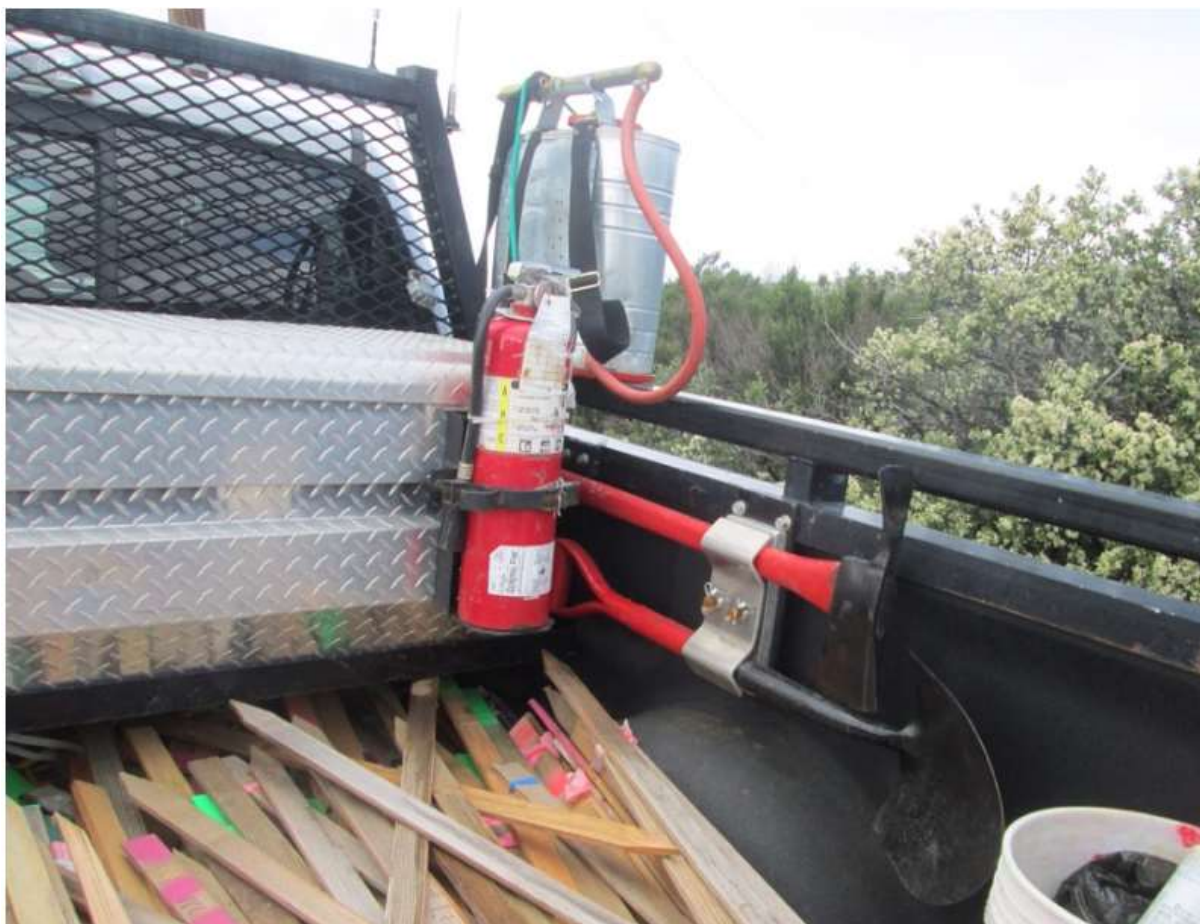
**Photo 2:** Pickup trucks used along the ROW were equipped with a 5 gallon backpack pump, Pulaski, round point shovel, and 2A10BC fire extinguisher in accordance with the CFPPP and MM-FF-1. Biological monitors were observed present during staking in accordance with MM BIO-23.

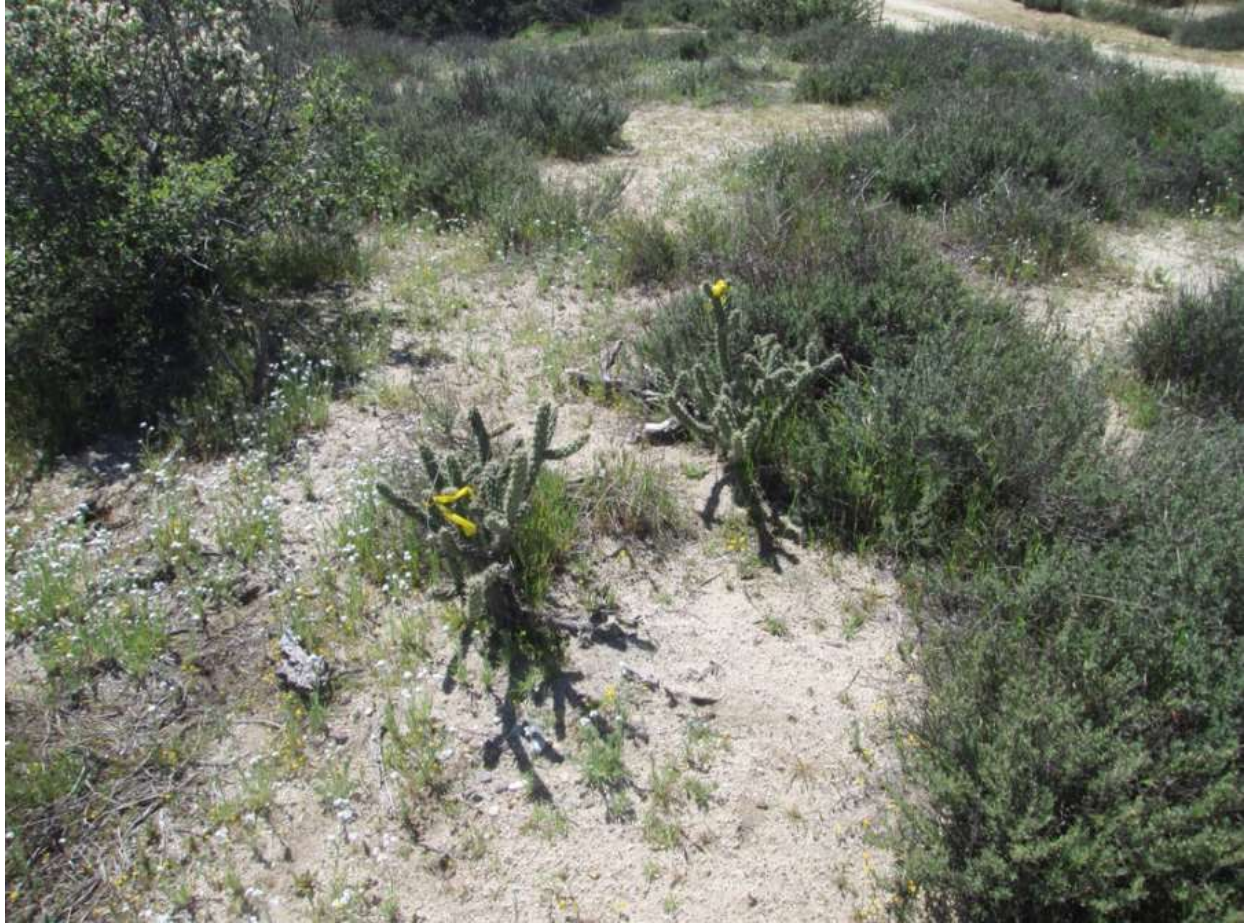
Crews were observed staking/delineating work areas along TL 6931 this reporting period (MM BIO-1). During staking and other work activities along the project alignments, crews were observed carrying the required activity-specific fire tools and equipment (a 5 gallon backpack pump, round point shovel, Pulaski, and 2A10BC fire extinguisher) in accordance with the Construction Fire Prevention/Protection Plan (MM FF-1) (See Photo 2—Attachment A). Biological monitors were observed participating and overseeing staking of work areas along TL 6931 and monitoring construction activities along project alignments in accordance with MM BIO-3 and MM BIO-22. Restoration crews were observed along TL 6931 surveying and flagging succulents for avoidance during construction (MM BIO-15) (See Photo 3—Attachment A).

**Photo 3:** Succulents were observed flagged for avoidance at Z44271 (TL 6931) in accordance with MM BIO-15 and NCCP requirements.

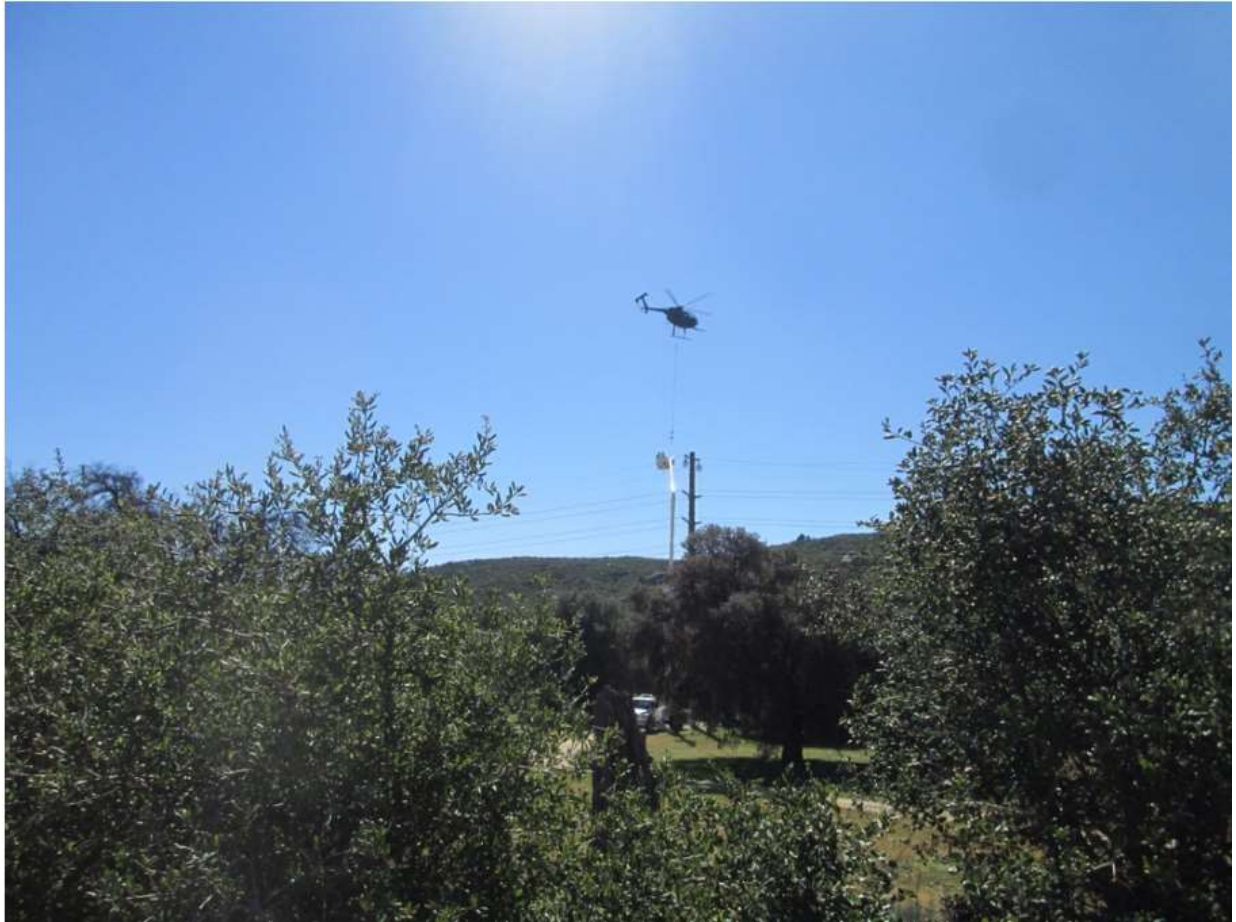
Helicopter activities continued at TL 625B and TL 629E to support overhead work (See Photo 4—Attachment A). In accordance with the Aviation Safety Plan and MM PHS-5, the designated area for helicopter landing and staging in the Japatul Spur Staging Yard remained delineated, with a ground crew member on-site to ensure safety of all construction personnel in the area. During fiber optic stringing activities along TL 629E, SDG&E's Lead Environmental Inspector (LEI) was observed monitoring an active red-tailed hawk (*Buteo jamaicensis*) nest in an oak tree adjacent to Z40583 during fiber optic stringing activities. To prevent disturbance to the nest, the CPUC ECM observed the LEI directing the construction crew to use a bucket truck at Z40583, as opposed to a helicopter, for sock line stringing in accordance with MM BIO-28 and the Nesting Bird Management Plan (NBMP). Approved avian biologists were observed in other areas conducting surveys along alignments and monitoring construction activities within the vicinity of recorded active nests in accordance with the NBMP (See Photo 5—Attachment A) and. Signage indicating nesting buffer areas were observed in place and areas with nesting restrictions were communicated at the morning tailboards.

**Photo 4:** A construction crew was observed utilizing a helicopter to string sock line at Z40584 for fiber optic wire stringing between Z40572 to Z44182 (TL 629E).

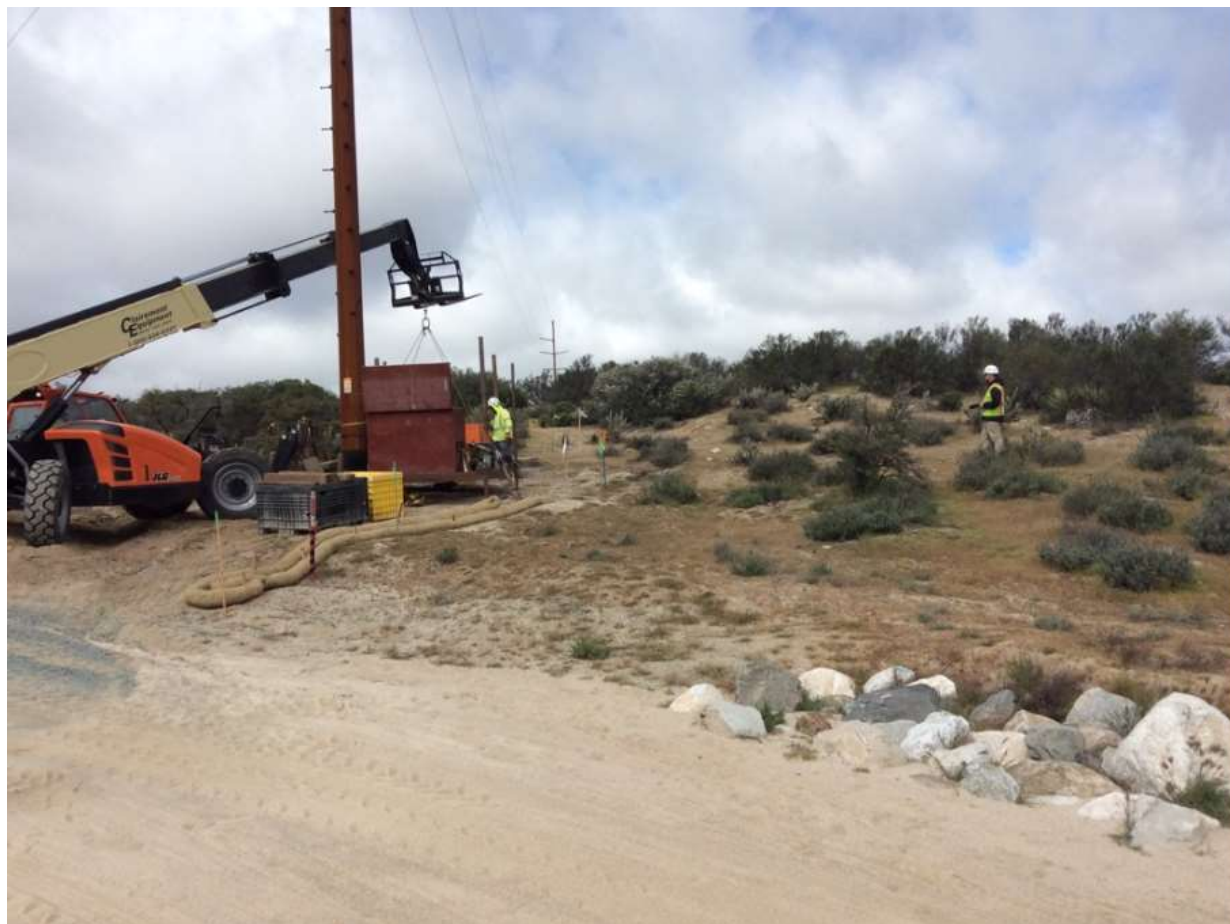
**Photo 5:** A qualified Avian Biologist was observed monitoring constructing activities adjacent to Pole Z44294 (TL 6931) near active nests in accordance with MM-BIO-28 in accordance with MM BIO-28 and the NBMP.

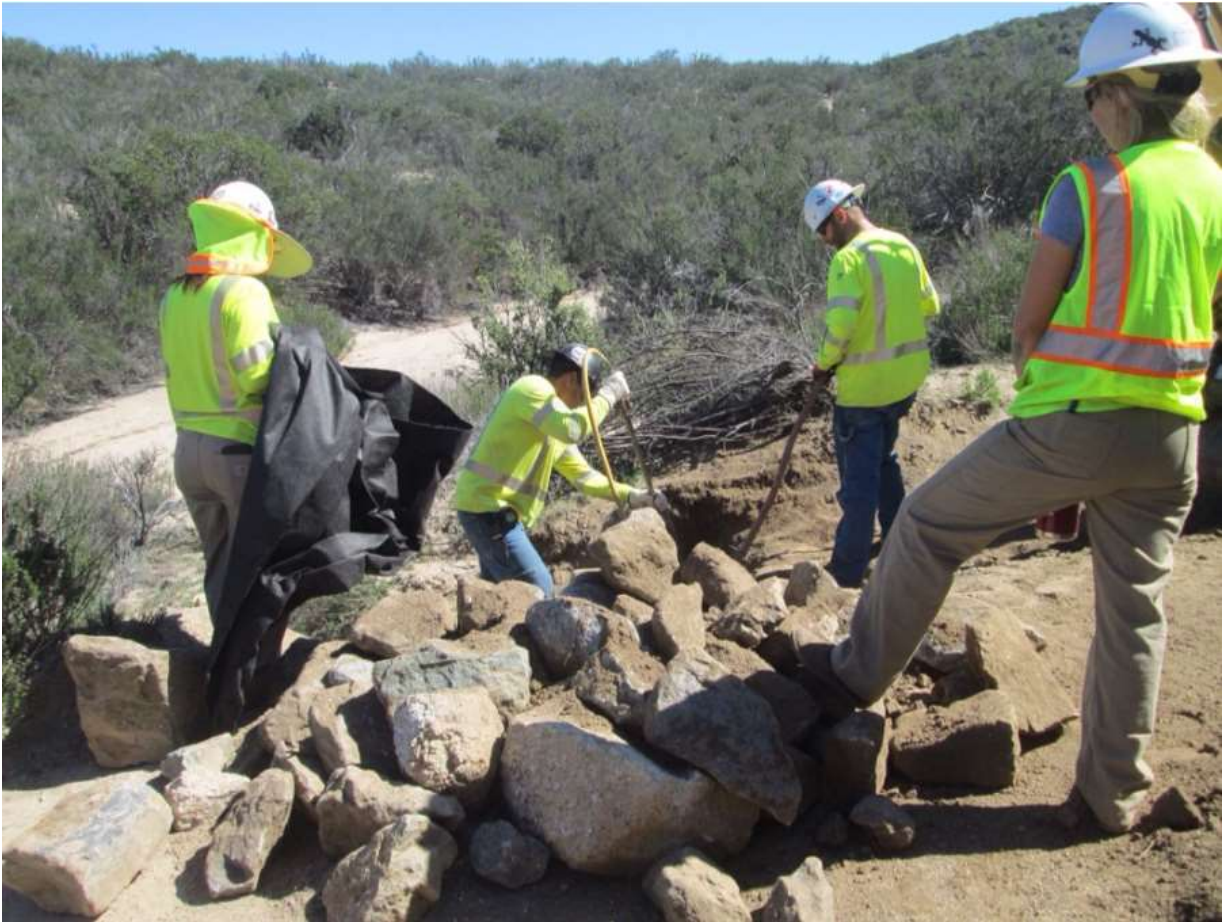
Construction crews were observed installing (TL 6931) and maintaining erosion control BMPs along project alignments, including waterbars and energy dissipation devices (See Photo 6—Attachment A), in

**Photo 6:** Geo Pacific Services crew observed performing energy dissipater maintenance along the access road between Z44173 and Z44175 (TL 629E) in accordance with MM-HYD-1.
