<b>California Public Utilities Commission</b> <b><i>Mitigation Monitoring, Compliance, and Reporting</i></b> <b><i>Program</i></b>
	<b>Cleveland National Forest Power Line Replacement</b> <b>Projects</b>  <b>Compliance Status Report: 024</b>  <b>August 20, 2017</b>

This compliance status report covers construction activities from August 7 through August 20, 2017.

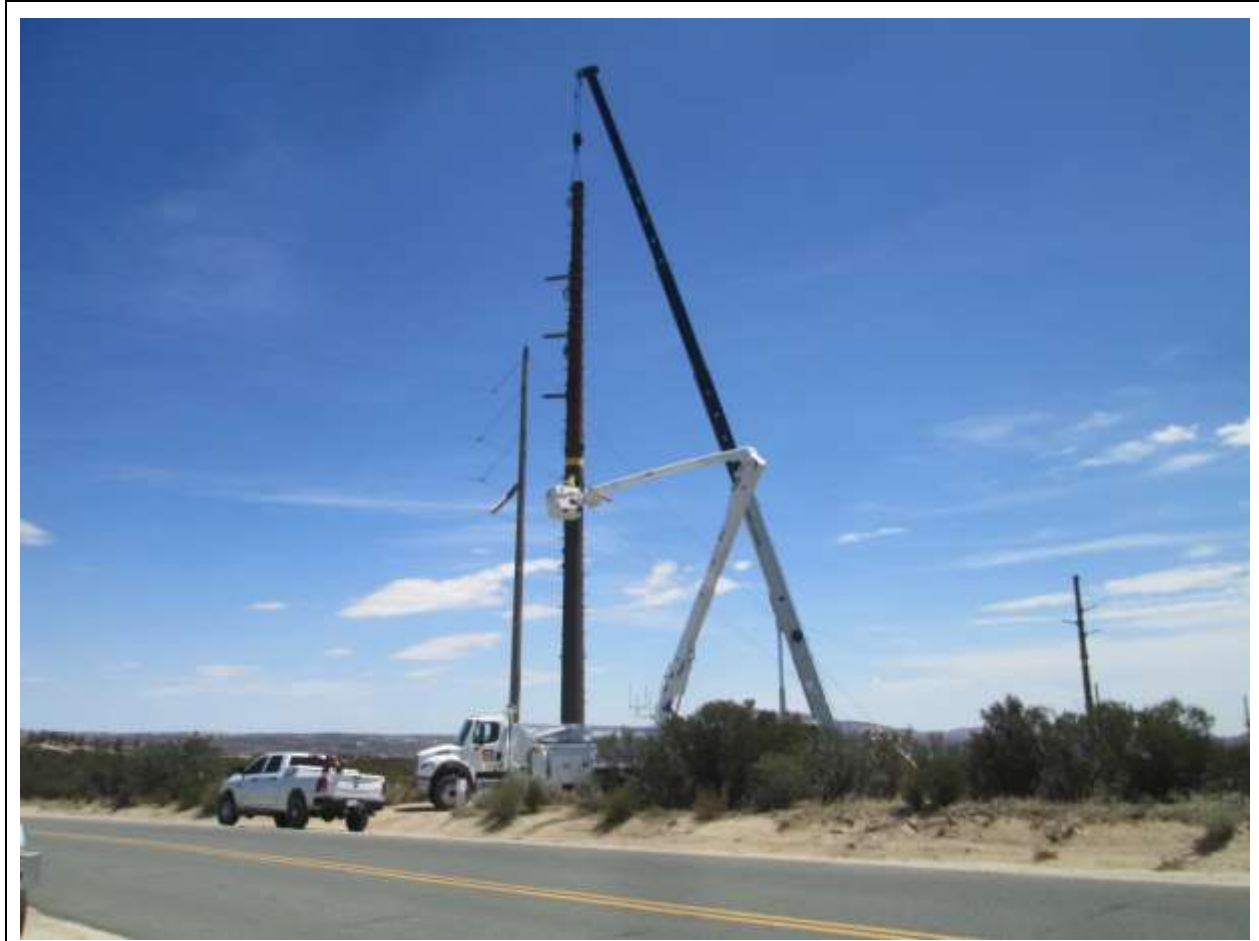
During this reporting period, construction crews were observed setting poles (See Attachment A – Photo 1) and removing old poles along TL 6931, as well as installing underground transmission line to Crestwood Substation along TL 629E/6931. Along TL 682, Crews were observed drilling for micropile foundations, trimming oaks mid-span and within workspaces to maintain required transmission line clearances, clearing vegetation at pole sites, and installing perimeter chain link fence around Warner Substation Staging and Fly Yard. Helicopter external load operations and human external load operation were observed being performed to support drilling and overhead transmission line work along TL 682 in accordance with the Aviation Safety Plan (MM PHS-5). At C 440, Seismic Refraction Testing work was observed being conducted along the underground transmission line right-of-way (See Attachment A – Photo 2).

**Photo 1:** A construction crew observed installing a new pole at Pole Z44270 (TL 6931).

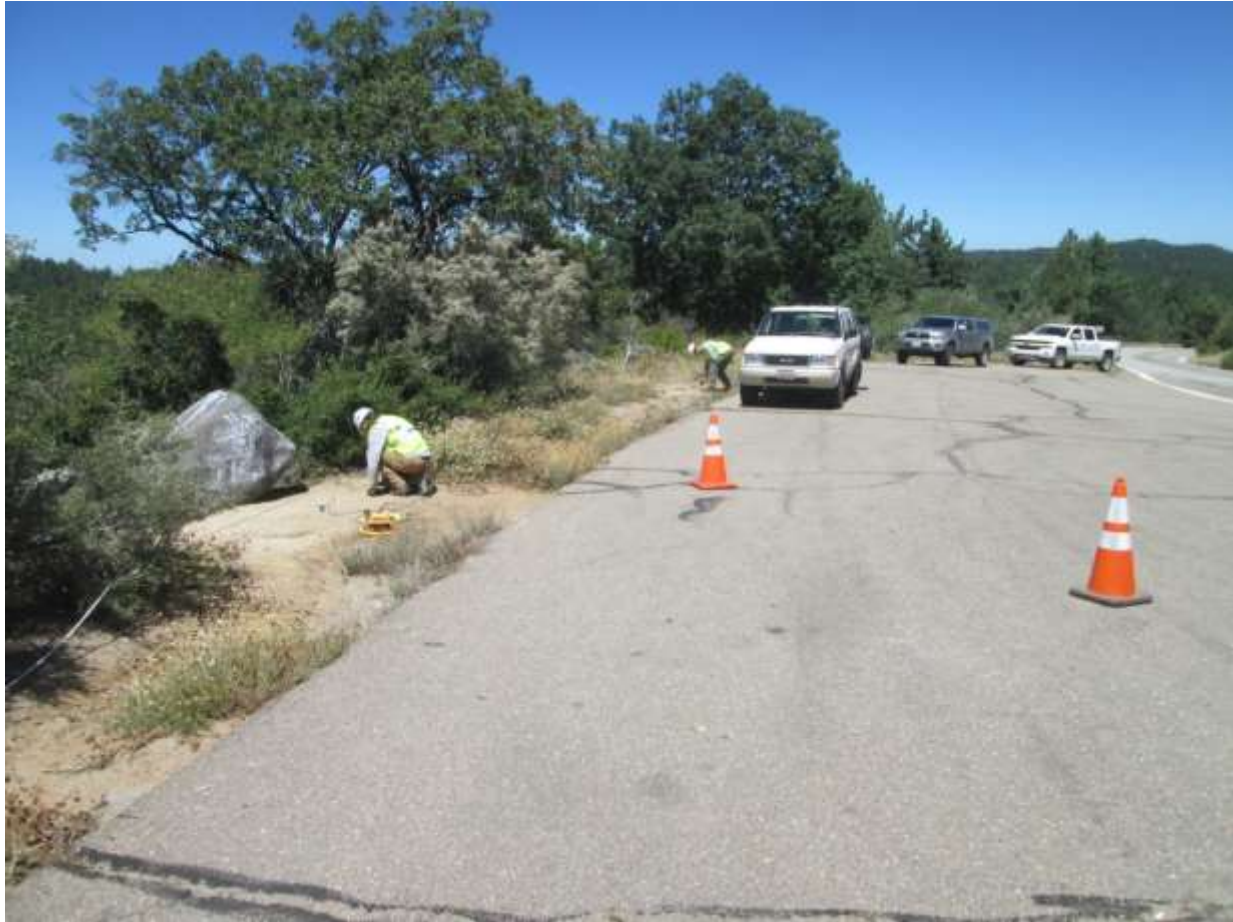
**Photo 2:** Seismic Refraction Testing observed being performed at seismic line S12 for the C 440 underground distribution line along Sunrise Highway.

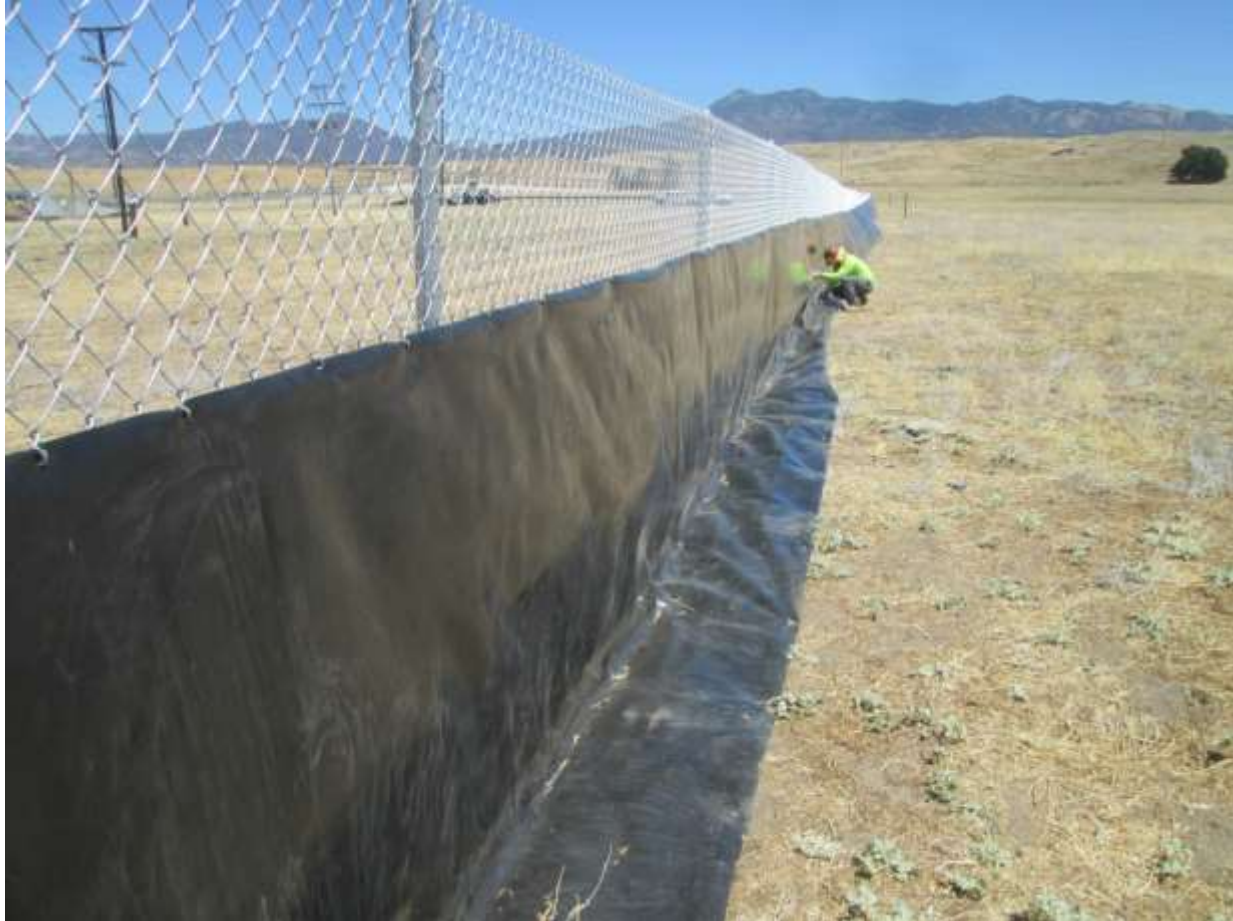
**Photo 3:** In accordance with MM BIO-31, a construction crew was observed installing Stephens' kangaroo rat exclusion barrier around the perimeter of Warner Substation Staging Yard (TL 682).

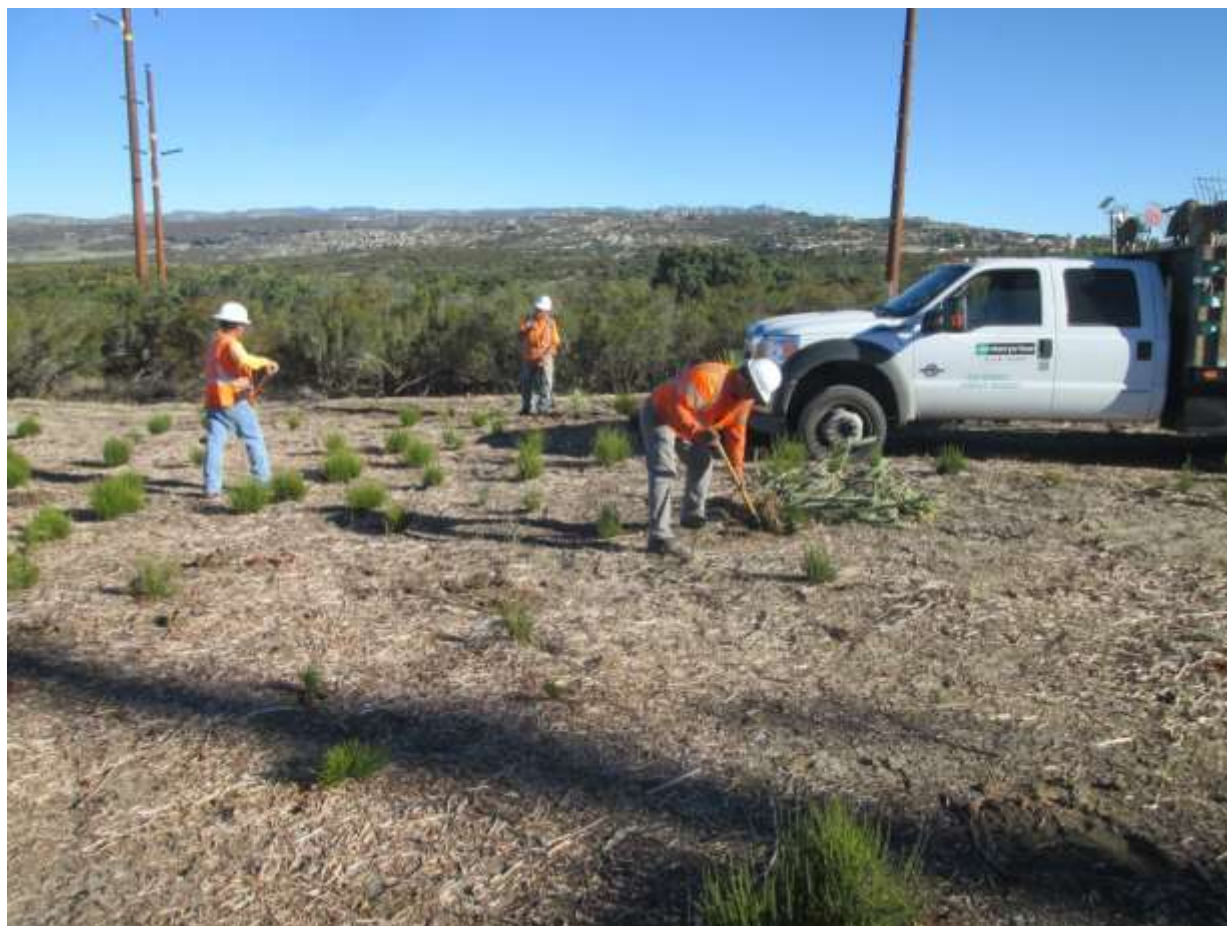
**Photo 4:** A restoration crew observed salvaging succulents previously avoided during vegetation clearing at the Z44270 stringing site (TL 6931) in accordance with the Habitat Restoration Plan (MM BIO-4), Special Status Species Salvage and Relocation Plan (MM BIO-15), and California Desert Native Plant Act.

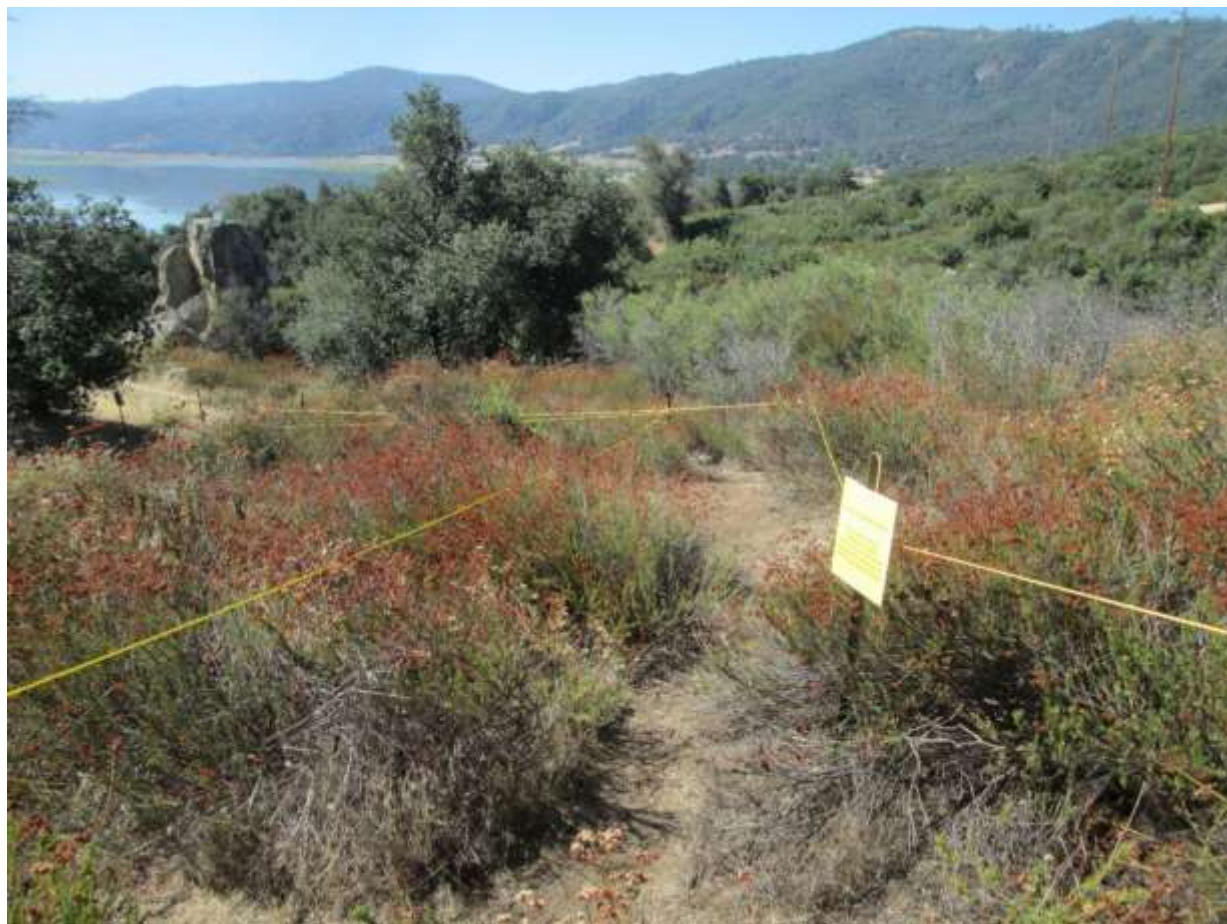
Cultural resource monitors, including archaeological and native American monitors, were observed monitoring construction activities within the vicinity of previously recorded cultural resources in accordance with MM CUL-1. Cultural resource monitors were observed spot checking cultural ESA fencing installed to prevent unauthorized access into areas with previously recorded cultural resources in accordance with the Historic Properties Management Plan (HPMP) (See Attachment A – Photo 5).

**Photo 5:** Cultural resource ESA fencing installed to prevent unauthorized access into areas with previously recorded cultural resources in accordance with the Historic Properties Management Plan (HPMP) was observed along all project rights-of-way.

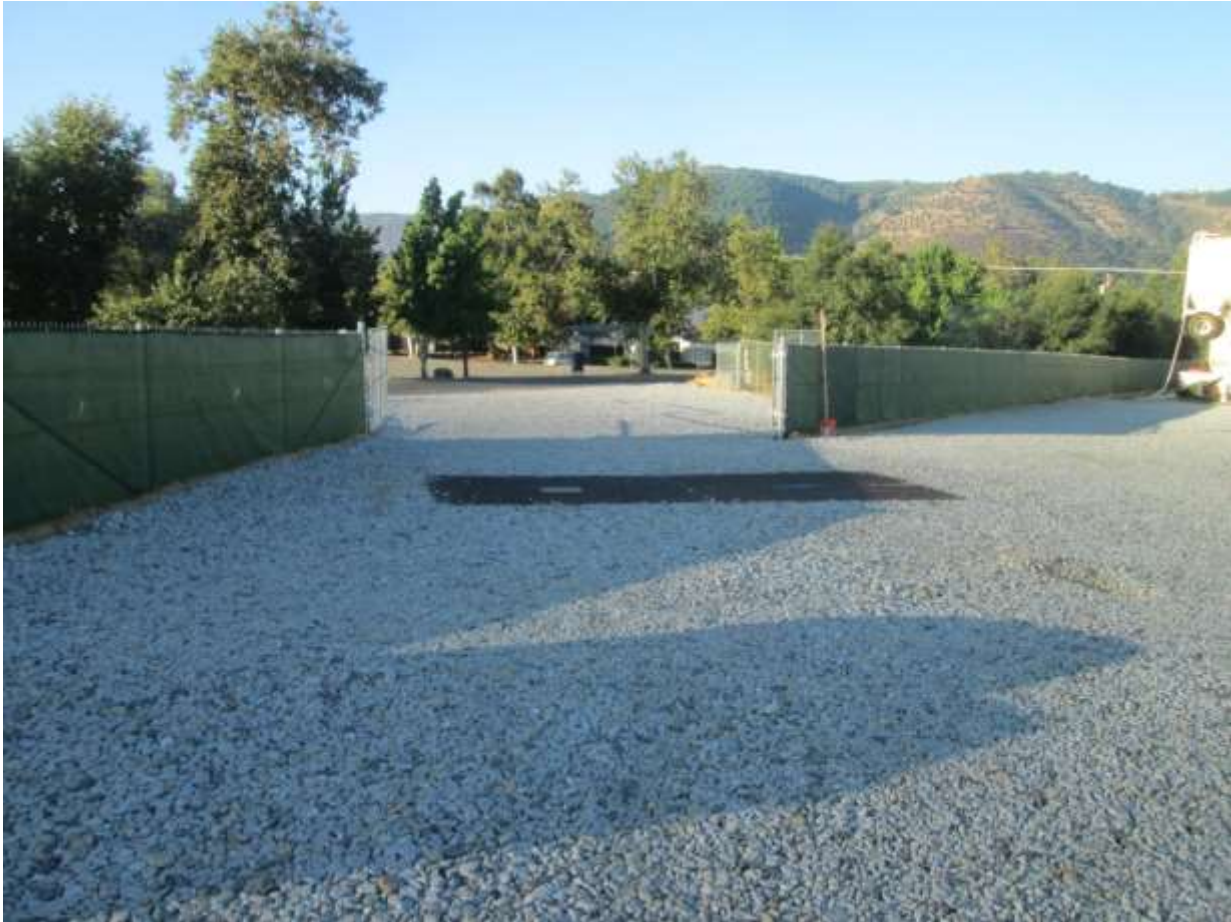
In accordance with APM VIS-02, construction activities were observed being kept as clean and inconspicuous as possible and opaque mesh used as a visual screen was observed around the perimeter of staging areas (Attachment A – Photo 6).

**Photo 6:** In accordance with the SWPPP (MM HYD-1, APM HYD-09, and MM BIO-7), rattle plates and gravel aggregate were installed at the ingress and egress of Orchard Staging Yard (TL 682) to prevent dirt/mud from being tracked onto public roadways. In accordance with APM VIS-02, opaque mesh material was installed around the perimeter of the yard as a visual screening measure.
