California Public Utilities Commission <i>Mitigation Monitoring, Compliance, and Reporting Program</i>
	Cleveland National Forest Power Line Replacement Projects Compliance Status Report: 026 September 17, 2017

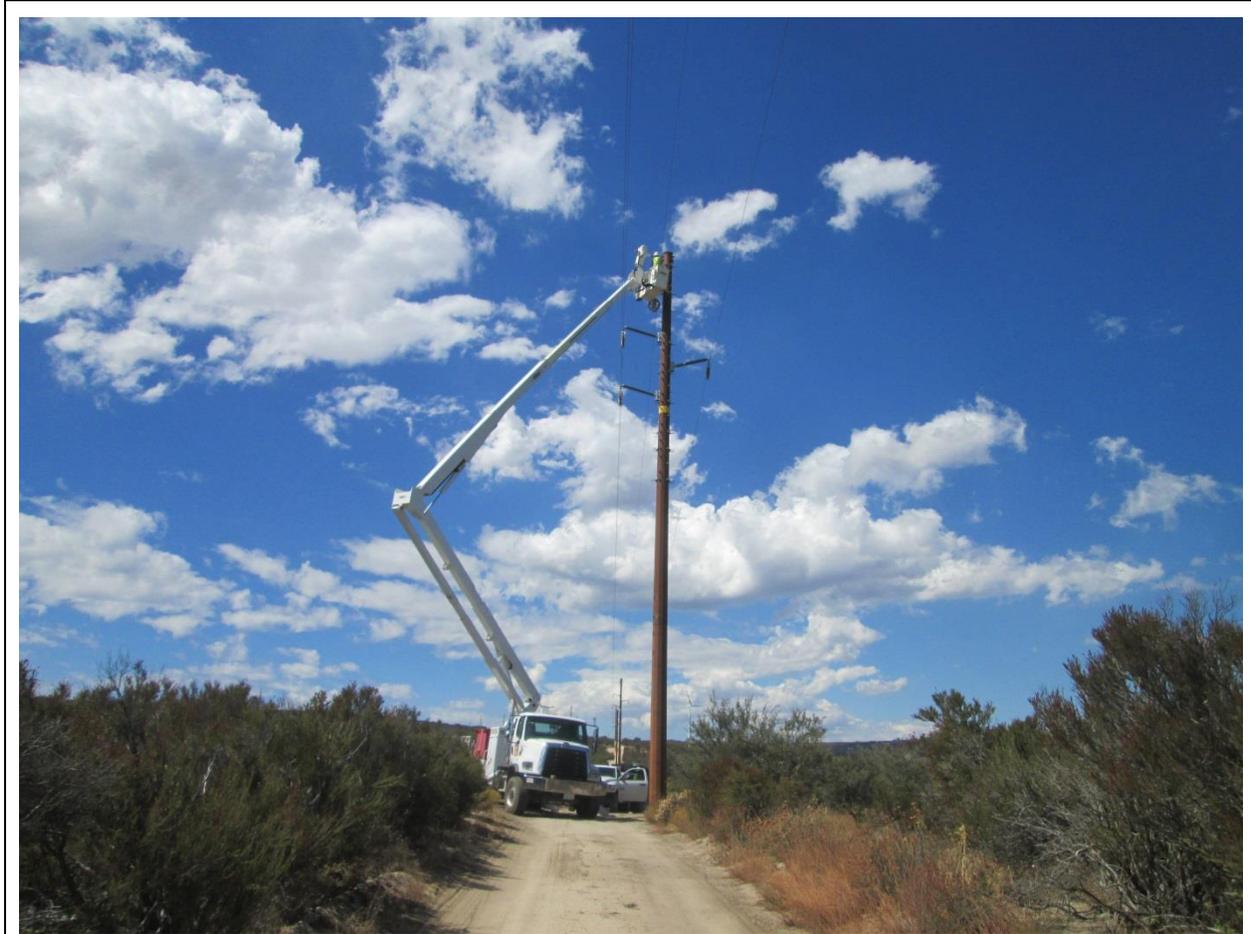
During this reporting period, CPUC ECMs observed construction crews conducting overhead work (See Photo 1—Attachment A), conducting distribution pole realignment/relocation activities, setting new

Photo 1: A construction crew observed conducting overhead line work in preparation for wire stringing activities at Pole Z44247 (TL 6931).

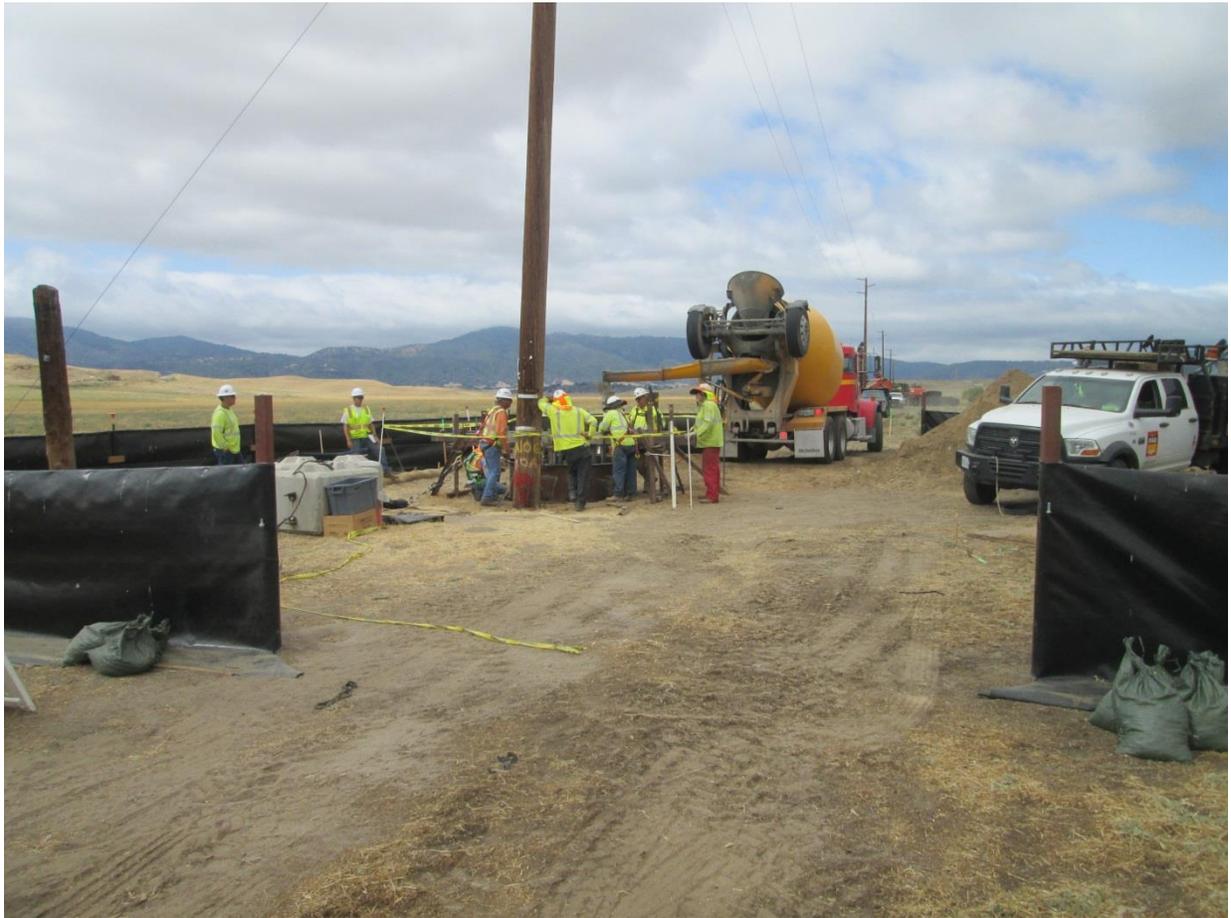
Photo 2: A construction crew observed pouring concrete during conventional foundation construction at Pole Z118232 (TL 682). Stephens' kangaroo rat exclusion barrier was observed around the perimeter of the workspace in accordance with MM BIO-31.

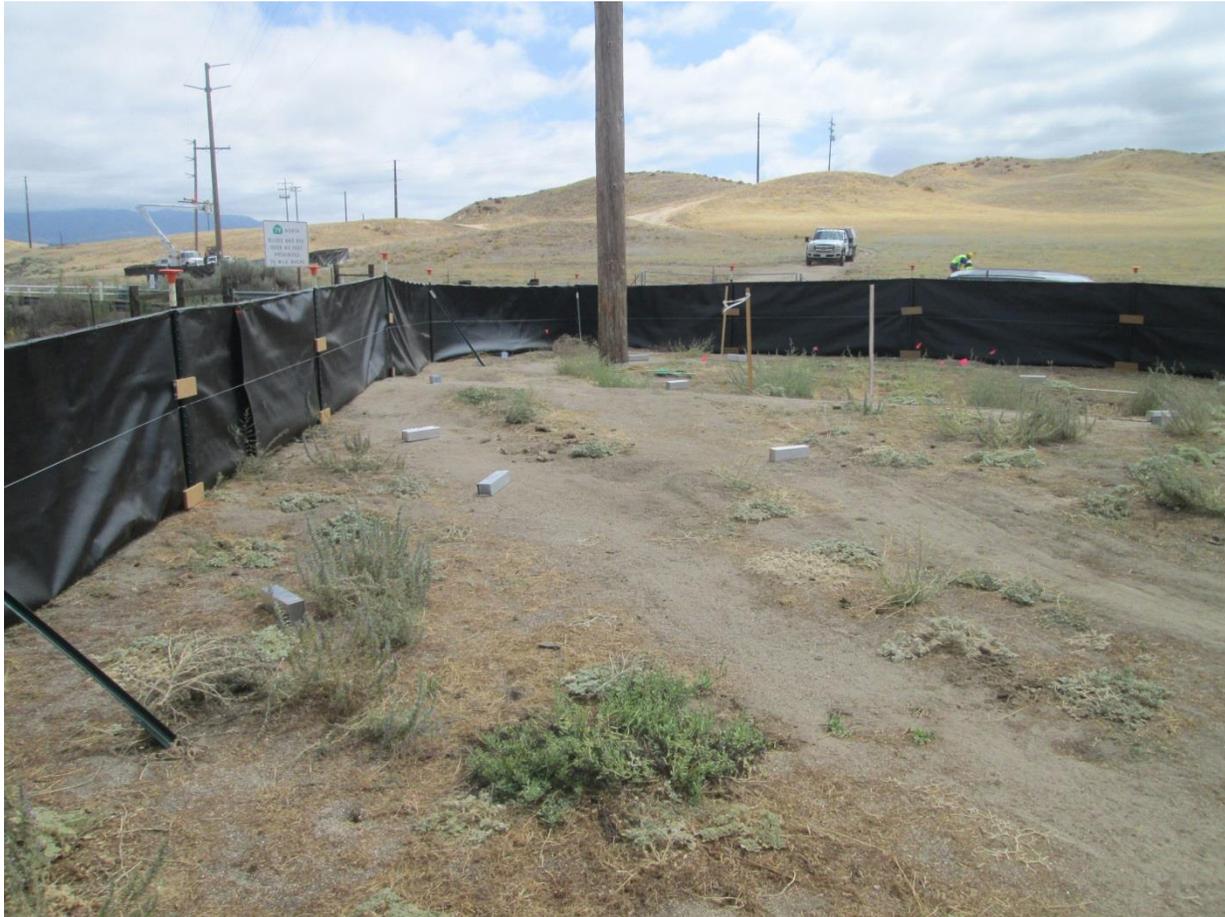
Photo 3: In accordance with MM BIO-31, Stephens' kangaroo rat avoidance and minimization measures were observed being implemented, and included the use of traps (pictured) within the workspace at Pole Z118234 (TL 682). Trapping within the exclusion barrier is required for five consecutive nights prior to the commencement of construction activities.

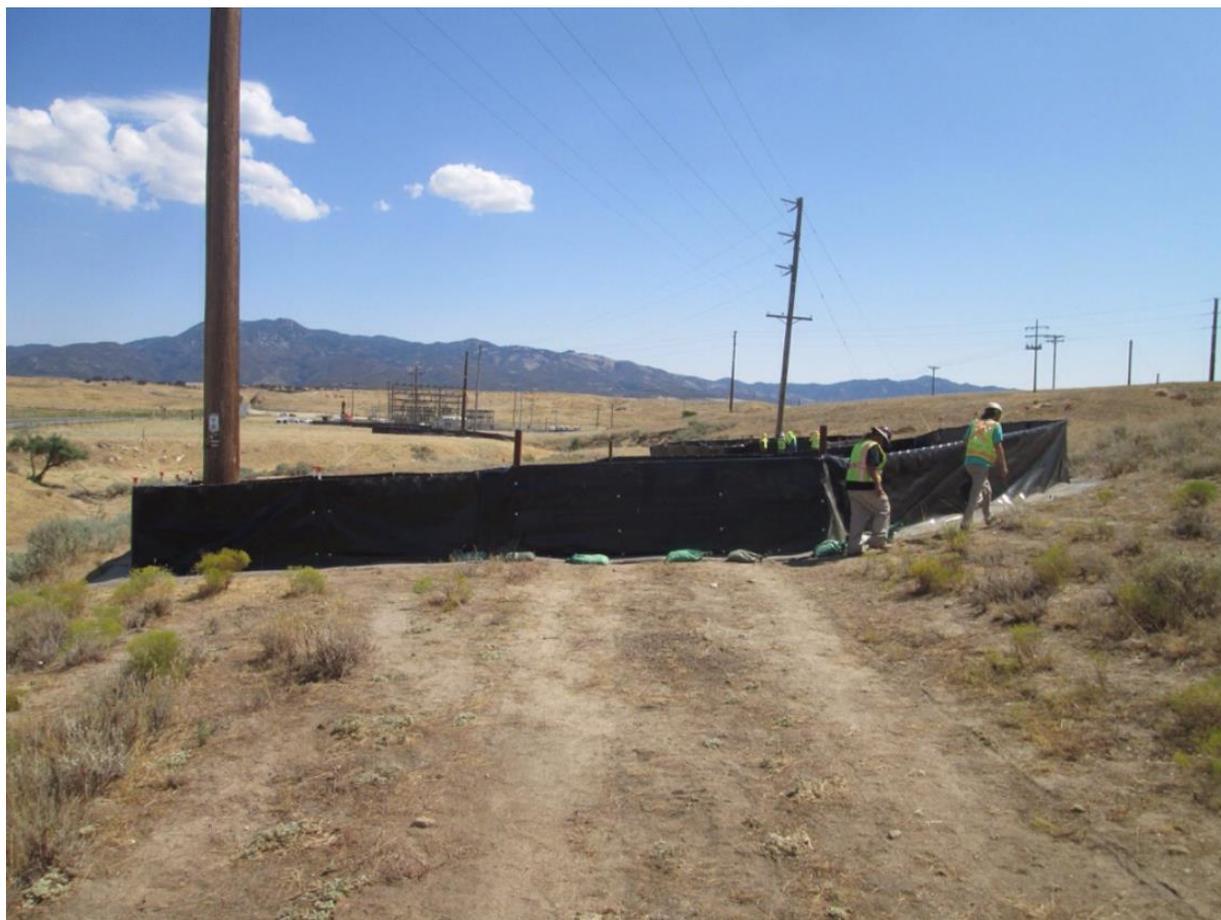
Cultural resource monitors, including archaeological and Native American monitors, were observed monitoring ground disturbing activities such as pole hole drilling/auguring, and inspecting excavated soils for potential sensitive cultural resources in accordance with MM CUL-1 (See Photo 4—Attachment A). In addition, an archeological monitor was observed directing a BMP installation crew to lay perimeter fiber rolls on the ground surface on the downslope side at certain pole locations along TL 682, instead of trenching them into the ground to prevent impacts to potentially buried cultural resources in the area. Cultural resource monitors were observed spot checking cultural ESA fencing installed to prevent unauthorized access into areas with previously recorded cultural resources in accordance with the Historic Properties Management Plan (HPMP). In accordance with APM CUL-08, a paleontological monitor was observed monitoring pole hole drilling/auguring along TL 682 and inspecting excavated soils for the presence of fossils.

Photo 4: At a pole location along TL 682, archeological and Native American monitors were observed monitoring excavated soils for sensitive cultural resources in accordance with MM CUL-1. (9-10 inches of excavation were dug with hand tools to avoid potential impacts to SKR in accordance with MM BIO-31).

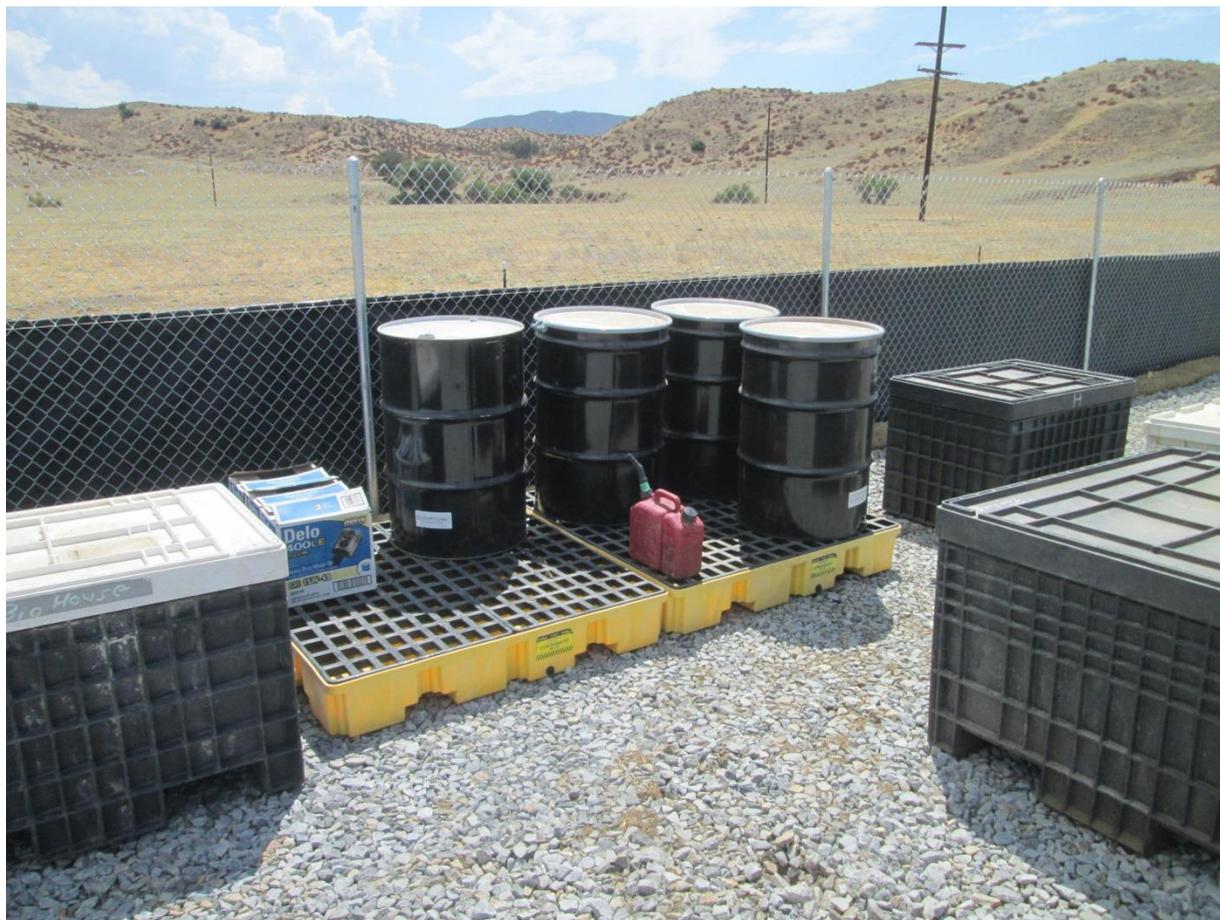
Photo 5: At Warner Substation Staging Yard (TL 682), hazardous materials were observed being stored above catchment pallets in accordance with the SWPPP and MM PHS-2.

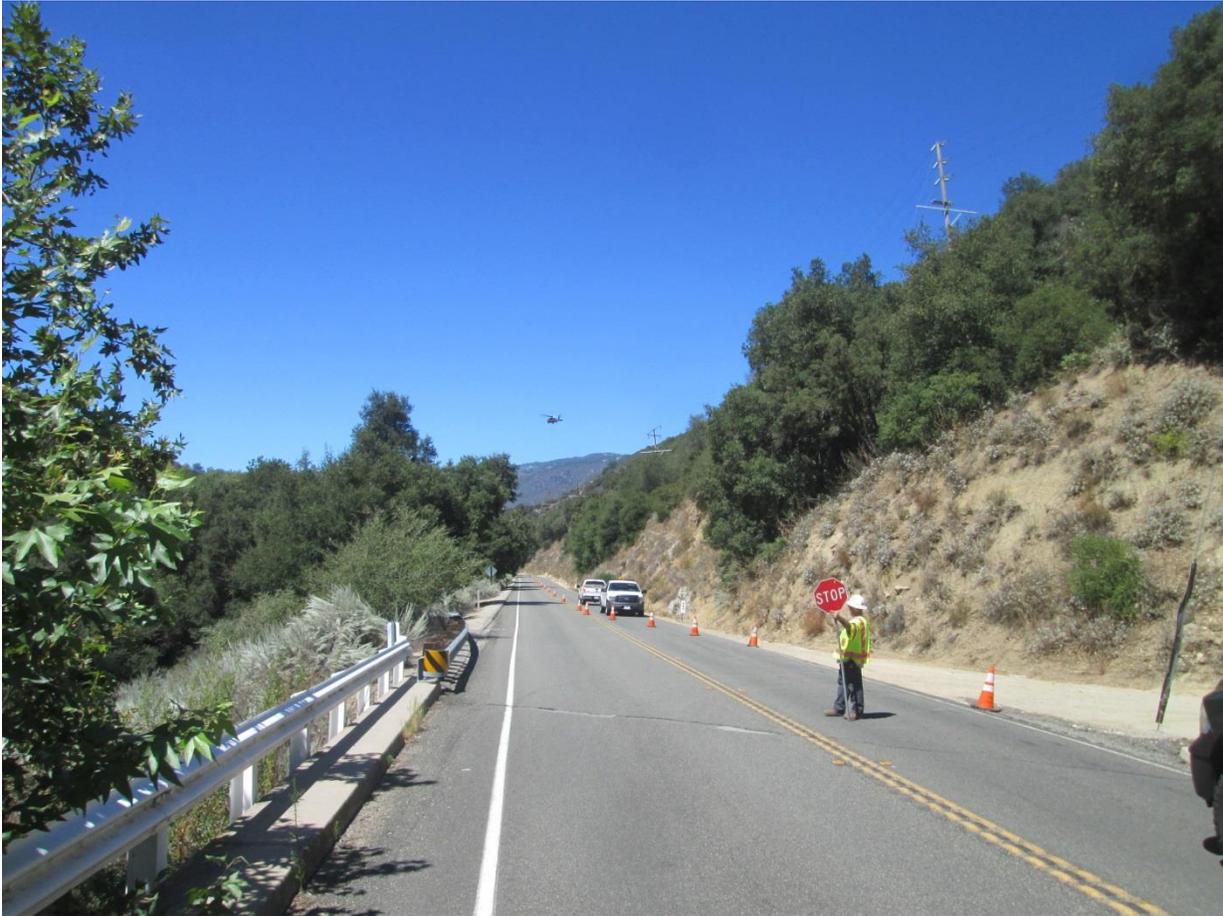
Implementation of traffic control measures continued to be observed in this reporting period. Traffic control measures, such as the placement of signage and cones as well as the use of flagpersons were observed in accordance with APM TRANS-02. During helicopter external load operations along TL 682, traffic control notification signs, cones, and flagpersons were observed being utilized to temporarily stop traffic when loads were transported over public roads, including Highway 76 and East Grade Road (See Photo 6—Attachment A).

Photo 6: During helicopter external load operations assisting in transport of materials and equipment used in foundation drilling and grouting along TL 682, traffic control notification signs, cones, and flagpersons were utilized to temporarily stop traffic when loads were transported over Highway 76 (APM TRANS-02).
