California Public Utilities Commission <i>Mitigation Monitoring, Compliance, and Reporting Program</i>
	Cleveland National Forest Power Line Replacement Projects Compliance Status Report: 030 November 12, 2017

This compliance status report covers construction activities from October 30 through November 12, 2017.

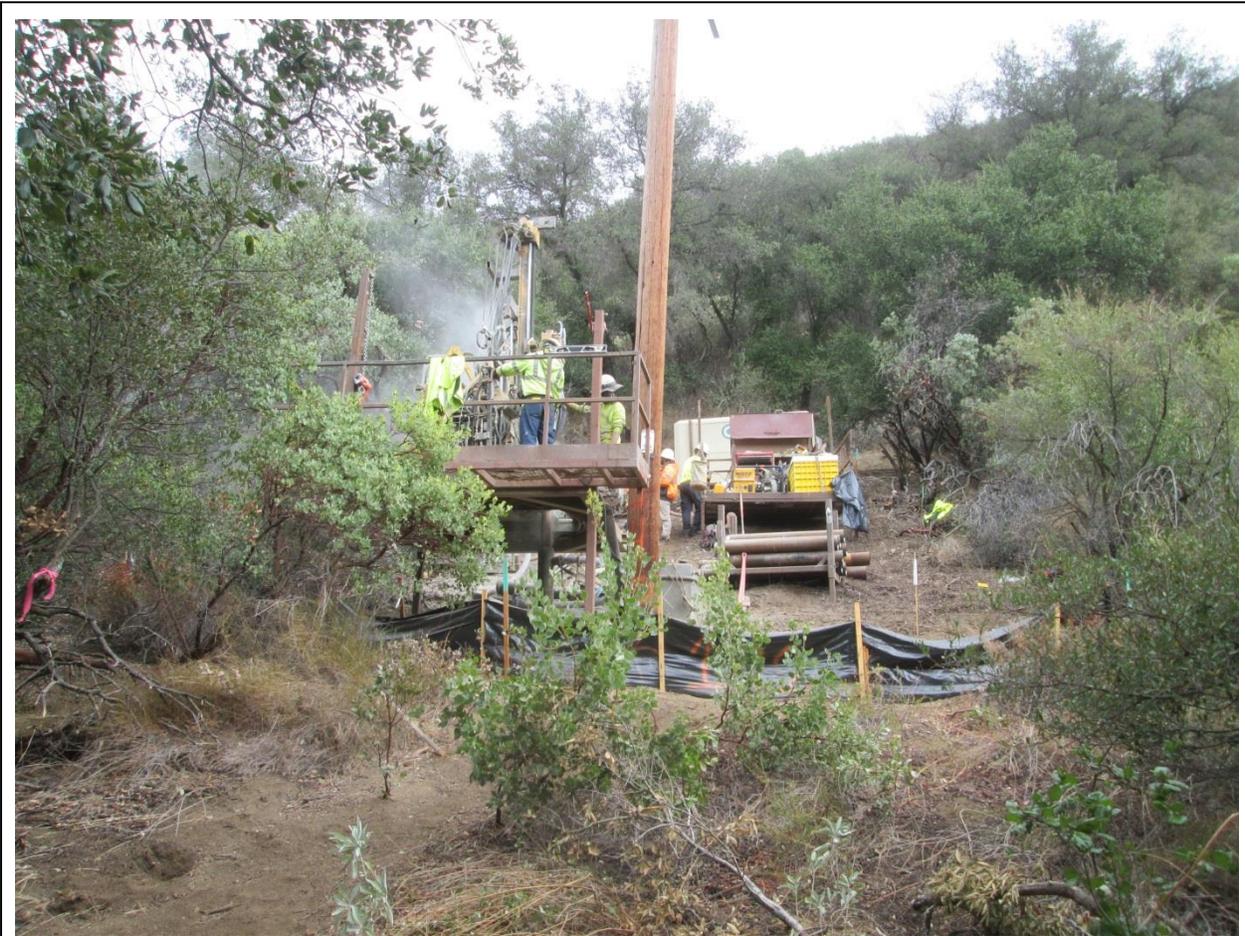
Photo 1: Micropile foundation drilling observed at Pole Z118126 (TL 682). Silt fencing was observed along the downslope side of the workspace for sediment control in accordance with the project's Erosion Control Plan and SWPPP (MM HYD-1), APM HYD-09, and MM BIO-7.

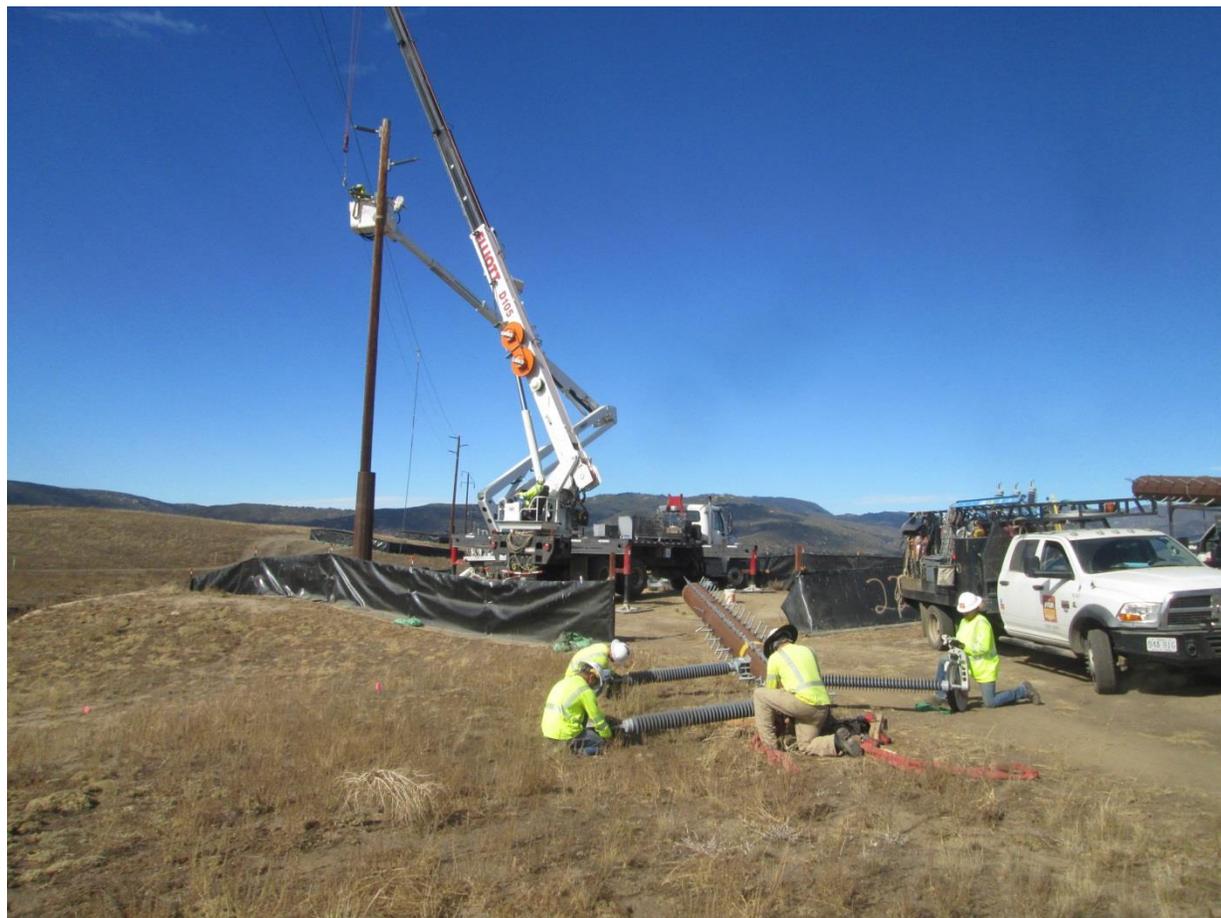
Photo 2: A construction crew observed removing the old wooden pole and preparing the new steel pole for installation at Pole Z118216 (TL 682). Stephens' kangaroo rat exclusion barrier was observed surrounding the workspace in accordance with MM BIO-31.

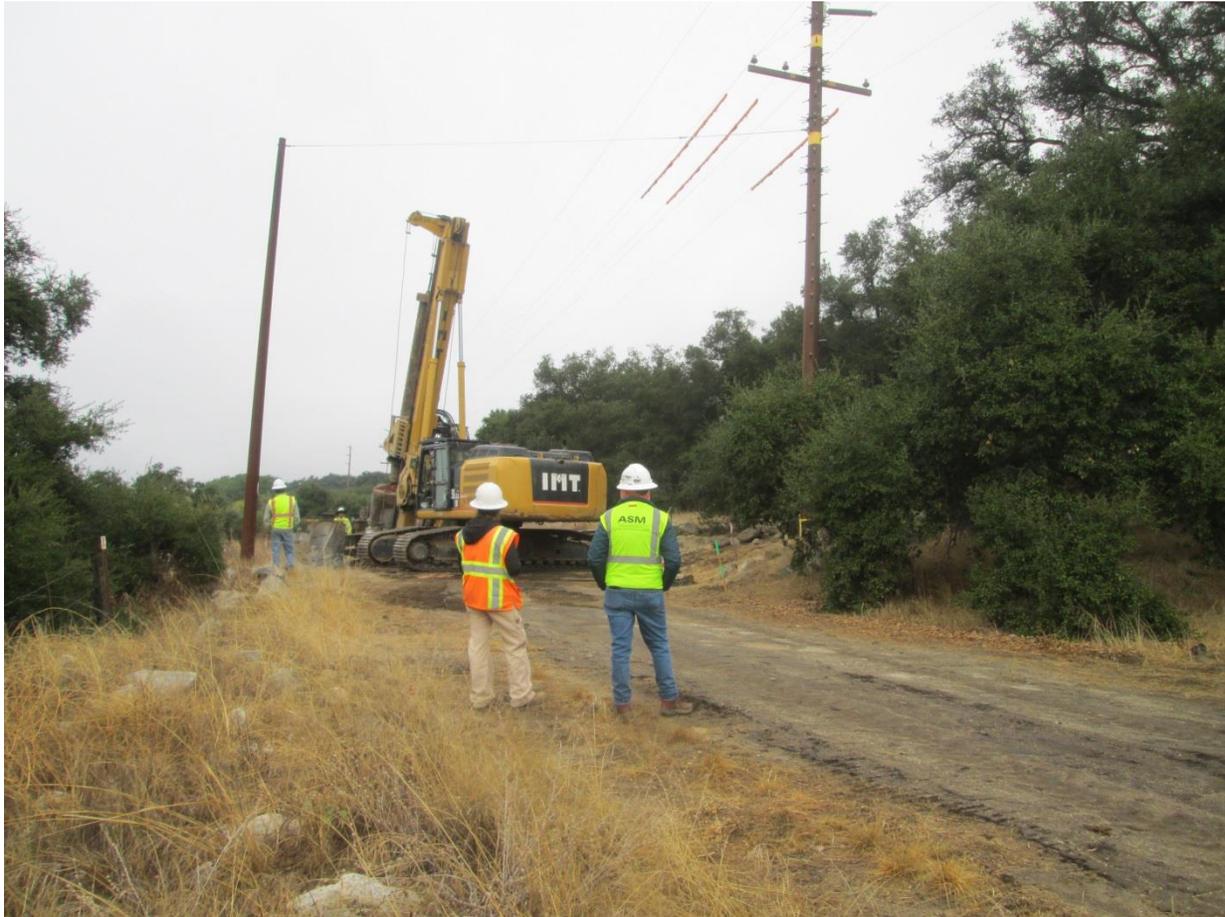
Photo 3: During pole hole drilling at Pole Z118044 (TL 682), archeological and Native American monitors were observed monitoring the construction activity and inspecting excavated soil for the presence of sensitive cultural resources in accordance with the HPMP, MM CUL-1, MM CUL-3, and APM CUL-04.

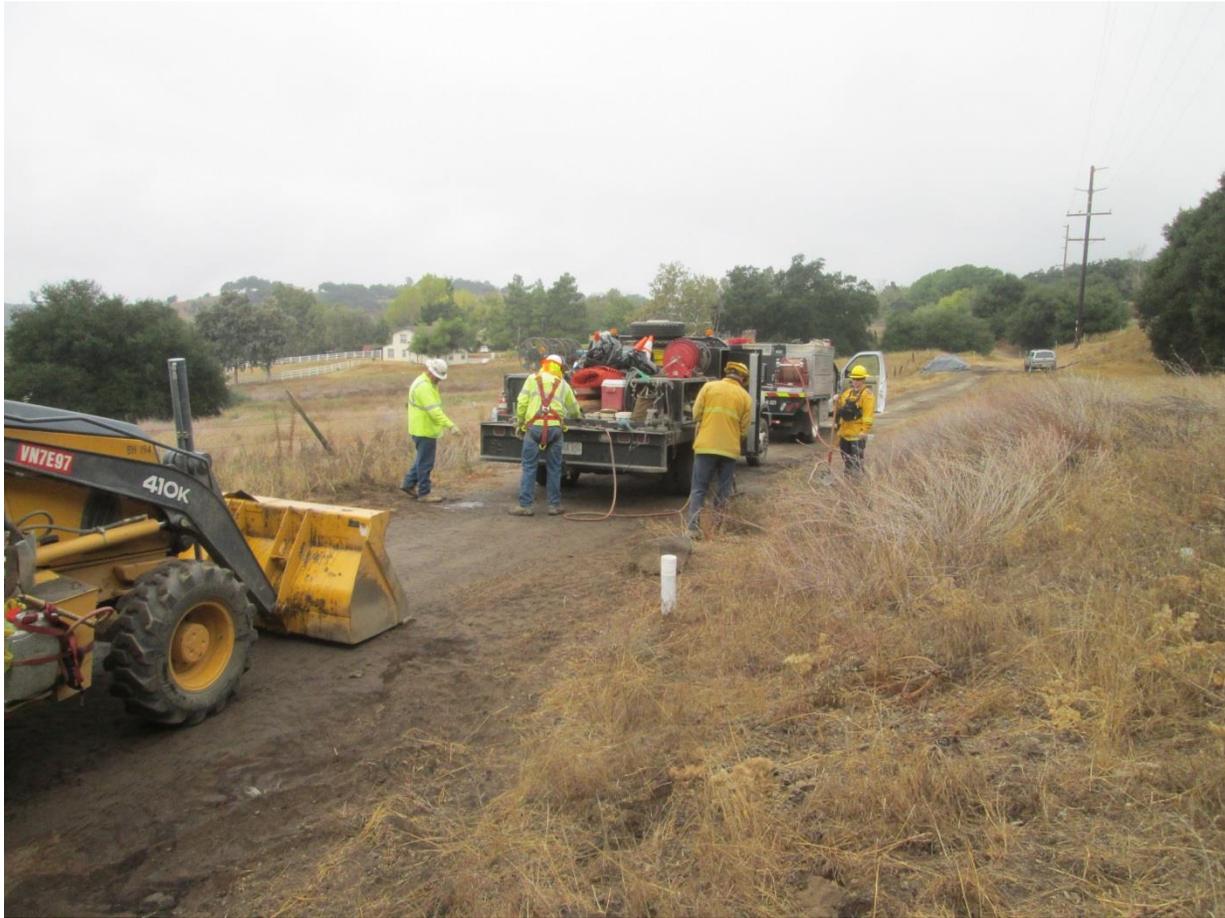
Photo 4: During welding work conducted by the pole hole drilling crew at Pole Z118044 (TL 682), a dedicated fire patrol was observed wetting down the surrounding area prior to the hot work and monitoring the activity to ensure fire safety and compliance in accordance with the CFPPP, MM FF-1, and APM HAZ-01.

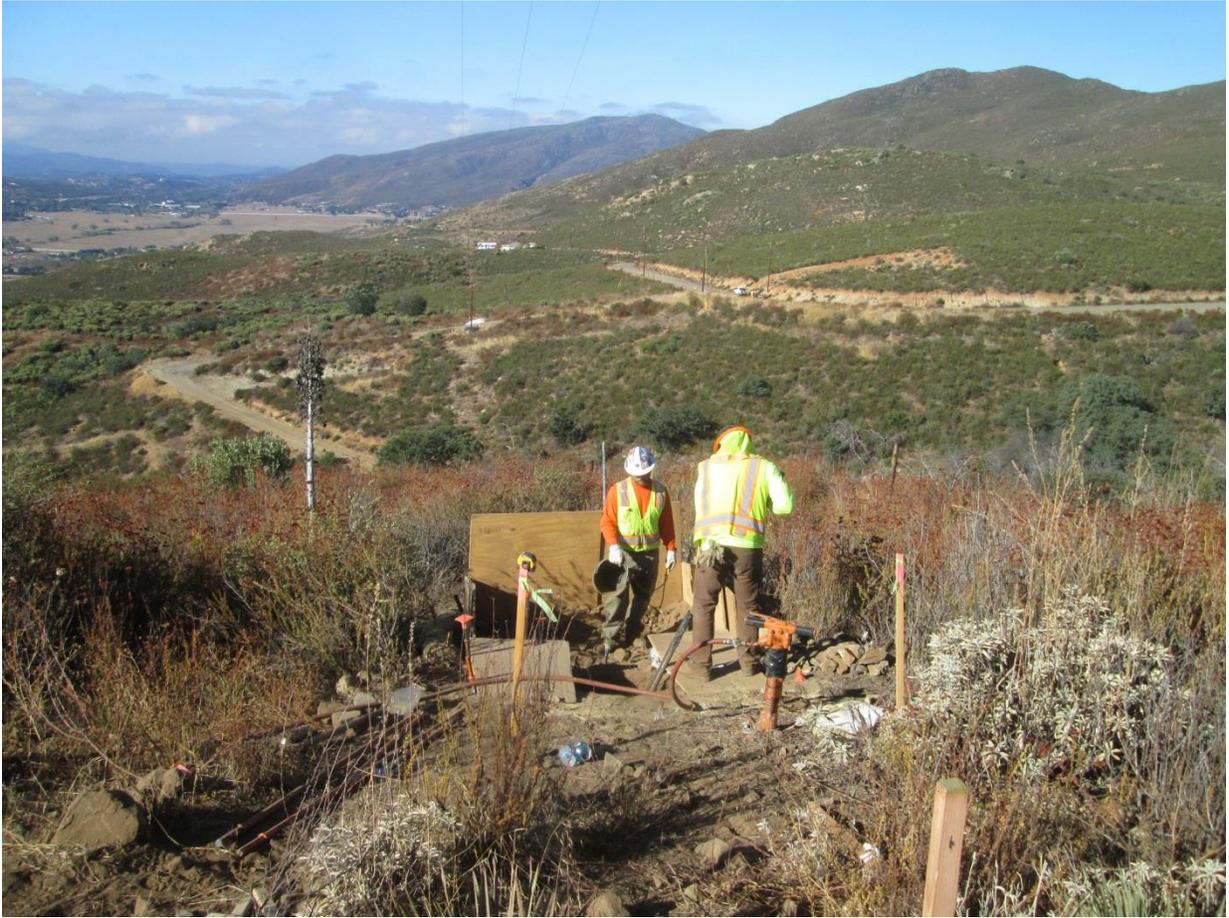
Photo 5: A construction crew observed excavating a hole for pole anchor installation at Pole P172702 (C 78) within the approved and delineated workspace in accordance with MM BIO-1.

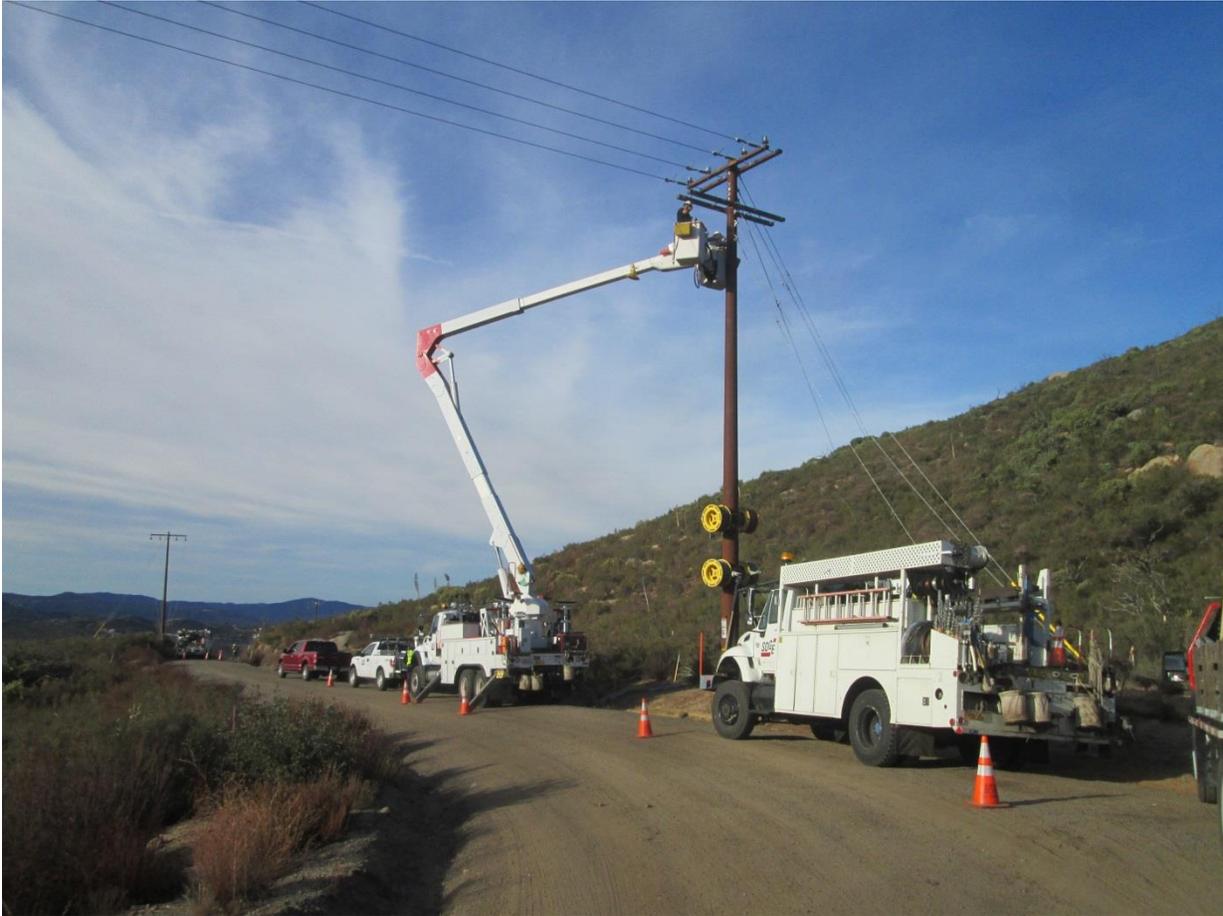
Photo 6: During the rope stringing in preparation for conductor wire stringing at P257760 (C 78), cones and traffic control flaggers (not pictured) were in place along Viejas Grade Road to ensure traffic safety in accordance with APM TRANS-02.
