| | California Public Utilities Commission <i>Mitigation Monitoring, Compliance, and Reporting Program</i> |
| | Cleveland National Forest Power Line Replacement Projects Compliance Status Report: 031 November 26, 2017 |

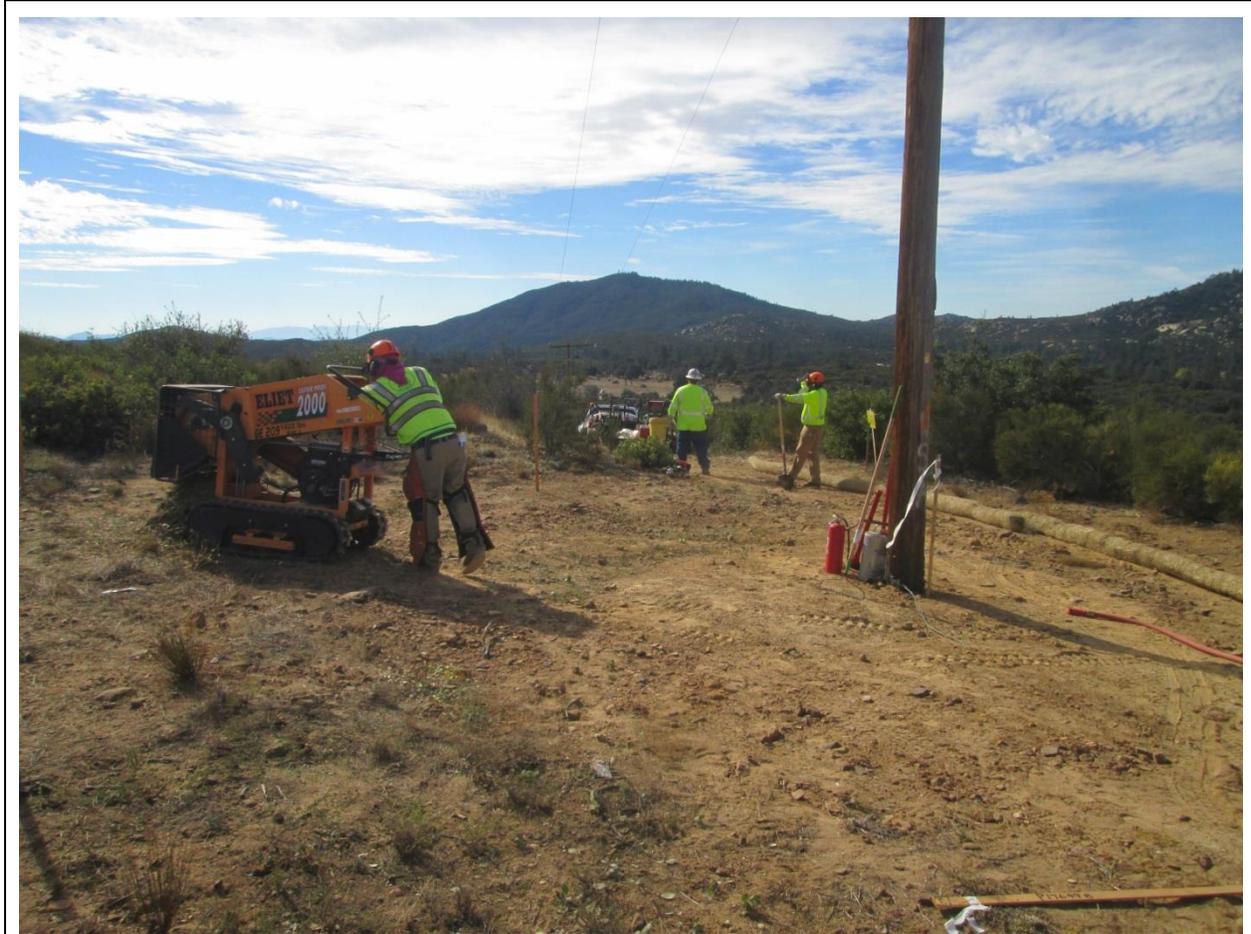
During this reporting period along C 442, construction activities observed by Dudek third party ECMs included clearing vegetation (See Photo 1 – Attachment A), installing erosion control BMPs (i.e. fiber

APM HAZ-01) (See Photo 1 – Attachment A). In addition to a set of fire tools (5 gallon backpack pump, round point shovel, Pulaski, and 2A10BC fire extinguisher), 100 gallons of water with a pump and hose was observed on site for activities that required it, such as access road grading near Pole P177005 (C 442), chipping of vegetation at Pole P176998 (C 442), and trenching for ground wire and rod installation at Pole Z118056 (TL 682).

Photo 1: A construction crew observed clearing vegetation at Pole P176998 (C 442). The crew was observed staging the required 5 gallon backpack pump, round point shovel, Pulaski, and 2A10BC fire extinguisher, along with 100 gallons of water with pump and hose (not pictured) in accordance with Fire Prevention Matrix (off CNF land), CFPPP (MM FF-1 and APM HAZ-01), and APM HAZ-04.

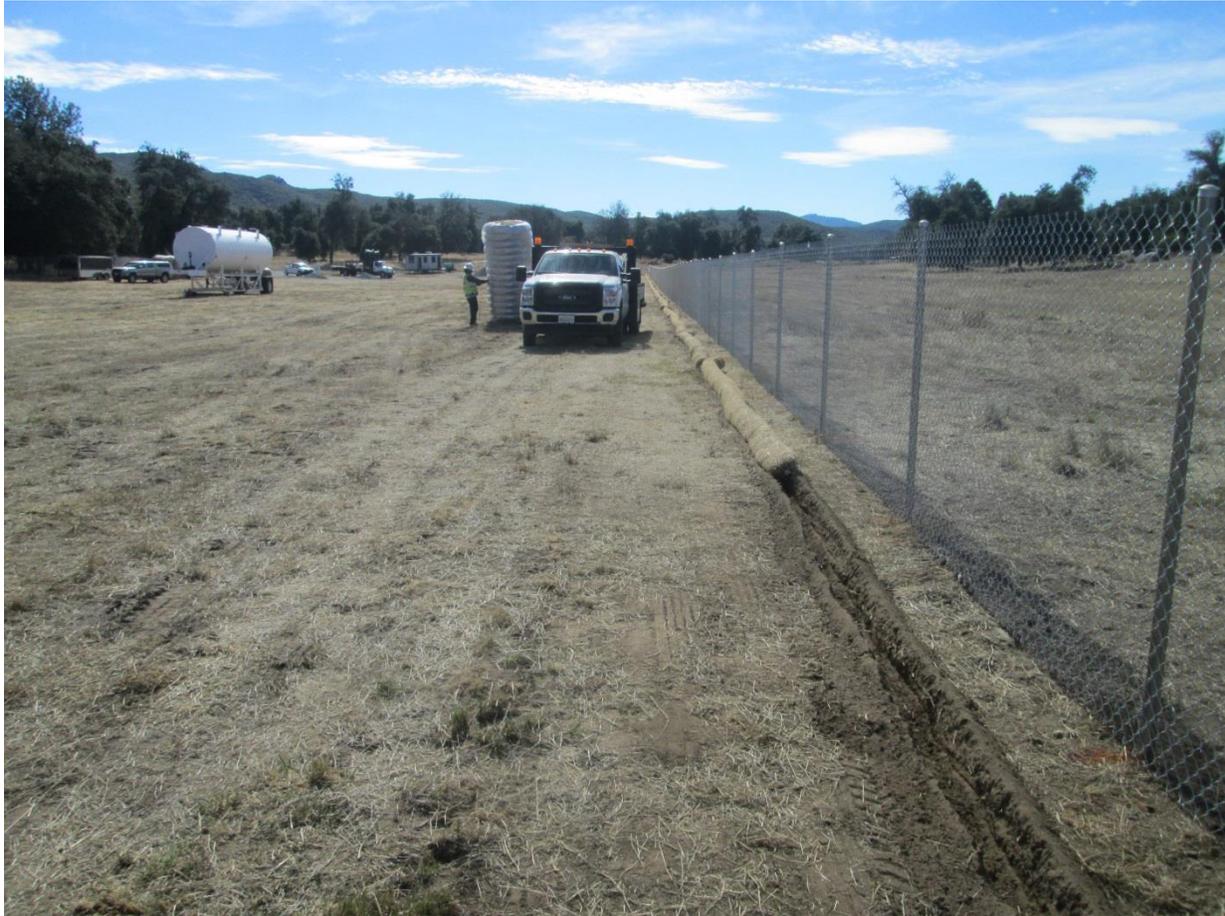
rolls) (See Photo 2 – Attachment A), drilling pole holes (See Photo 3 – Attachment A), digging anchor holes, grading/repairing existing access roads (See Photo 4 – Attachment A), and delineating a designated helicopter landing area at Corte Madera Staging Area. Along C 78, crews were observed clearing vegetation (See Photo 5 – Attachment A), installing erosion control BMPs, digging anchor holes, and pulling rope for wire stringing with the assistance of a helicopter. Along TL 682, construction crews were observed chipping vegetation, installing ground wire and rods (See Photo 6 – Attachment A), drilling pole holes, setting poles, and proof-testing micropiles.

Photo 2: A construction crew observed installing perimeter fiber rolls at Cortez Madera Staging Yard (C 442) in accordance with the project's Erosion Control Plan, SWPPP (MM HYD-1, MM BIO-7) and APM HYD-09.

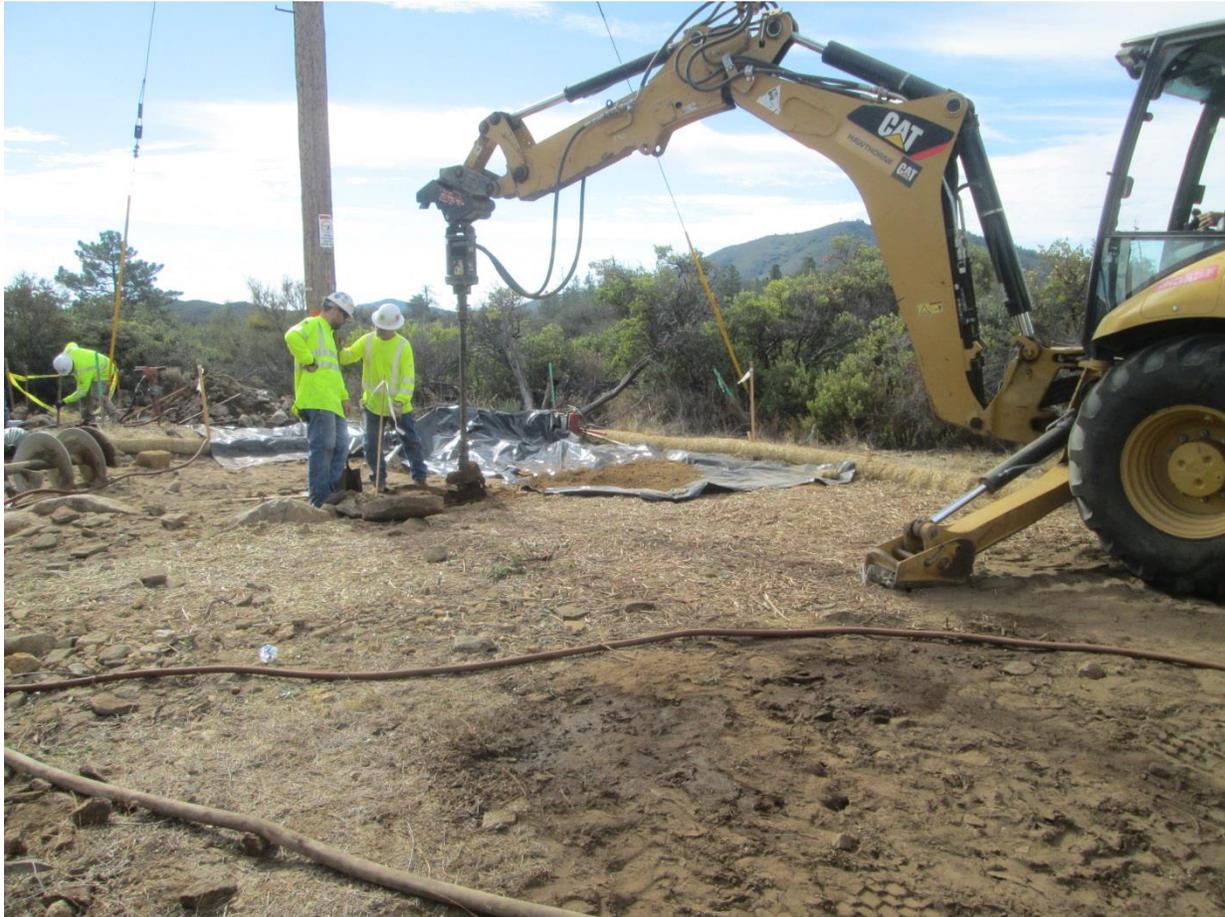
Photo 3: During pole hole drilling at Pole Z118044 (TL 682), drill spoils were placed on a sheet of plastic to prevent erosion in accordance with the project's Erosion Control Plan, SWPPP (MM HYD-1, MM BIO-7) and APM HYD-09.

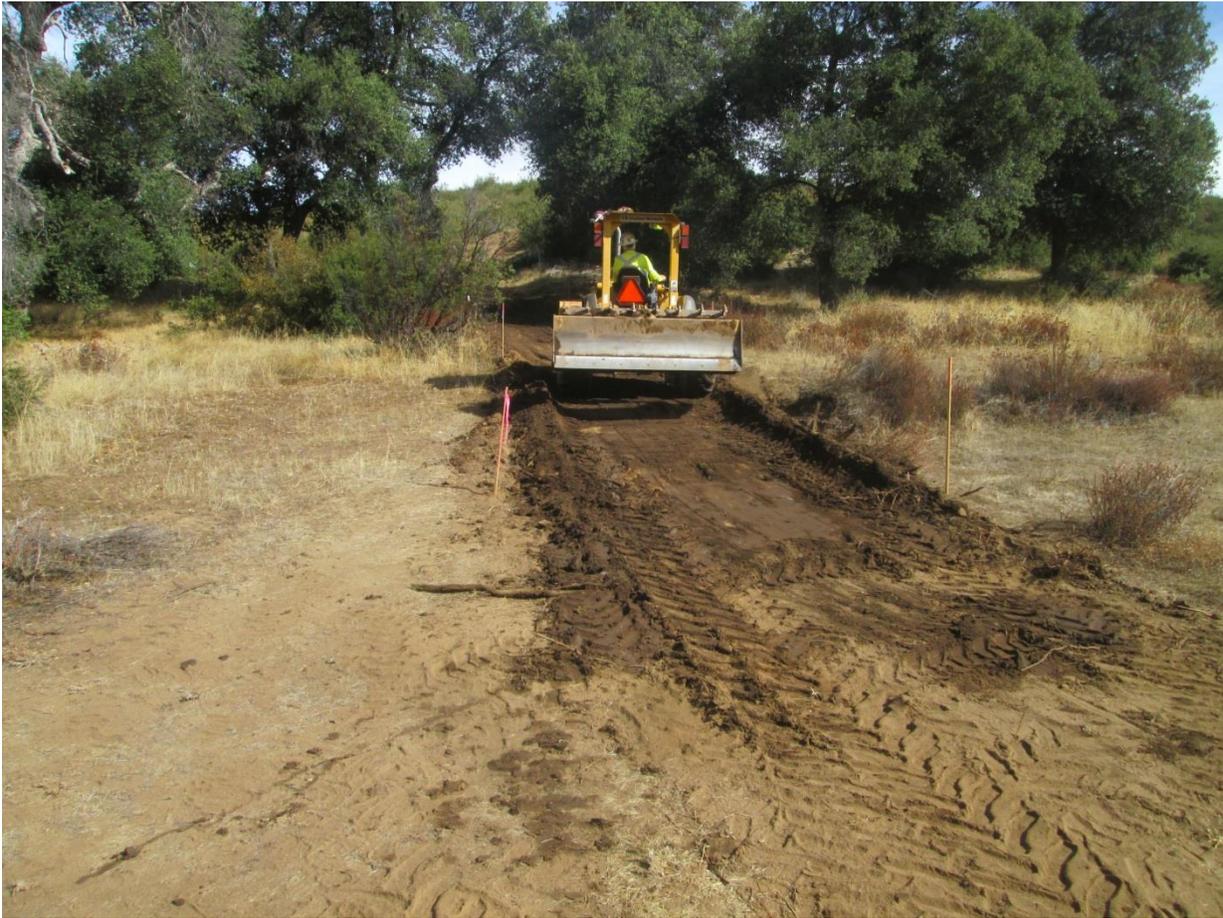
During construction activities, crews were observed adhering to delineated work limits and working within existing access roads in accordance with MM BIO-1 (See Photo 4 – Attachment A). In accordance with MM BIO-3 and MM BIO-22, biological monitors were observed conducting full time monitoring of initial ground-disturbing activities as well as vegetation clearing (See Photo 5 – Attachment A). To prevent wildlife entrapment, completed pole holes were observed securely covered in accordance with MM BIO-23. Crews were observed using trash bags to contain and collect trash at worksites in accordance with MM BIO-26. On November 15, during pole hole drilling at Z118016 (TL 682), a steel plate used to cover the pole hole after completion was observed laying down outside of the delineated workspace on a sheet of plastic. The SDG&E Lead Environmental Inspector (LEI) was notified of the issue, who then directed the crew to bring the steel plate back into the workspace. Sensitive biological resources were not impacted as a result. On November 17, the third party ECM notified the on-site biological monitor that a bucket truck outrigger being used during rope stringing (in preparation for wire stringing) was observed just outside of the workspace limits at Pole P172711. The biological monitor said that the area would be documented.

Photo 4: During the grading and maintenance of an existing access road near Pole P177001 (C 442), stakes were installed along the road limits to ensure grading was conducted only within approved areas in accordance with MM BIO-1.

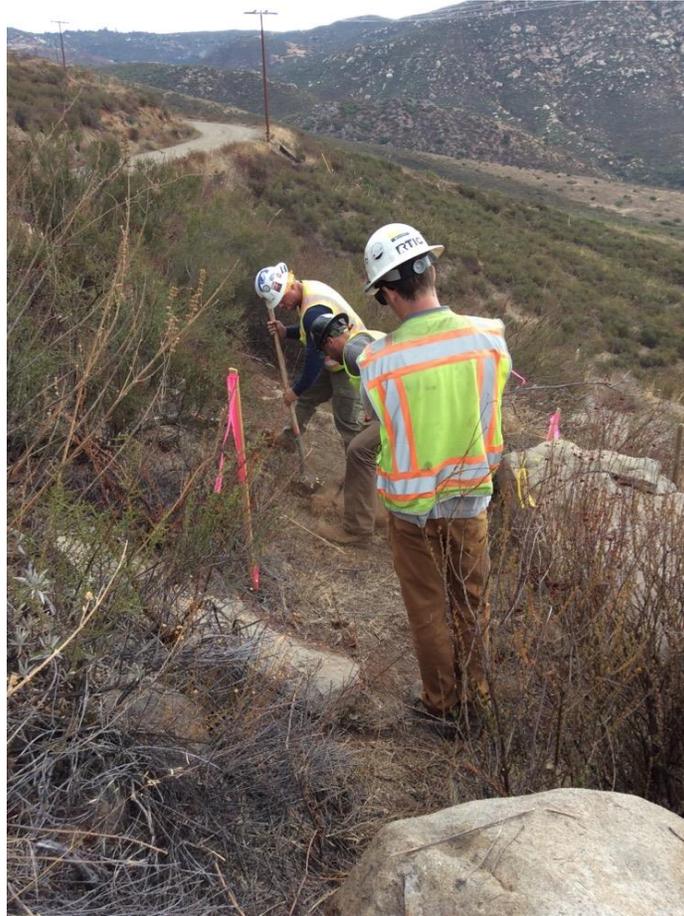
Photo 5: During vegetation clearing at Pole P257735 (C 78), a biological monitor was observed on site in accordance with MM BIO-3 and MM BIO-22.

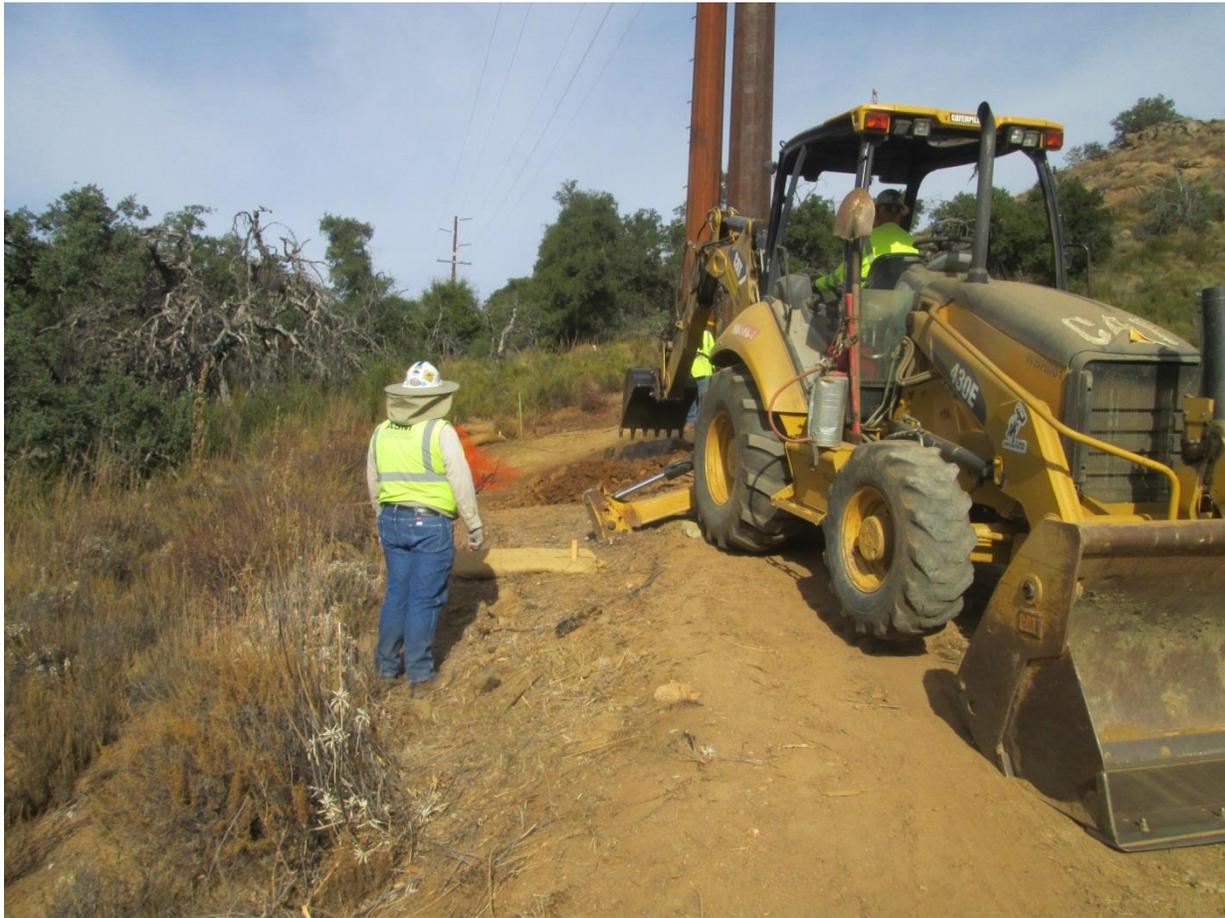
Photo 6: During trenching for ground wire and rod installation, an archeological monitor was observed on site inspecting excavated soils for the presence of sensitive cultural resources in accordance with the Historic Properties Management Plan, MM CUL-1, MM CUL-3, and APM CUL-04.
