California Public Utilities Commission <i>Mitigation Monitoring, Compliance, and Reporting Program</i>
	Cleveland National Forest Power Line Replacement Projects Compliance Status Report: 033 December 24, 2017

SUMMARY

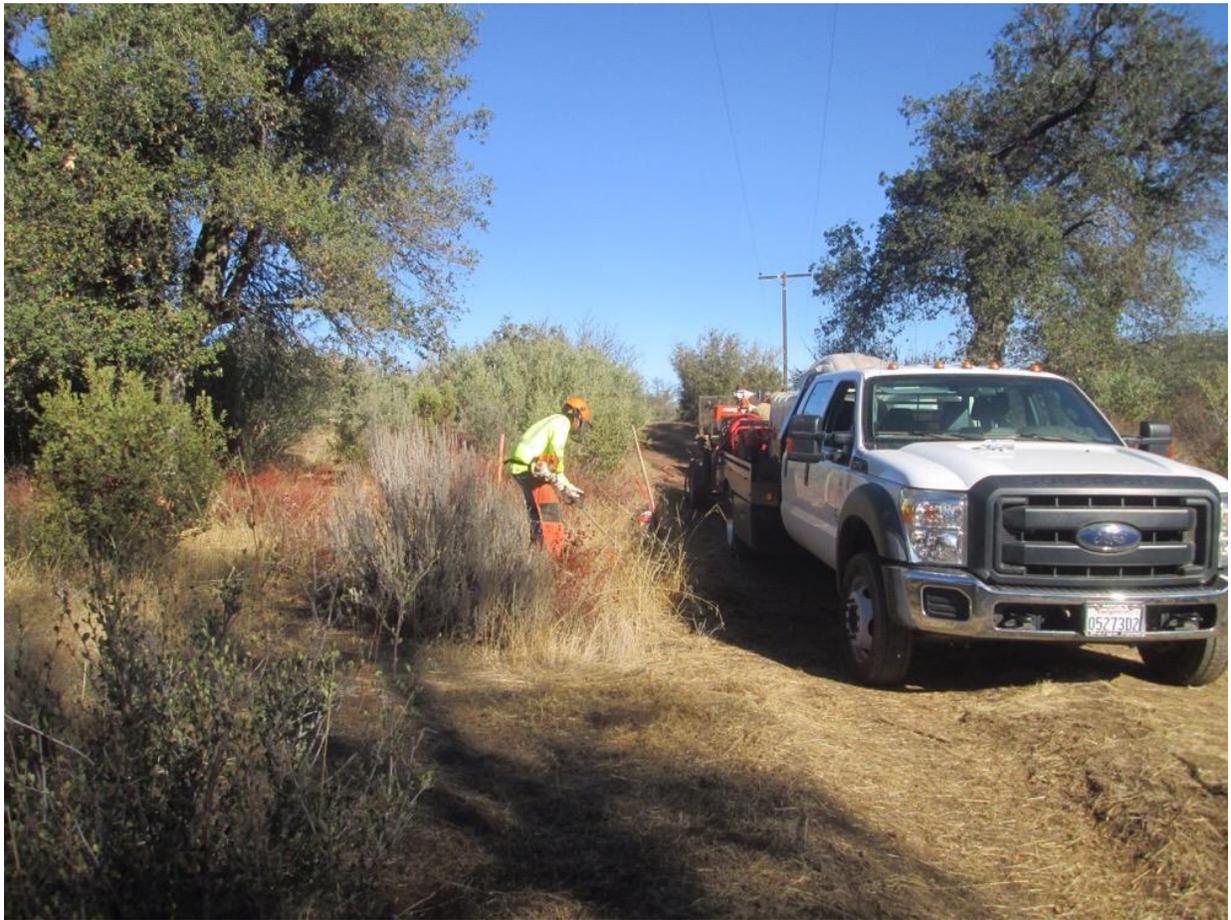
Photo 1: A construction crew is observed clearing vegetation at the wire stringing site near Pole P176988 (C 442).

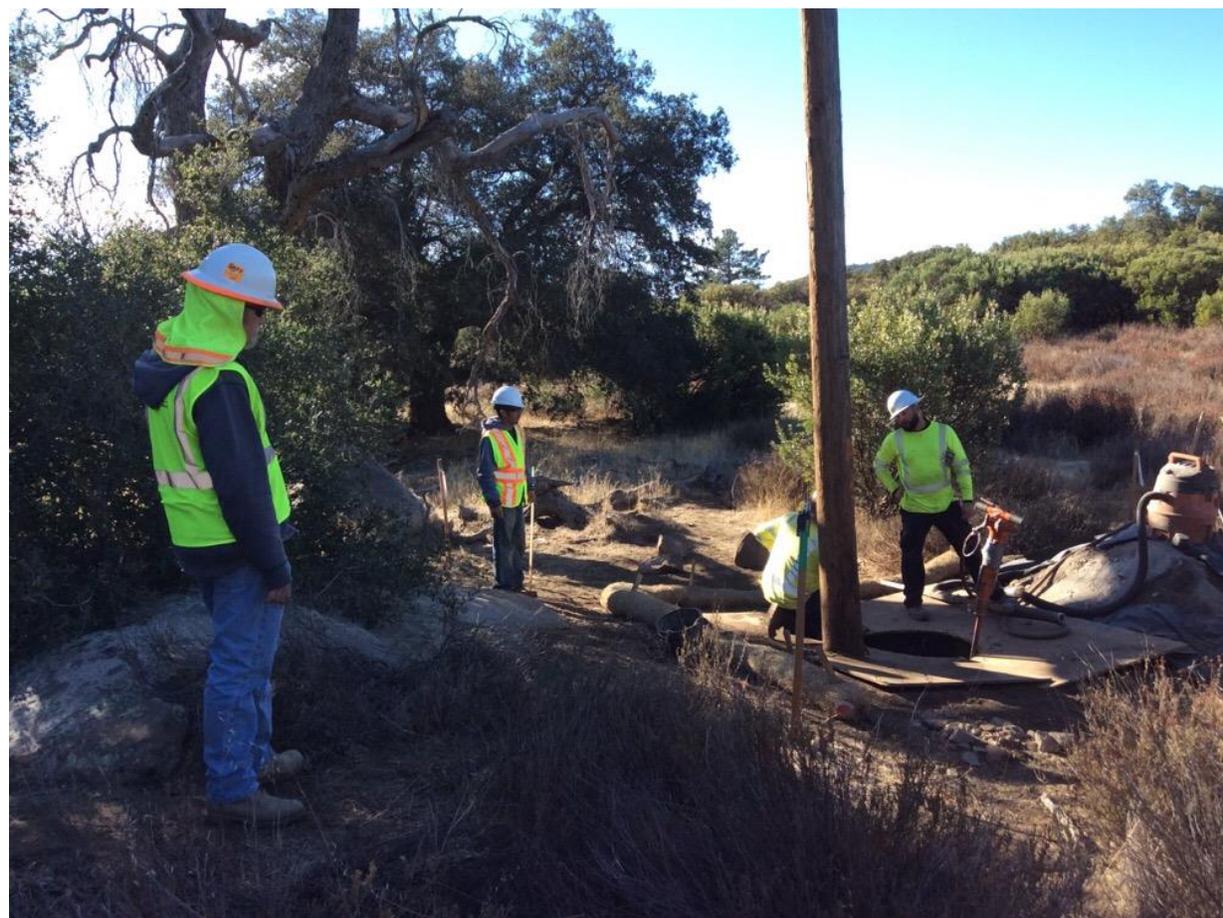
Photo 2: A construction crew observed using a jackhammer and hand tools to dig an excavation at Pole P177004 (C 442). Archaeological and Native American Monitors were observed inspecting excavated soil in accordance with MM CUL-1.

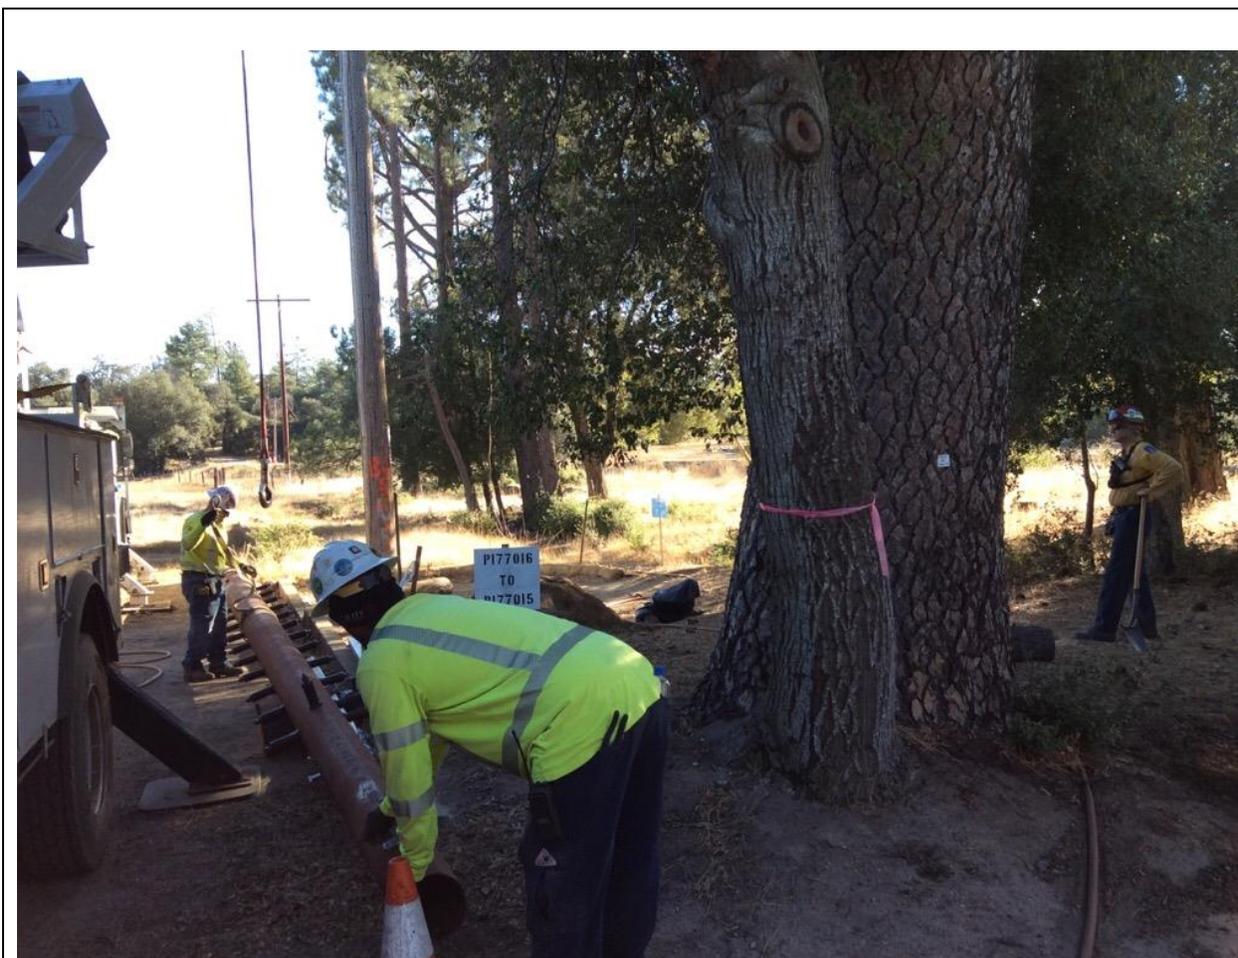
Photo 3: A construction crew observed framing and preparing the pole to be set at Pole P177016 (C 442). A Fire Patrol was observed accompanying the crew and inspecting the site for compliance with the CFPPP.

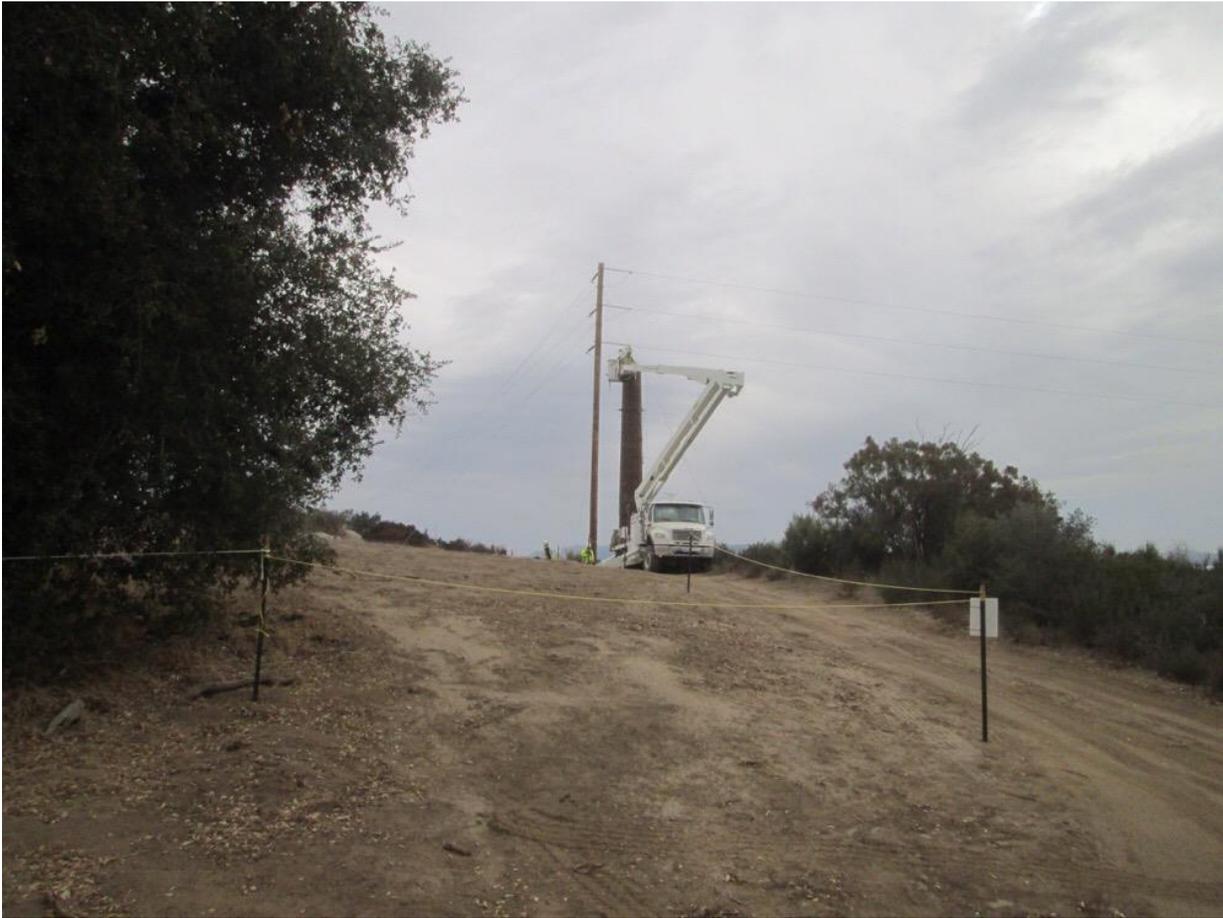
Photo 4: During pole setting along TL 682, a cultural resources ESA was observed adjacent to the work area in accordance with the Historic Properties Management Plan.

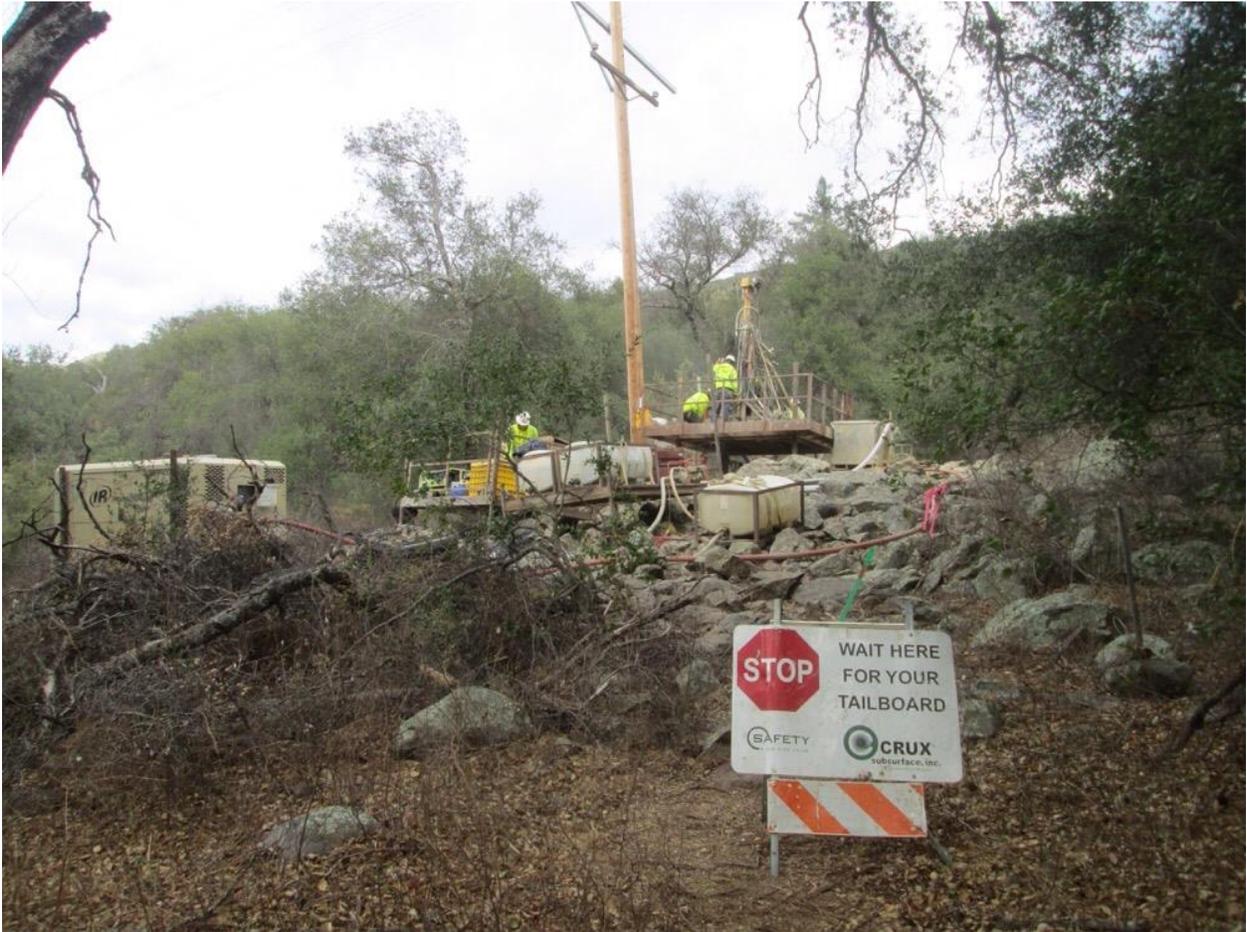
Photo 5: A construction crew observed drilling micropiles at Pole Z118113 (TL 682).

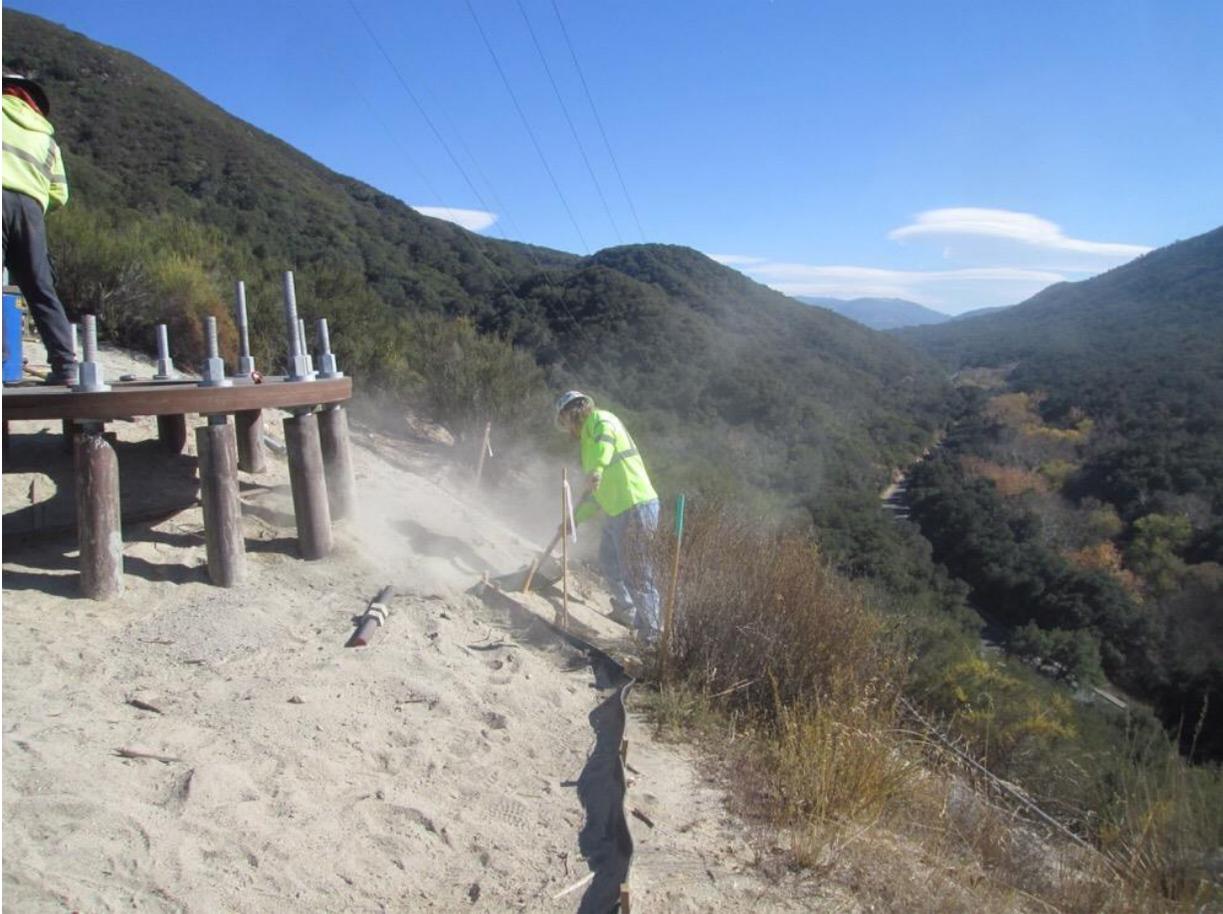
On December 16, the third party ECM notified the project LEI about a small sediment breach over the prowattle at Pole Z118164 (TL 682). The LEI passed along the info to the Blackhawk environmental monitor, who was preparing a BMP repair punch list. On December 20, the third party ECM notified the project LEI of approximately 2.5 feet of prowattle detached from the ground surface at Pole Z118114 (TL 682) and of sediment overload on the perimeter prowattle at Pole Z118132. Shortly after, the on-site Biological Monitor was observed shoveling away the sediment load on the perimeter prowattle (See Photo 6 – Attachment A). The BMP maintenance needs were communicated to the Blackhawk environmental monitor.

Photo 6: A Biological Monitor was observed removing excess sediment piled up on the perimeter of a prowatte at Pole Z118132 (TL 682), shortly after the Lead Environmental Inspector was notified of the issue.
