# California Public Utilities Commission *Mitigation Monitoring, Compliance, and Reporting Program*

# **Cleveland National Forest Power Line Replacement Projects**

**Compliance Status Report: 034**

**January 7, 2018**

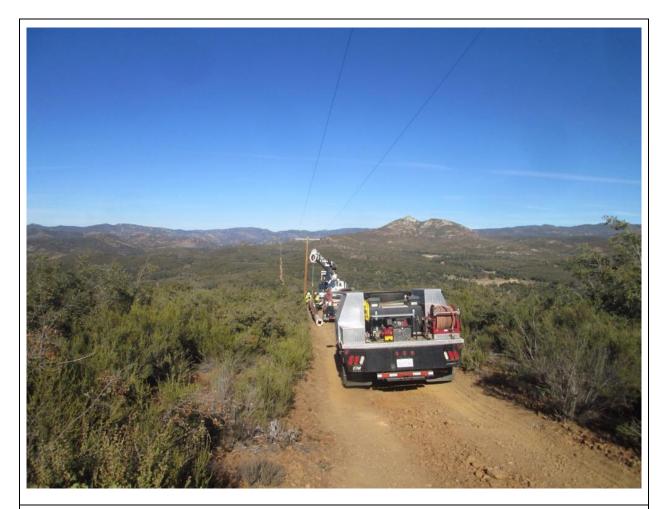
During this reporting period along C 442, construction activities observed by Dudek third party ECMs included framing steel replacement poles (See Photo 1 – Attachment A), drilling anchor holes (See

**Photo 1**: A construction crew observed framing a steel pole at Pole P176991 (C 442).

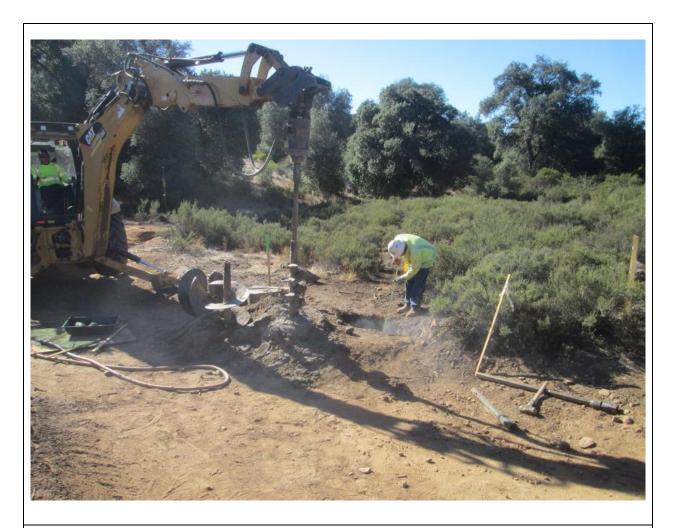
During construction activities, crews were observed adhering to delineated work limits and working within existing access roads in accordance with MM BIO-1 (See Photo 2 – Attachment A). However, on January 3, a construction crew let down two legs of the drill platform outside the work limits at Pole Z118111 (TL 682), and on January 5, a construction crew staged a workbox outside the work limits at Pole Z118128 (TL 682) due to the steepness of the site and safety concerns. Both sites were surveyed by Biological and Archaeological Monitors in advance to ensure no sensitive resources would be damaged.

**Photo 2:** During anchor hole drilling at Pole P176988 (C 442), crews were observed adhering to the delineated work space limits in accordance with MM BIO-1.

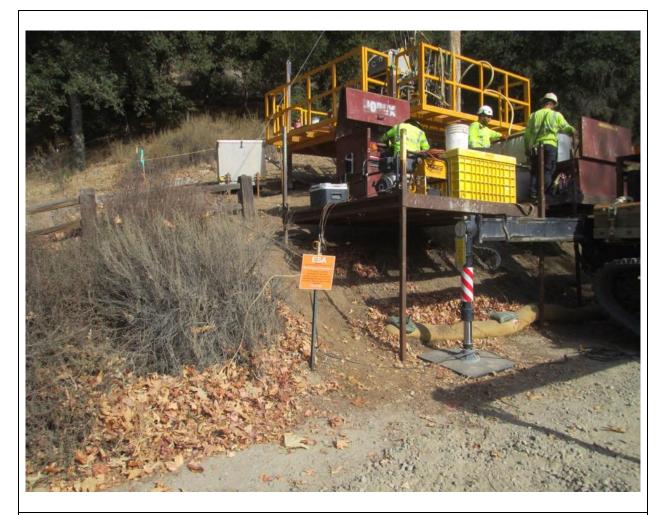
**Photo 3:** During micropile foundation drilling at Pole Z118106 (TL 682), ESA fencing was observed around the work space in accordance with the Historic Properties Management Plan.

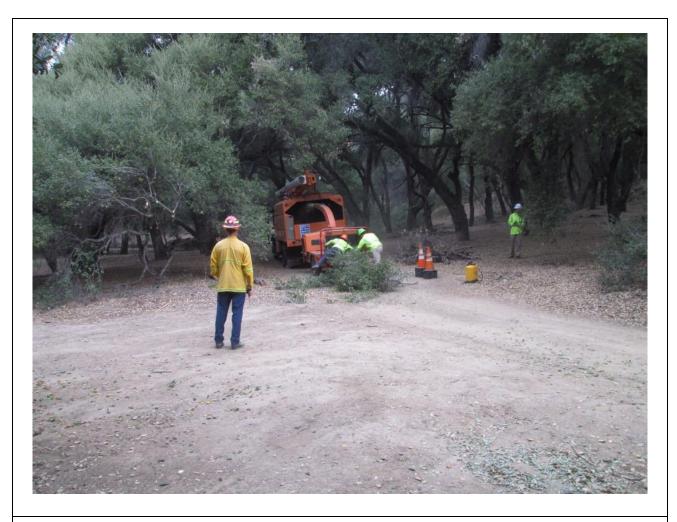
During construction activities along both rights-of-way, construction fire patrols were observed inspecting sites for compliance with the Construction Fire Prevention/Protection Plan (CFPPP) (MM FF-1) (See Photo 4 – Attachment A). Construction crews were observed staging the required fire tools and equipment based on the Project Activity Level (on CNF land)/Fire Potential Index (off CNF land) and the construction activity being performed as allowed in the Fire Prevention Matrices CFPPP (MM

**Photo 4:** During tree trimming and chipping at the wire stringing site between Poles Z202586 and Z118122 (TL 682), a fire patrol was observed monitoring the activity in accordance with the CFPPP.

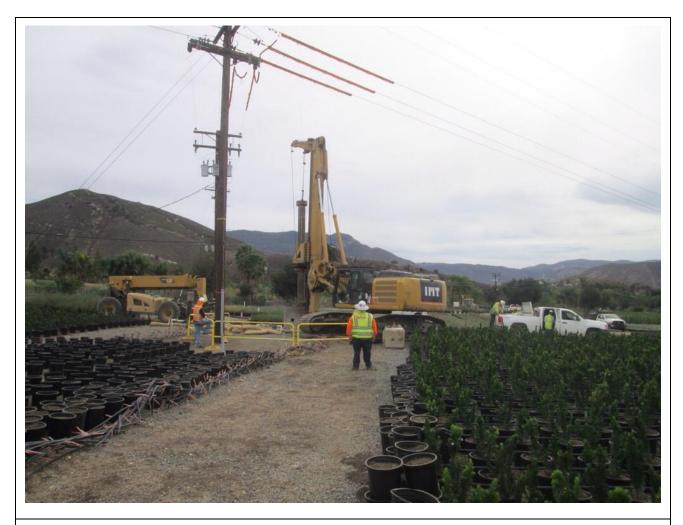
**Photo 5:** During pole hole drilling at Pole Z118002 (TL 682), Archaeological and Native American Monitors were observed monitoring the activity in accordance with the HPMP, MM CUL-1, MM CUL-3, and APM CUL-04.

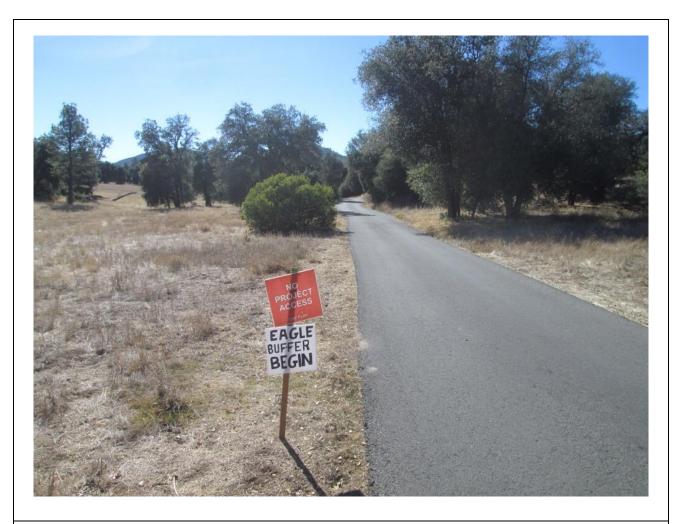
In accordance with MM BIO-3 and MM BIO-22, Biological Monitors were observed conducting full time monitoring of initial ground-disturbing activities as well as vegetation clearing. To prevent wildlife entrapment, completed pole holes were observed securely covered in accordance with MM BIO-23. Crews were observed using trash bags to contain and collect trash at worksites in accordance with MM BIO-26. In accordance with MM BIO-28, the Avian Protection Plan, and the Nesting Bird Management Plan, sites along the alignments were surveyed for nesting raptors prior to work activities. On January 4, a Biological Monitor on C 442 notified the CPUC ECM that a one-mile nesting buffer had been established around a Bald Eagle nest originally observed on December 23, 2017, and that all work is being conducted outside the buffer until a buffer reduction is approved (See Photo 6 – Attachment A).

**Photo 6:** Nesting buffer signage was observed on Corte Madera Road to mark the limits of a one-mile buffer surrounding a Bald Eagle nest (C 442).
