<p>California Public Utilities Commission <i>Mitigation Monitoring, Compliance, and Reporting Program</i></p>
	<p>Cleveland National Forest Power Line Replacement Projects</p> <p>Compliance Status Report: 035</p> <p>January 21, 2018</p>

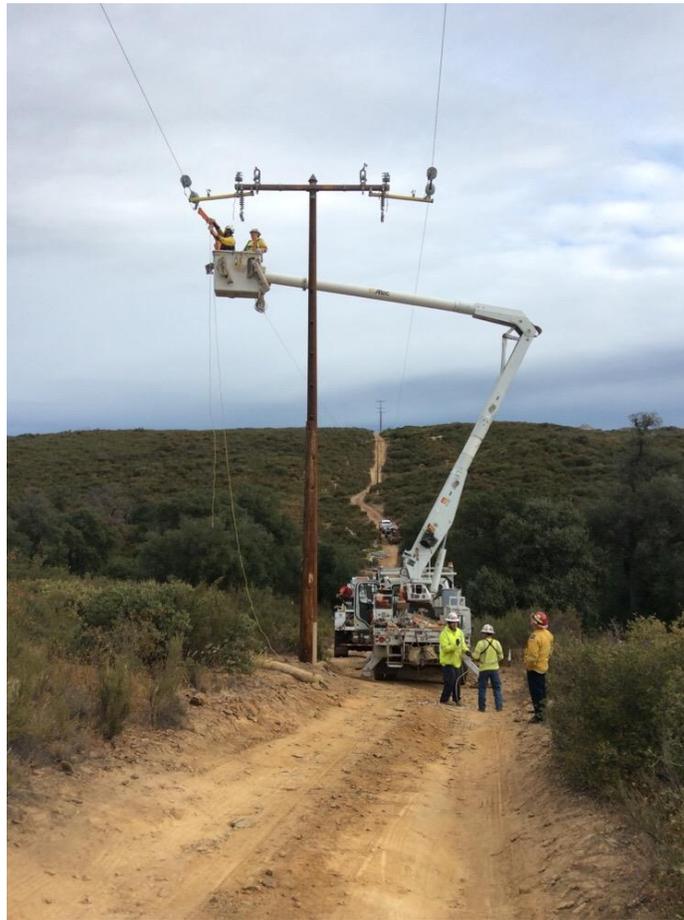
excavating/drilling pole and anchor holes, performing maintenance grading of existing access roads, spreading wire and installing wire protectors (See Photo 1 – Attachment A), and setting poles, removing old pole butts, and stringing wire. Along TL 682, crews were observed clearing vegetation and installing erosion control BMPs (See Photo 2 – Attachment A), drilling poles holes, constructing a foundation rebar cage and pouring concrete for conventional foundations (See Photo 3 – Attachment A), mobilizing equipment and materials, spreading wire, conducting helicopter external load operations to assist in micropile foundation construction activities, proof testing for micropile foundations (See Photo 4 – Attachment A), and stringing wire. Along TL 629A, a construction crew was observed conducting geotechnical borings (See Photo 5 – Attachment A).

During construction activities, construction fire patrols were observed inspecting sites for compliance with the Construction Fire Prevention/Protection Plan (CFPPP) and MM FF-1 (See Photo 1 – Attachment A). Construction crews were observed staging the required fire tools and equipment based on the Project Activity Level (on CNF land)/Fire Potential Index (off CNF land) and the construction activity being performed as allowed in the CFPPP Fire Prevention Matrices. A set of fire tools (5-gallon backpack pump, round point shovel, Pulaski, and 2A10BC fire extinguisher) was observed at all active construction sites in accordance with APM HAZ-01 and APM HAZ-04. During rebar foundation construction at Nursery Staging Yard (TL 682), a Capstone fire patrol was observed issuing a hot work permit, wetting down the surrounding area, and monitoring the hot work activity in accordance with the CFPPP.

Photo 1: A construction crew was observed spreading wire at Pole P176995 (C 442) to provide the overhead space needed for helicopter delivery of equipment and materials. A fire patrol was observed monitoring the work activity in accordance with the Construction Fire Prevention/Protection Plan and MM FF-1.

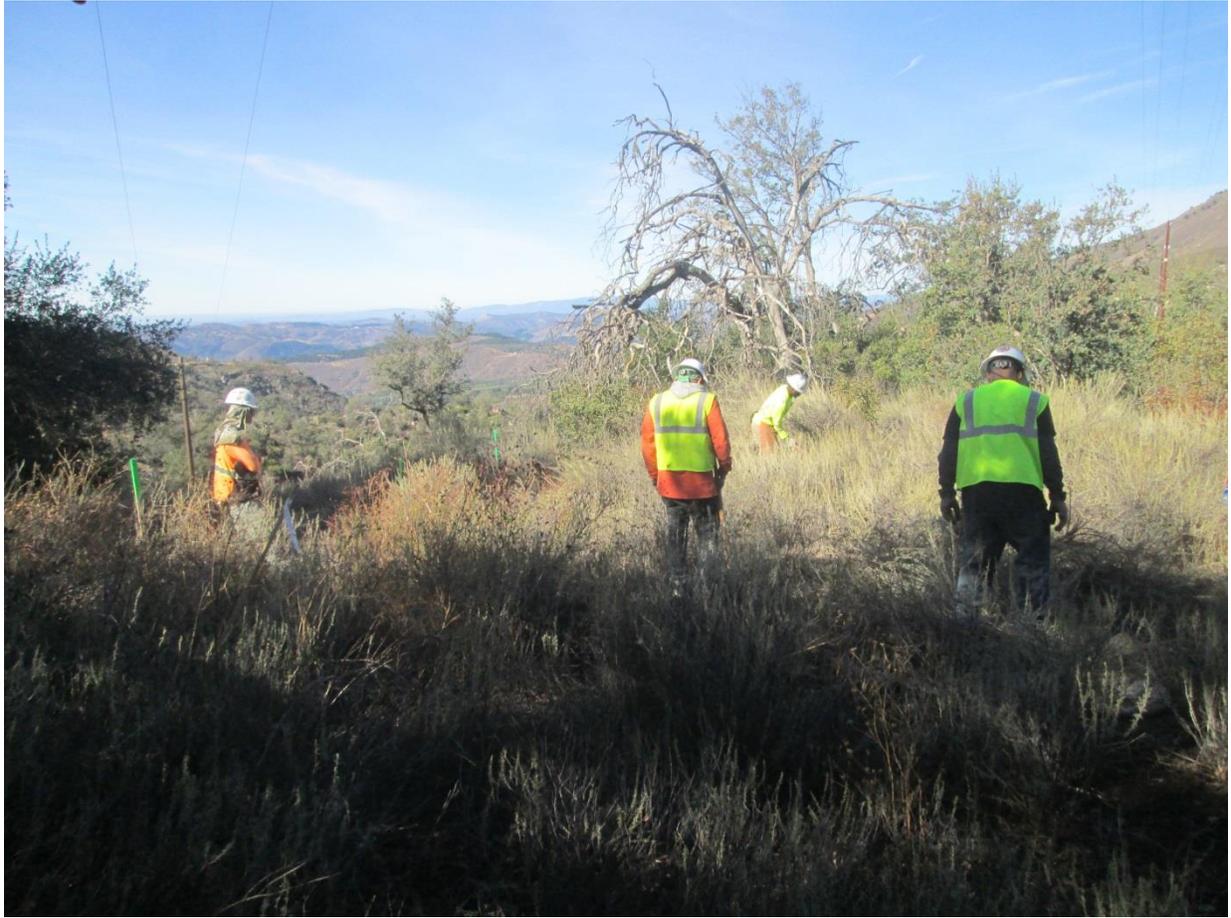
Photo 2: During vegetation clearing at Pole Z118029 (TL 682), archeological and Native American monitors were present in accordance with the Historic Properties Management Plan, MM CUL-1, MM CUL-3, and APM CUL-04.

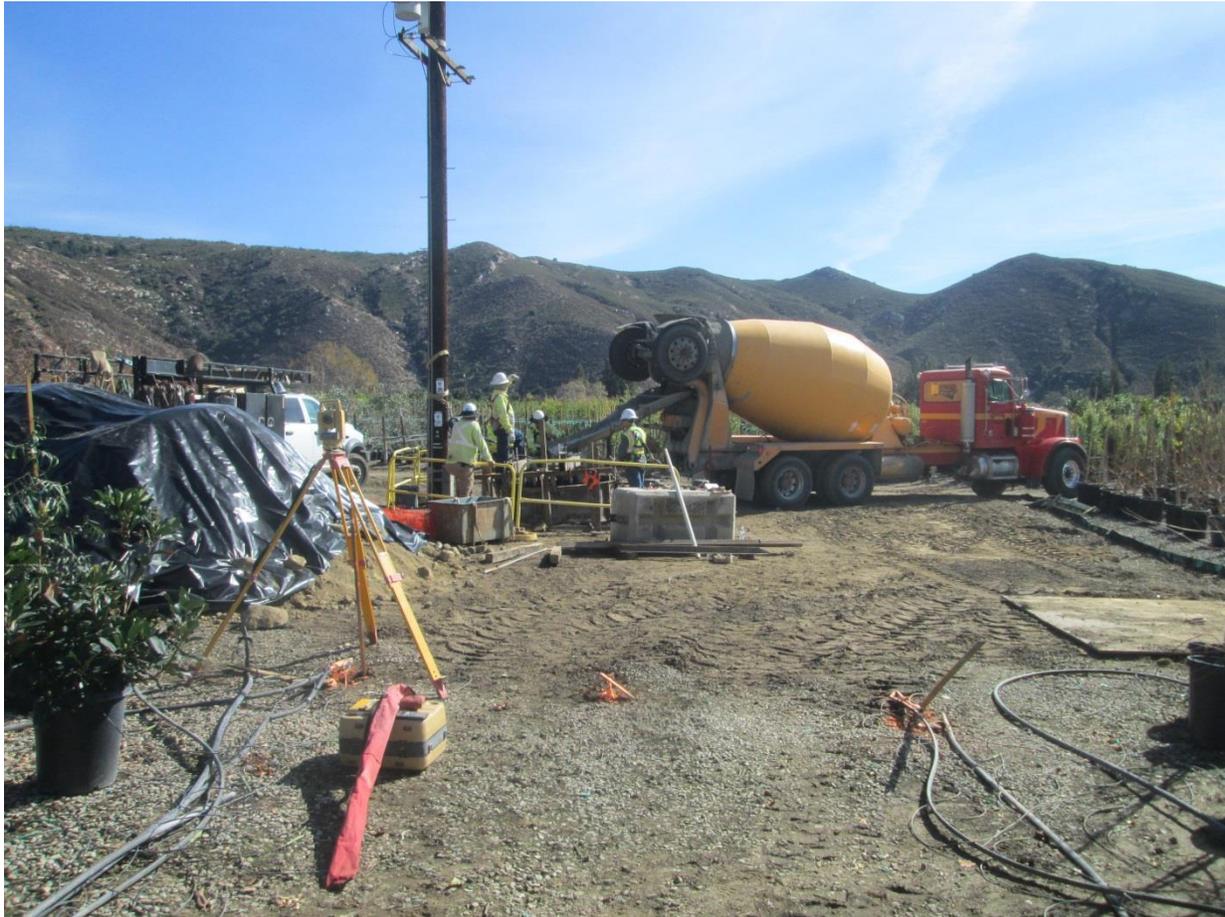
On January 10 (post rain event), construction contractor environmental monitors were observed using absorbent material to separate and clean oil and gas sheens from accumulated rainwater in drip/spill prevention containers at Warner Substation Staging Yard (TL 682) (See Photo 6 – Attachment A). Construction crews were also reminded at the morning tailboard to notify an environmental monitor if sheens were detected in drip/spill containment bins at their worksites so that proper cleanup and disposal could occur. During foundation construction, all concrete washouts were conducted into excavations where the concrete was poured, into a designated washout container, or captured in a holding tank in accordance with APM HYD-01 (See Photo 3 – Attachment A).

Photo 3: A construction crew observed pouring concrete at Pole Z118004. A dirt stockpile leftover from drilling was covered with visqueen to prevent erosion in accordance with the Storm Water Pollution Prevention Plan, MM HYD-1, MM BIO-7, and APM HYD-09. Concrete washout was placed in a washout bin in accordance with APM HYD-01.

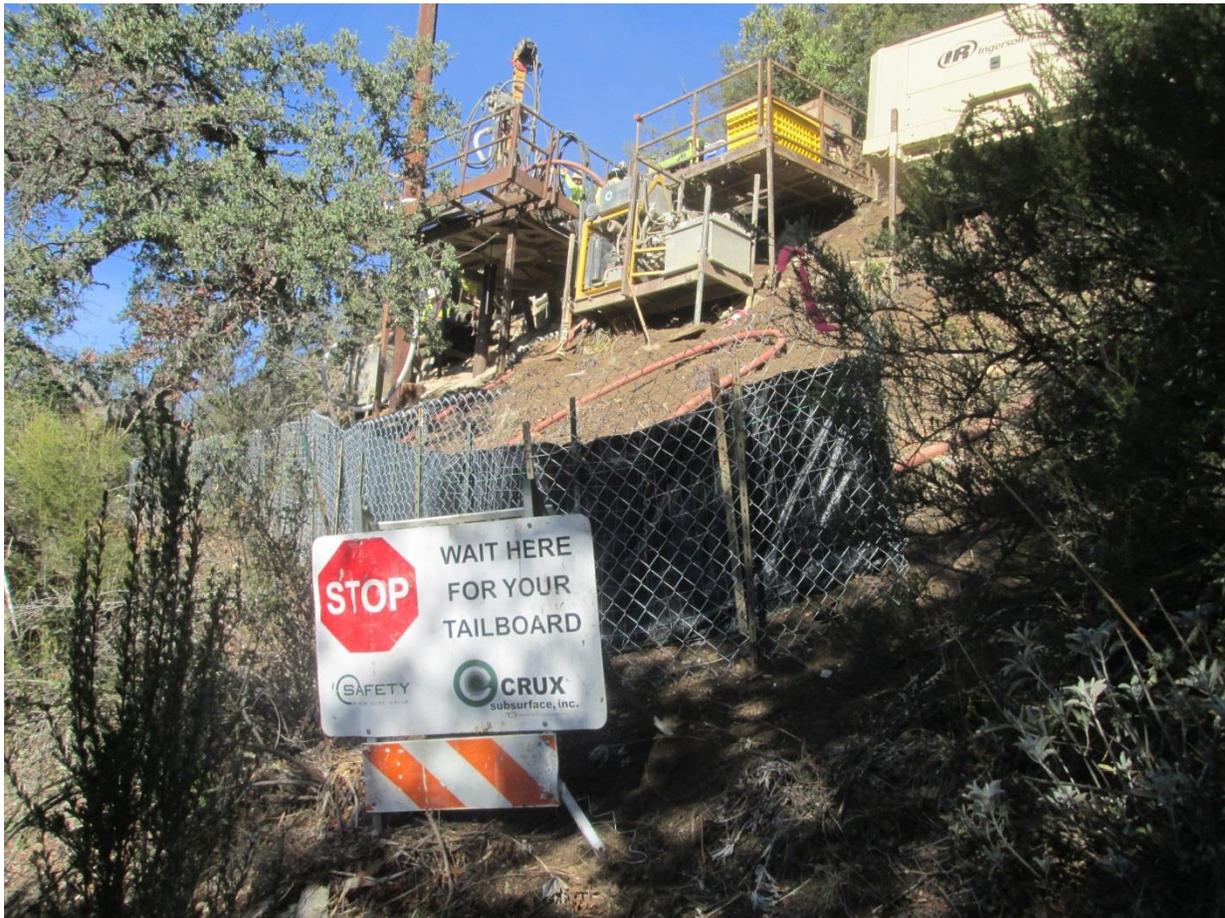
Photo 4: A construction crew observed drilling for a micropile foundation at Pole Z118109 (TL 682). Silt fencing was observed along the down slope side of the work space in accordance with the Storm Water Pollution Prevention Plan, MM HYD-1, MM BIO-7, and APM HYD-09.

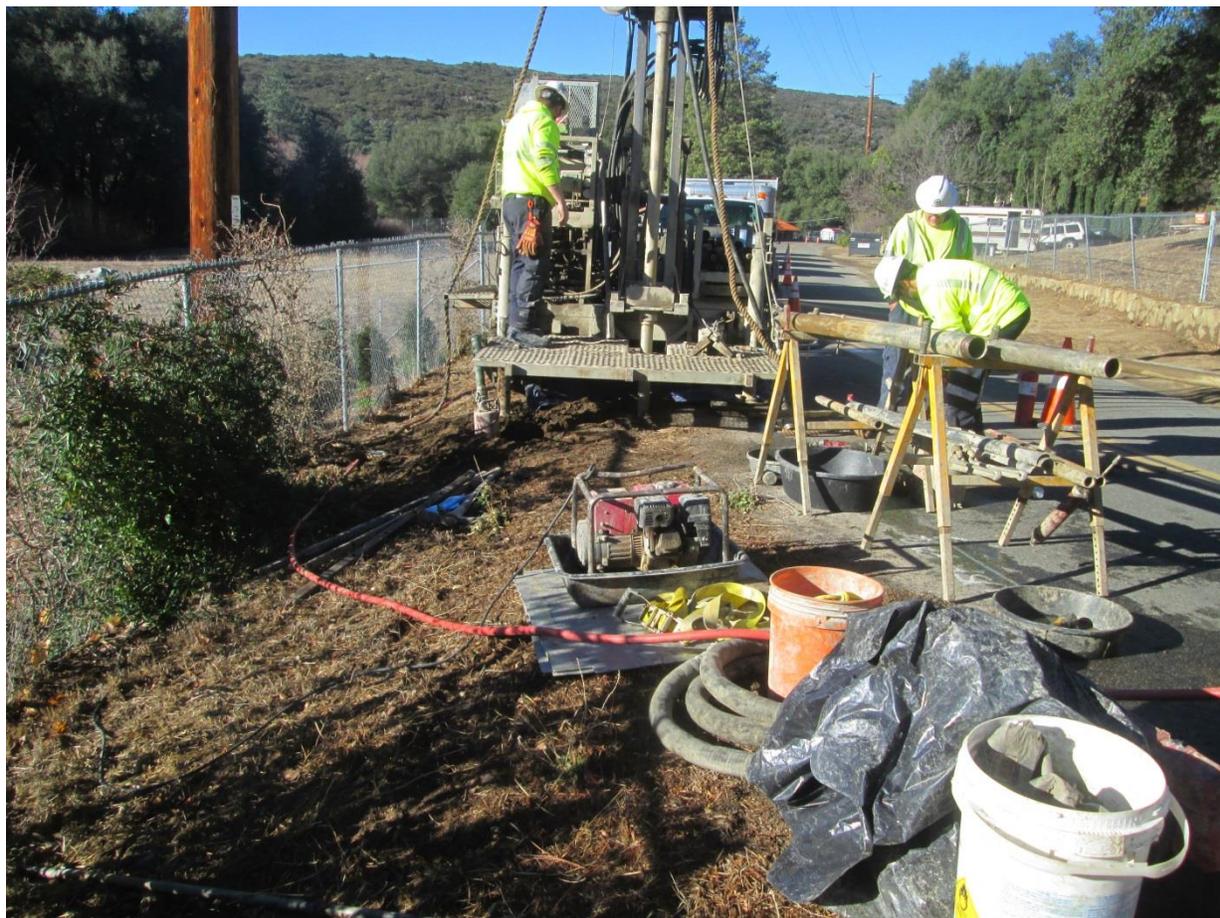
Photo 5: During geotechnical boring at B-4 (TL 629A), a drip pan was observed beneath a gas powered pump to prevent leaks/spills from being discharged into the soil in accordance with the Spill Response and Notification Plan and MM PHS-2.

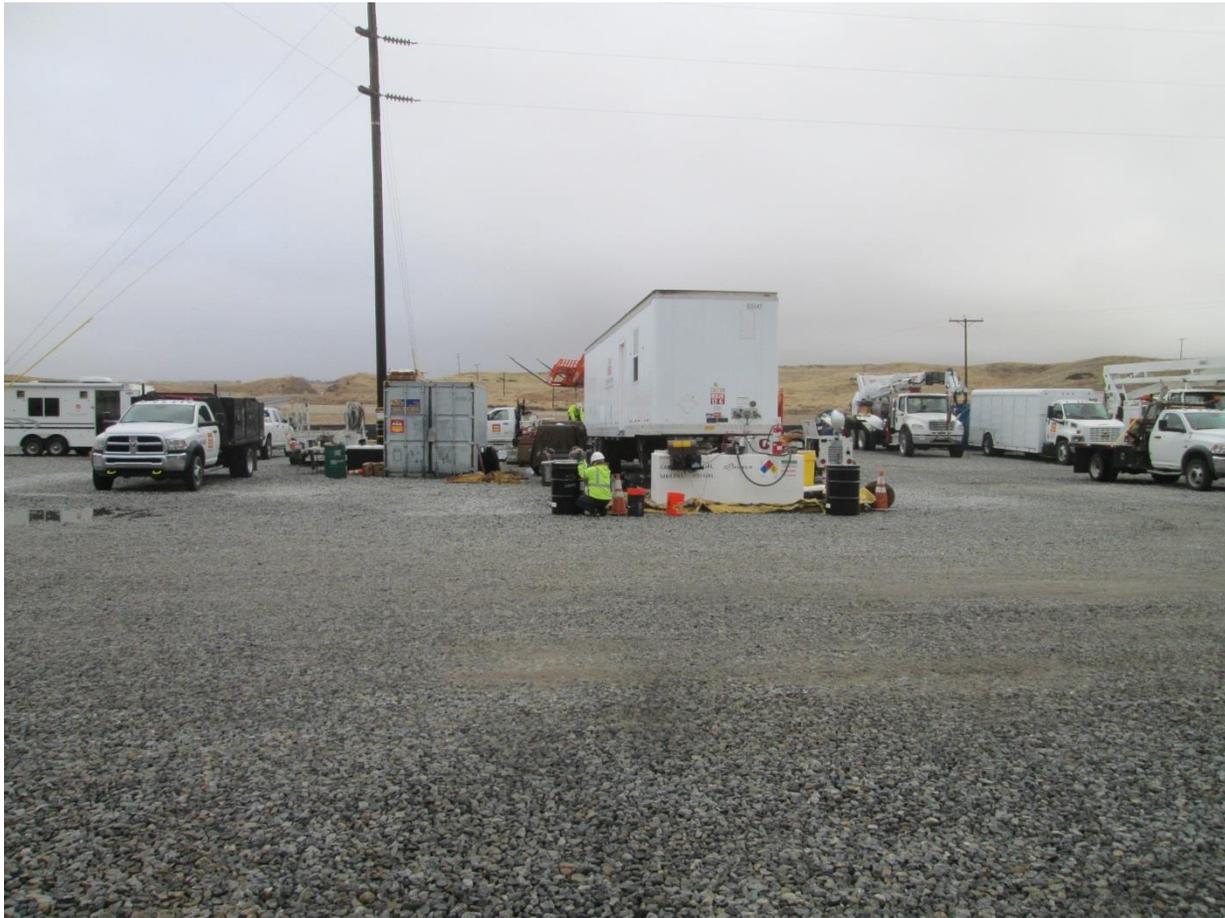
Photo 6: A construction contractor environmental compliance monitor is observed using absorbent pads to separate and soak up oil/gas sheens from accumulated rain water in spill prevention containers at the Warner Substation Staging Yard (TL 682) in accordance with the Spill Response and Notification Plan and MM PHS-2.
