California Public Utilities Commission <i>Mitigation Monitoring, Compliance, and Reporting Program</i>
	Cleveland National Forest Power Line Replacement Projects Compliance Status Report: 037 February 18, 2018

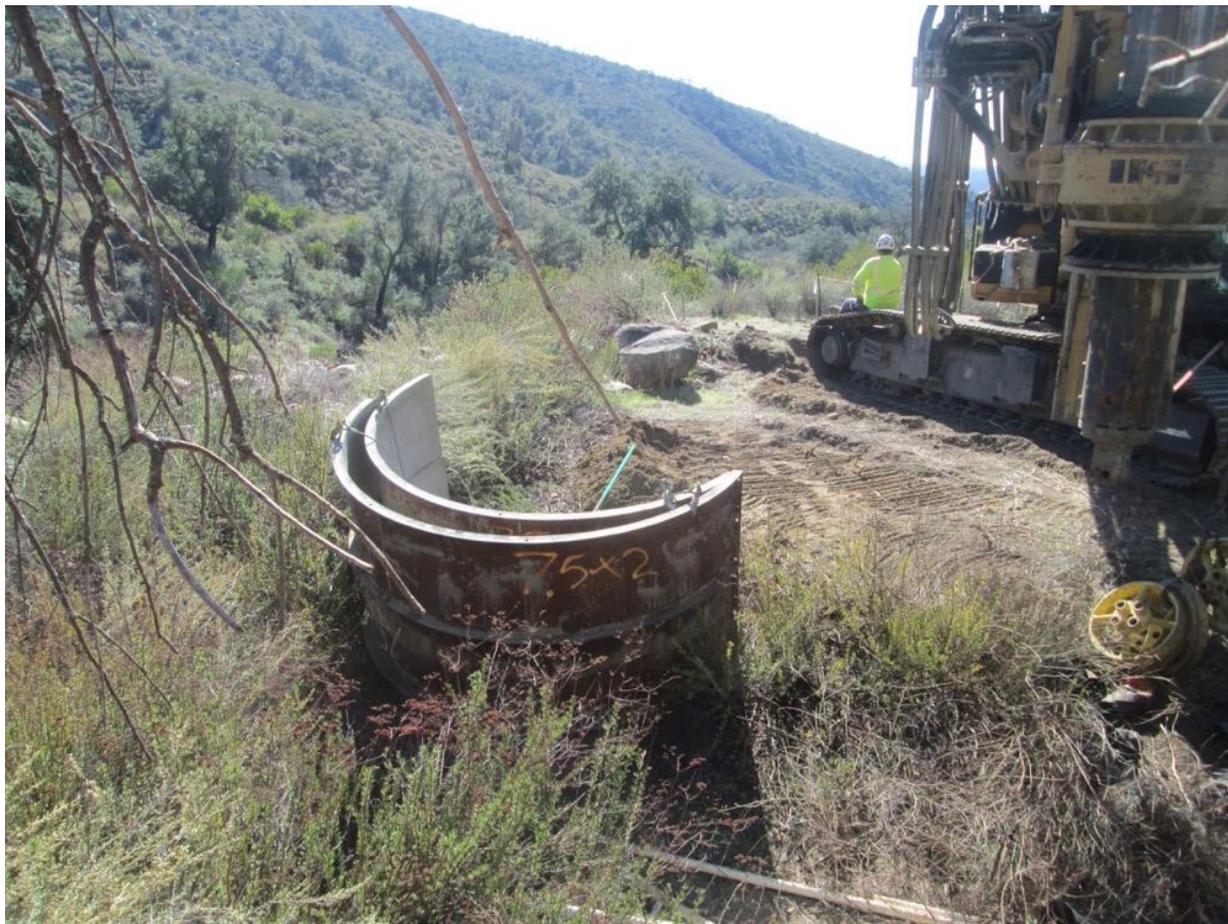
During construction activities, crews were observed adhering to delineated work limits and working within existing access roads in accordance with MM BIO-1. On February 6, a third party ECM observed that a foundation form had been set approximately three feet outside of the work limits at Z118018 (TL 682) where a crew was setting up for pole hole drilling (See Photo 1 – Attachment A). The Lead Environmental Inspector (LEI) notified the crew foreman to move the form into the delineated work area. No impacts to sensitive resources were observed.

Photo 1: During drill site set up at Z118018 (TL 682), a foundation form was observed being staged approximately three feet outside of the delineated workspace. The LEI was notified, who contacted the crew foreman and had the form brought back inside the approved workspace (MM-BIO-1).

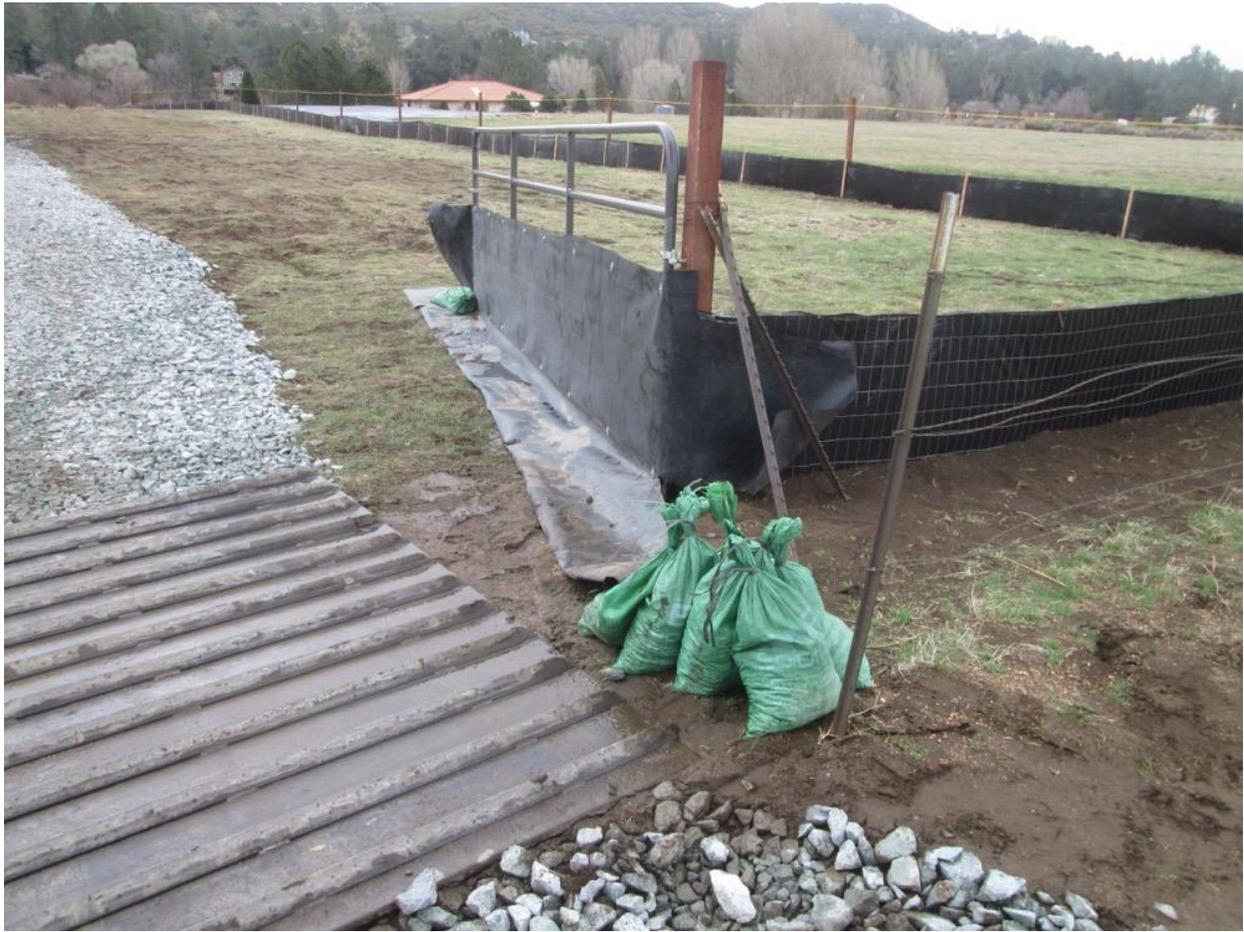
On February 12, the Lead Biological Monitor (BM) informed the third party ECM that silt fencing had been installed as exclusionary fencing surrounding the Creekside Staging Yard at the recommendation of the authorized arroyo toad biologist (See Photo 2 – Attachment A).

Photo 2: At the recommendation of the authorized biologist, arroyo toad protective measures for exclusionary purposes, such as the use of silt fencing around the yard and a rubber flap and gravel bags at the yard entrance, were observed being implemented at Creekside Staging Yard (Section 2.11 - Streambed Alteration Agreement).

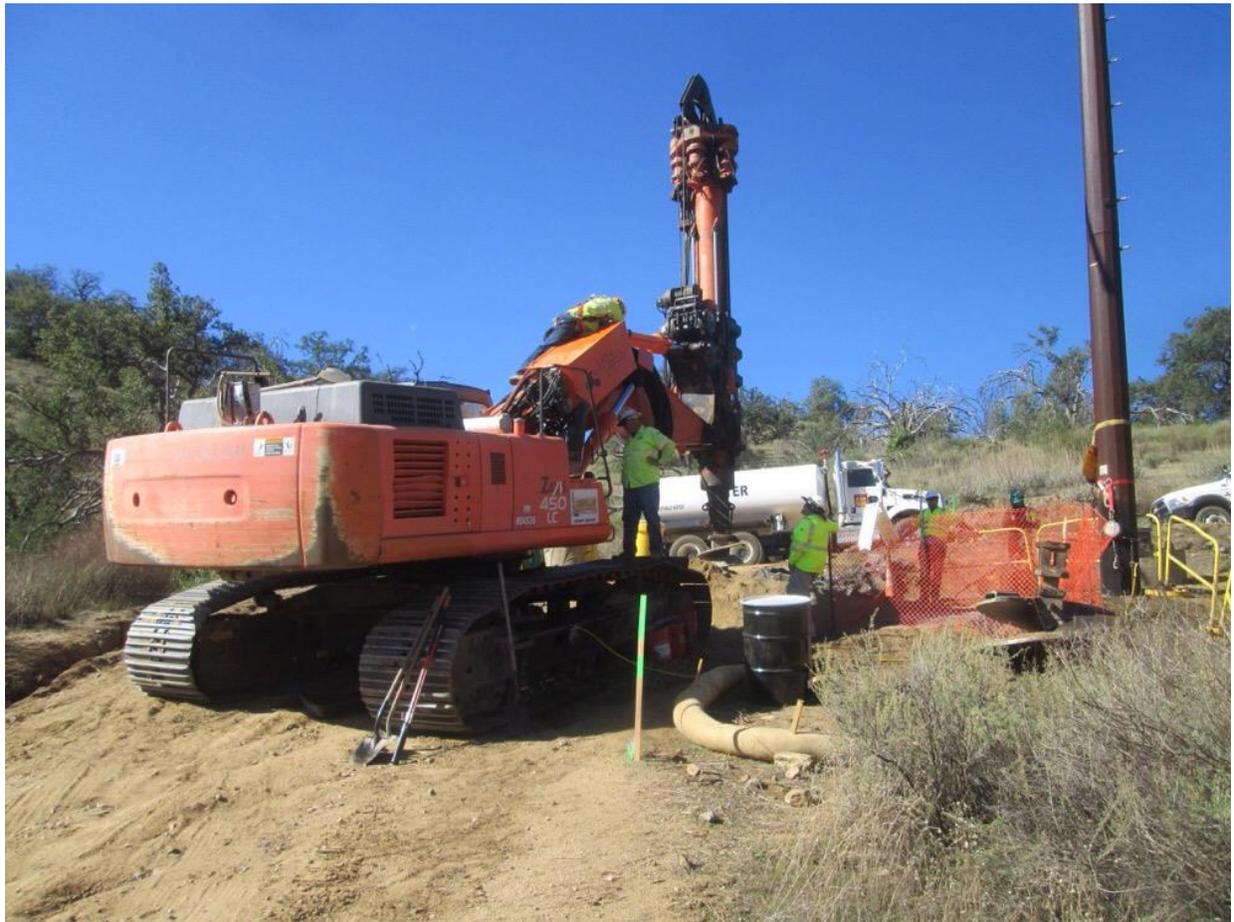
Photo 3: A drilling crew was observed repairing a hydraulic fluid leak on a drill rig and conducting stained soil cleanup. Absorbent pads and drip pans were observed being utilized, and stained soils were placed in a drum for disposal in accordance with the Spill Response and Notification Plan and MM-PHS-2.

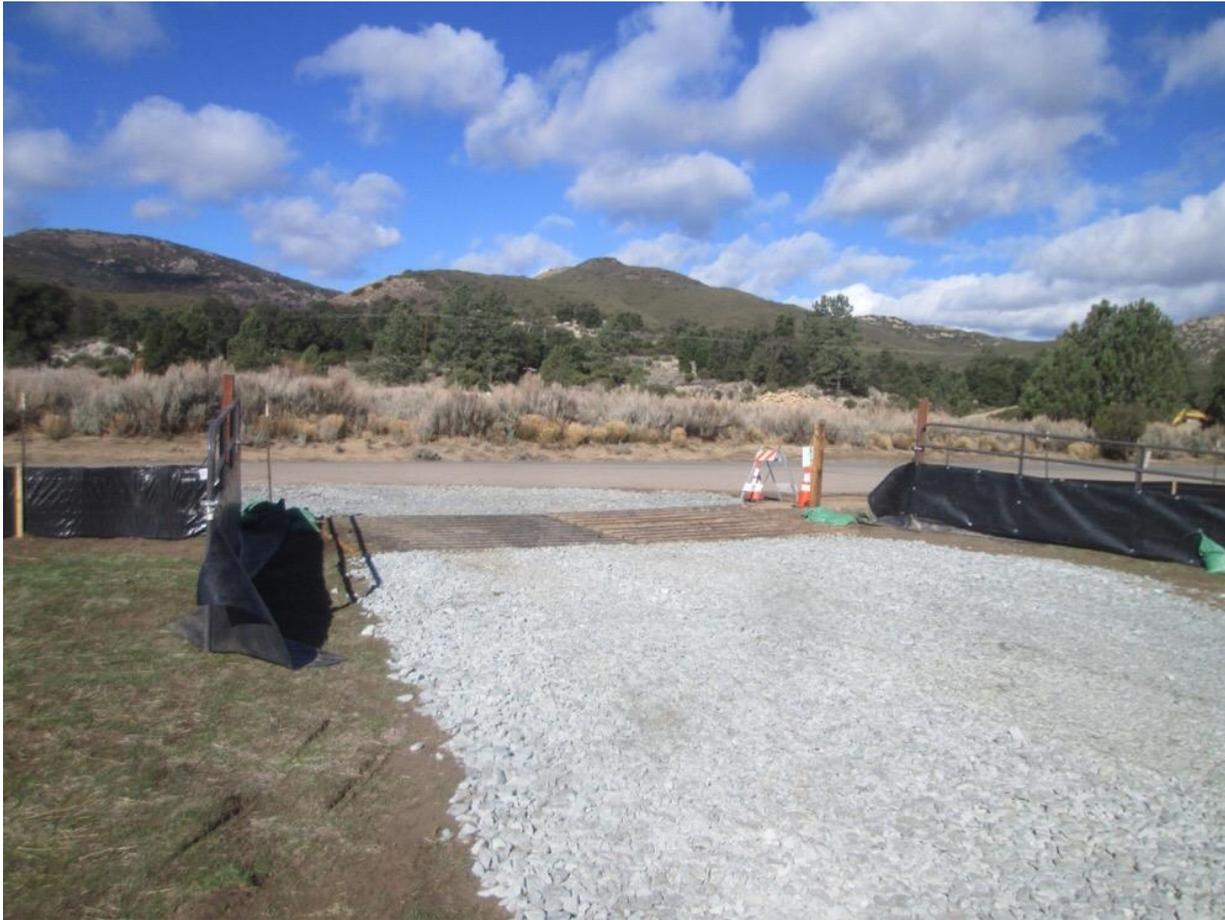
Photo 4: Track-out control BMPs, such as rattle plates and a rock apron were observed at the ingress and egress of Creekside Staging Yard in accordance with the SWPPP, Erosion Control Plan, MM-HYD-1, MM-BIO-7, and APM-HYD-09.

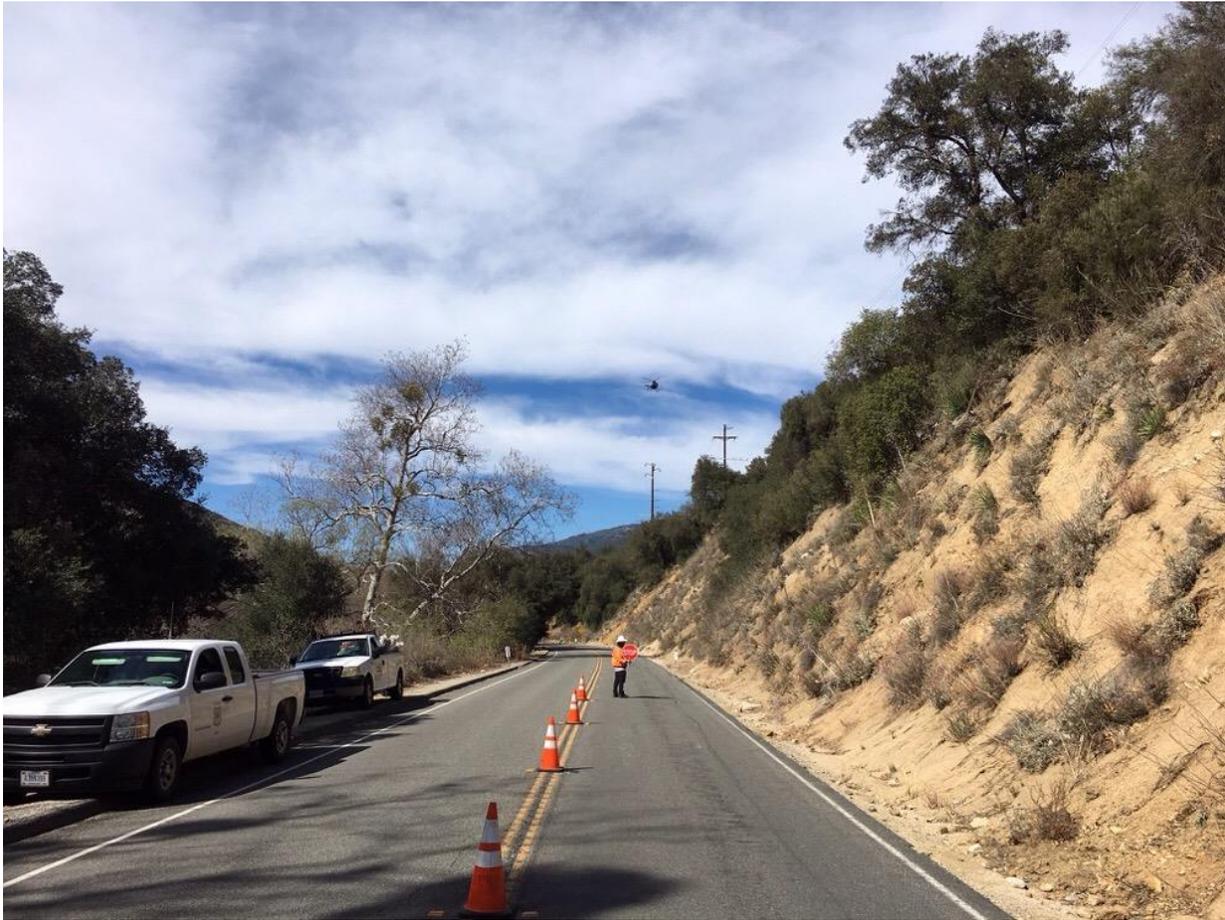
In accordance with APM TRANS-02, traffic control measures were implemented during this reporting period. Traffic control measures, such as the placement of signage and cones as well as the use of flag persons were observed along Pine Creek Road and Highway 76 (See Photo 5 – Attachment A).

Photo 5: During steel pole installation with helicopter assistance, traffic control was setup in multiple locations along Highway 76 to temporarily stop traffic when work occurred adjacent to the highway in accordance with MM-TRANS-2.
